THE SECOND RESTORATION OF THE WESTERN GATEWAY OF THE VARBOLA HILLFORT

Ülle TAMLA

RESTORATION OF THE DILAPIDATED GATEWAY IN 2006

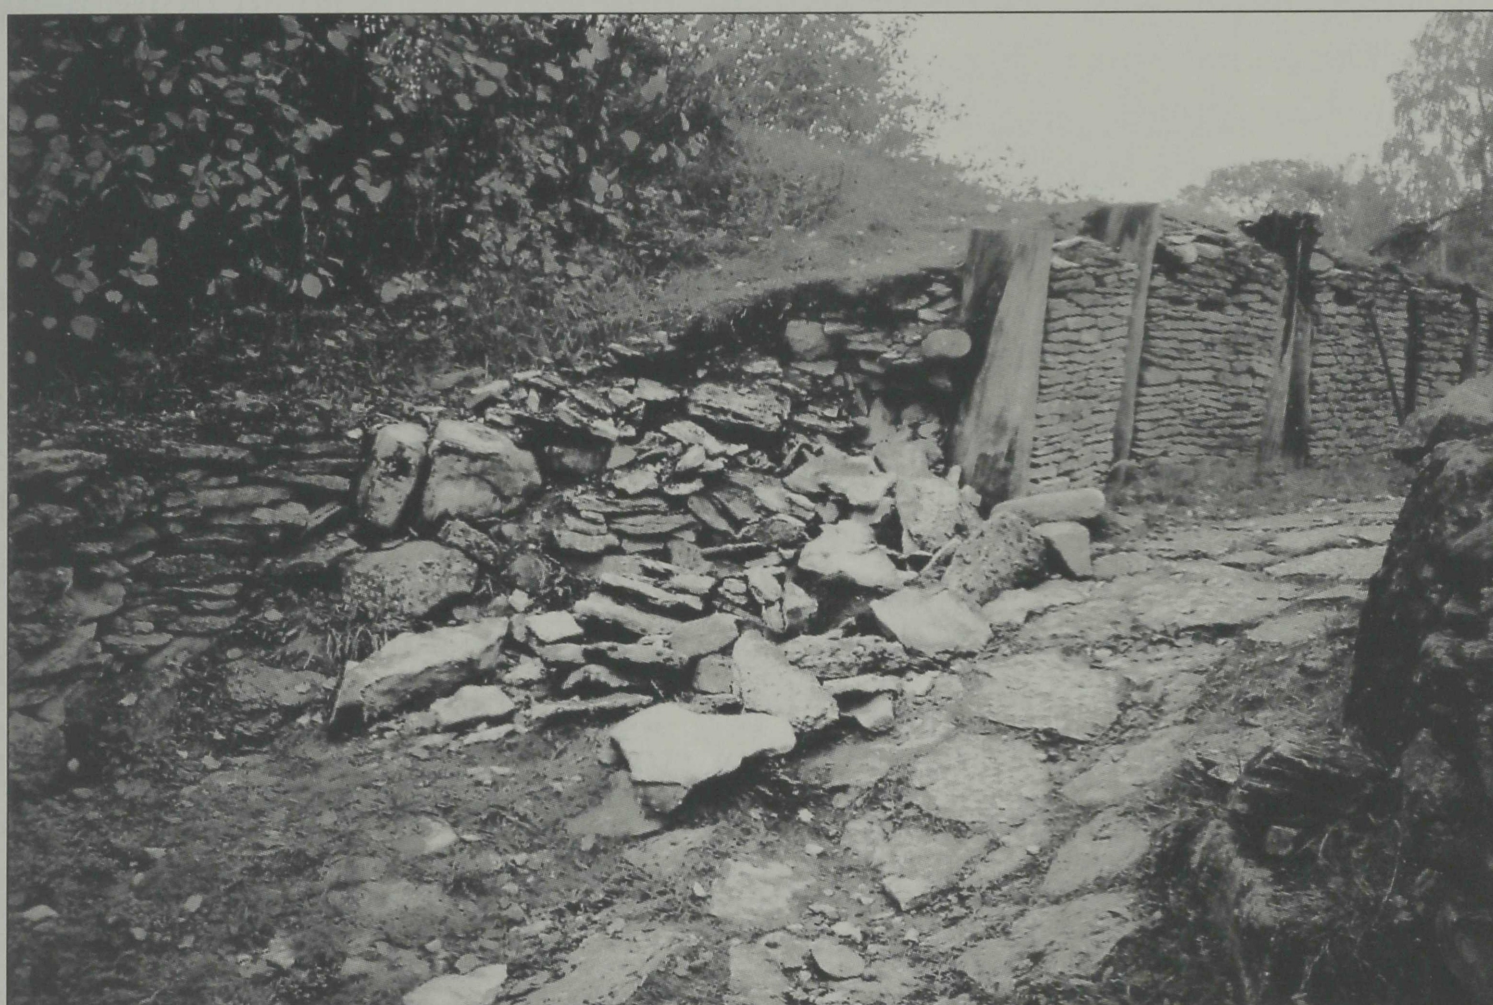
In August 2006 the western gateway of the Varbola hillfort (*Varbola Jaanilinn*), excavated and restored in 1984–1989, partly collapsed (Fig. 1). Although the damage to the fortification dating from the end of the prehistoric period was not extensive, the gateway had to be closed immediately. The entrance, restored about twenty years ago and the stage built to the courtyard at the same time, were in danger of further collapse since the heavy beams placed in each wall of the entrance during restoration were completely decayed.

*Fig. 1. Partly collapsed western gateway of the Varbola hillfort in August 2006.
Jn 1. Varing Varbola linnuse läänepoolses väravakäigis. Pildistatud 2006. a augustis.*

of the gateway in the course of the first restoration were decayed, which was the main reason why the westernmost post in the northern wall broke at the ground level and caused the collapse of a 1.5 m long and 1 m high section of the wall into the gateway (Fig. 1). To stop further dilapidation of the gateway it was decided to replace the decayed posts in the wall with new ones. It was also agreed that this time the posts must be of deeply impregnated softwood. At present the only supplier of deeply impregnated timber in Estonia is Kestvuspuit Ltd in Palivere, County of Läänemaa. The impregnation of timber there is performed in a hermetically closed chamber at high temperature and pressure. This method takes the preservative deep

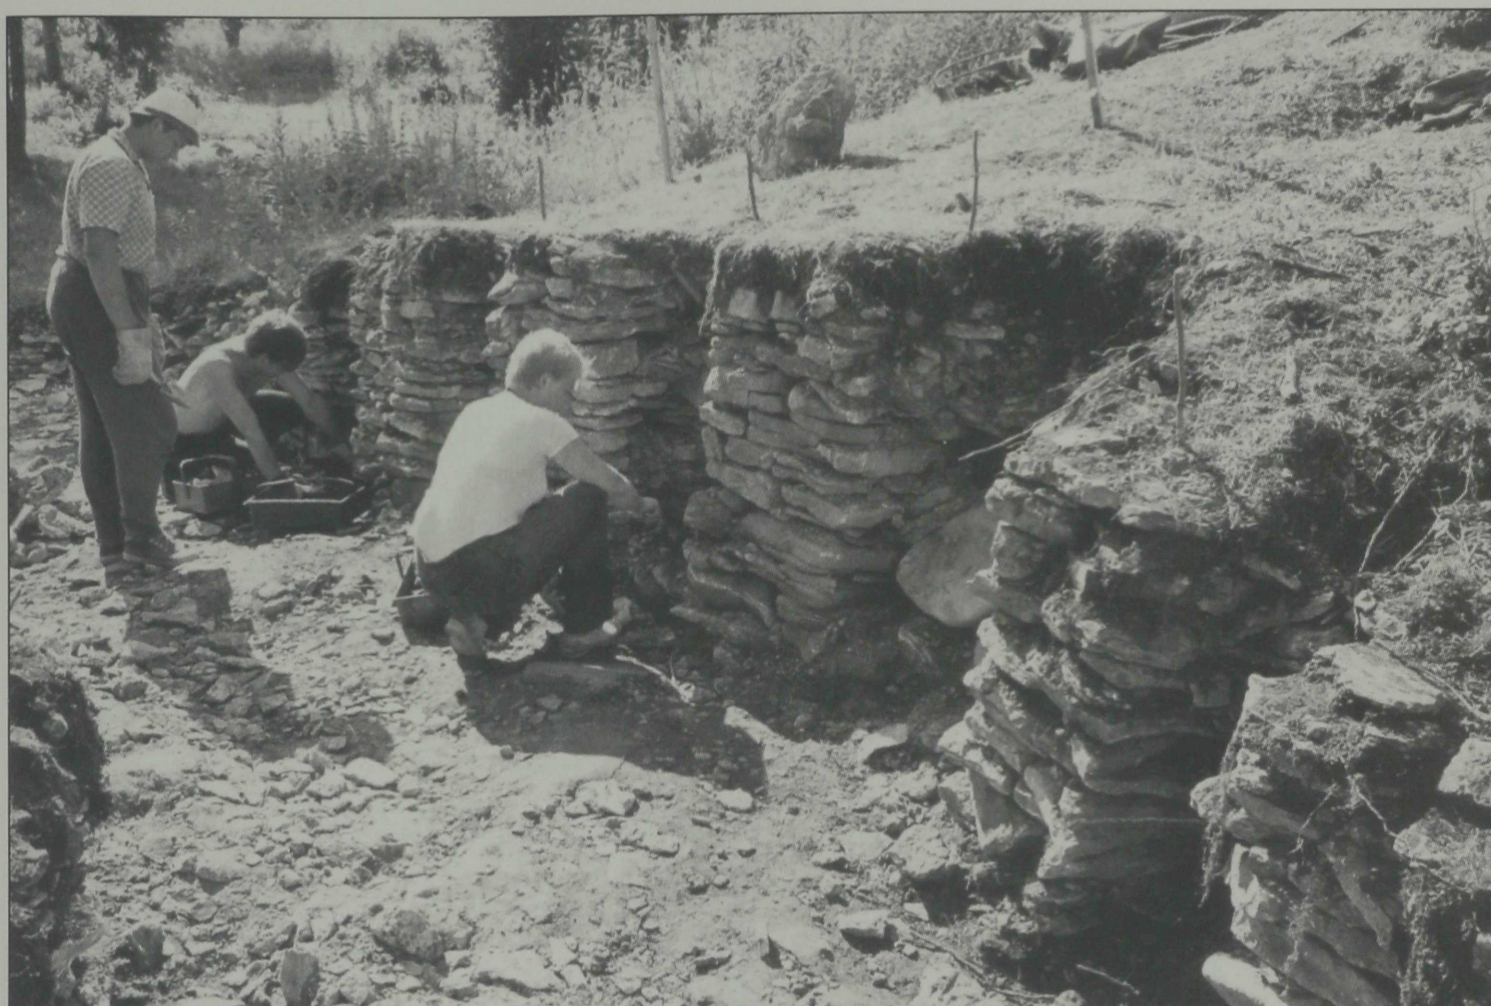
Fig. 2. Well preserved sections of the southern front wall of the western gateway.
Jn 2. Hästisäilinud esimüüri osad läänepoolse väravakäigu lõunaseinas.

destroyed parts must be restored so that the general appearance of the gateway would be historically correct. Therefore the rear wall of the southern side was preserved as it had come to light in the course of the excavations. Of the front wall the 1.0–1.3 m high sections between the posts were preserved (Fig. 2). Since the limestone slabs of the front wall were heavily damaged by fire, new stones were laid upon the original construction to stop the dilapidation. The new posts placed in the existing gaps also helped to preserve the front wall (Fig. 4). Suitable beams for the posts were cut in the nearby forest, where six dead pines with a diameter of 40–45 cm were chosen for that purpose.

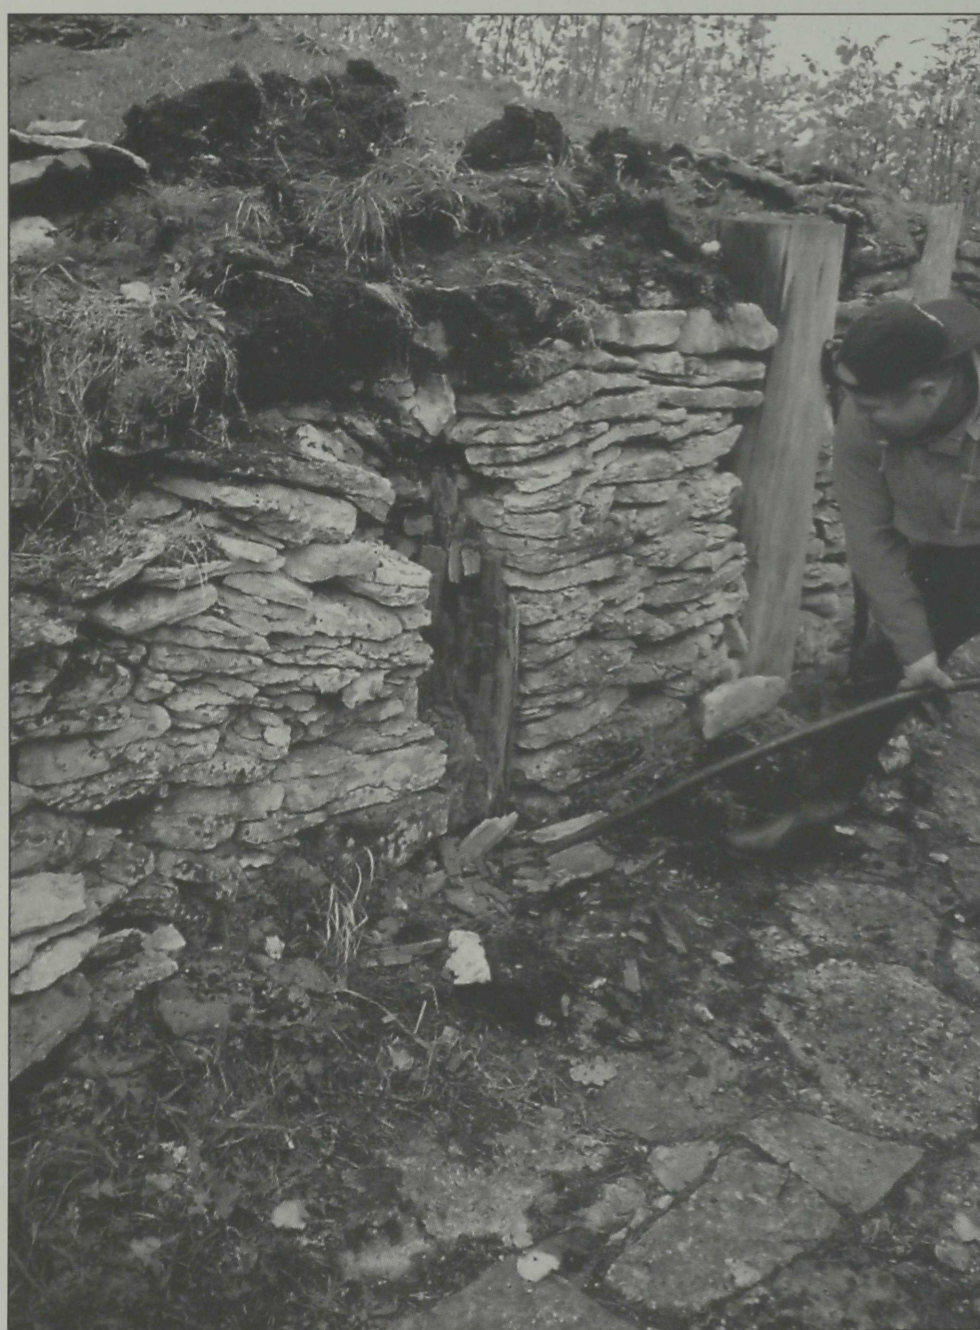
Fig.5. The removal of the first decayed post in 2006.
Jn 5. Esimese kõduposti eemaldamine 2006. a.

crumbled to the extent where their preservation was impossible (Fig. 5). Only in two places - the sections between the 1st and the 2nd, and the 2nd and the 3rd posts from the yard - 6-7 bottom stone layers could be left in their original places.

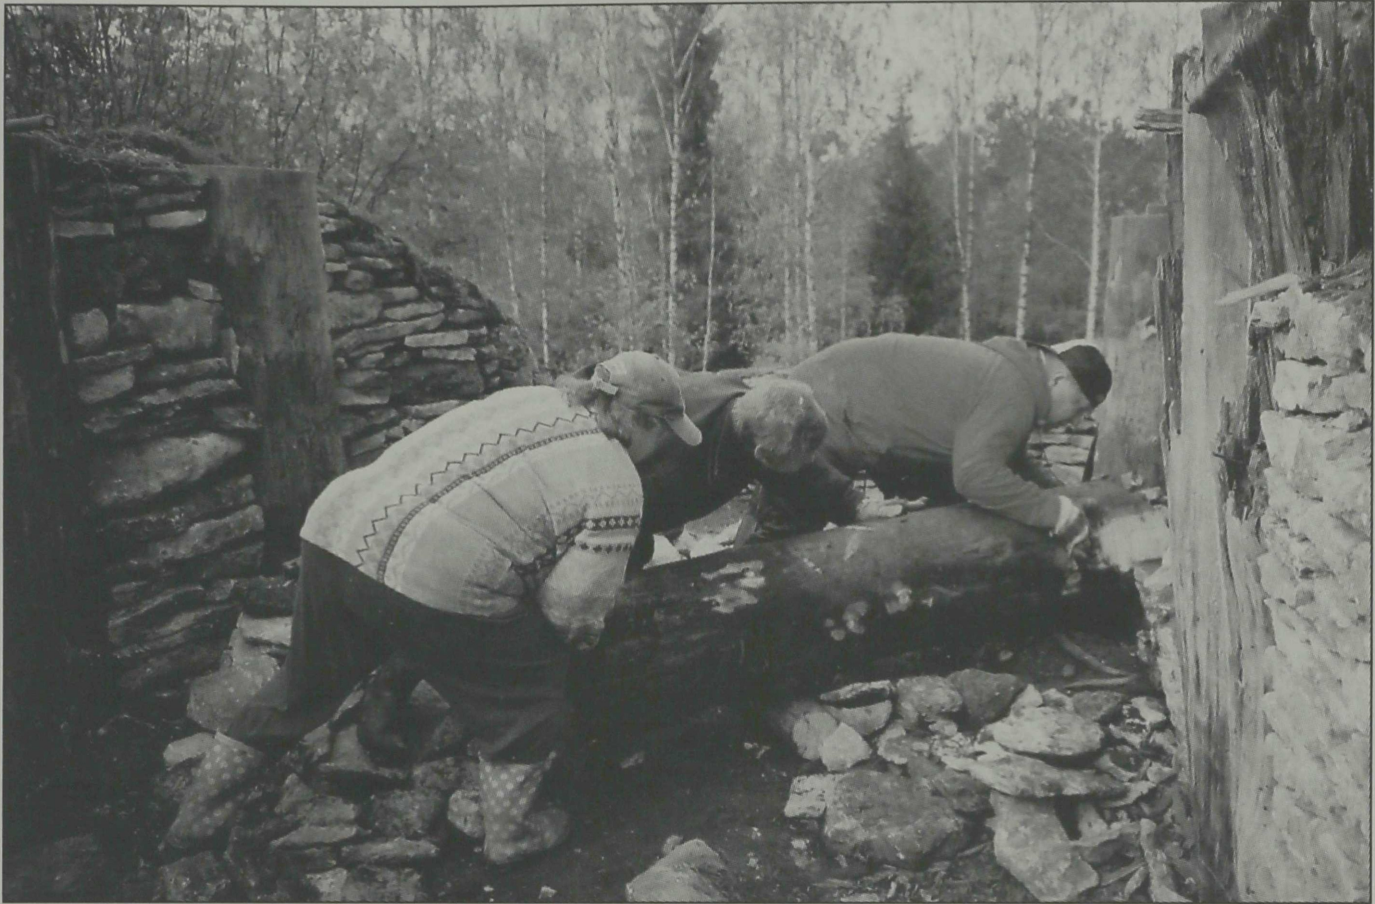
*Fig. 6. Placing a new post into the post-hole. View from East.
Jn 6. Uue posti asetamine postiauku. Vaade idast.*

For installing new posts the post-holes had to be cleared of the decayed wood and stones used for wedging. Then the posts were placed in holes, one by one (Fig. 6), and wedged

tightly. After that new front walls were built between the posts, laying the stones without mortar, slightly aslant towards the core of the rampart. In the southern wall of the gateway six large limestone slabs were lain one upon another against the seventh post, with a 0.7 m thick bioherm on the western side. This large upright stone marks the place in the southern wall where it curved out towards southwest, which may also be regarded as the outer end of the gateway.

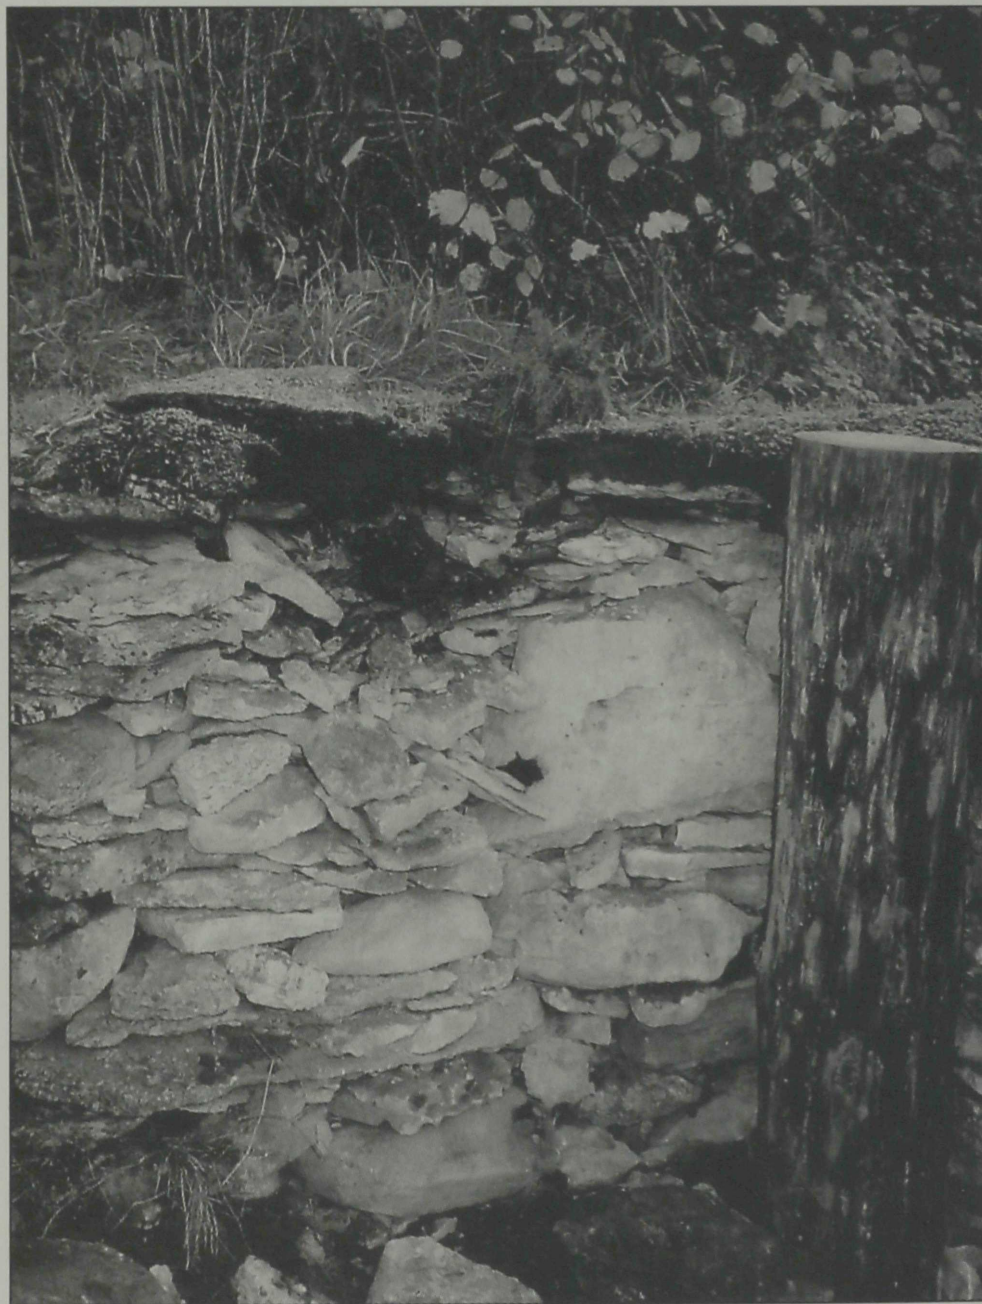
Fig. 7. The preserved rear wall section in northern wall of the gateway. View from S.

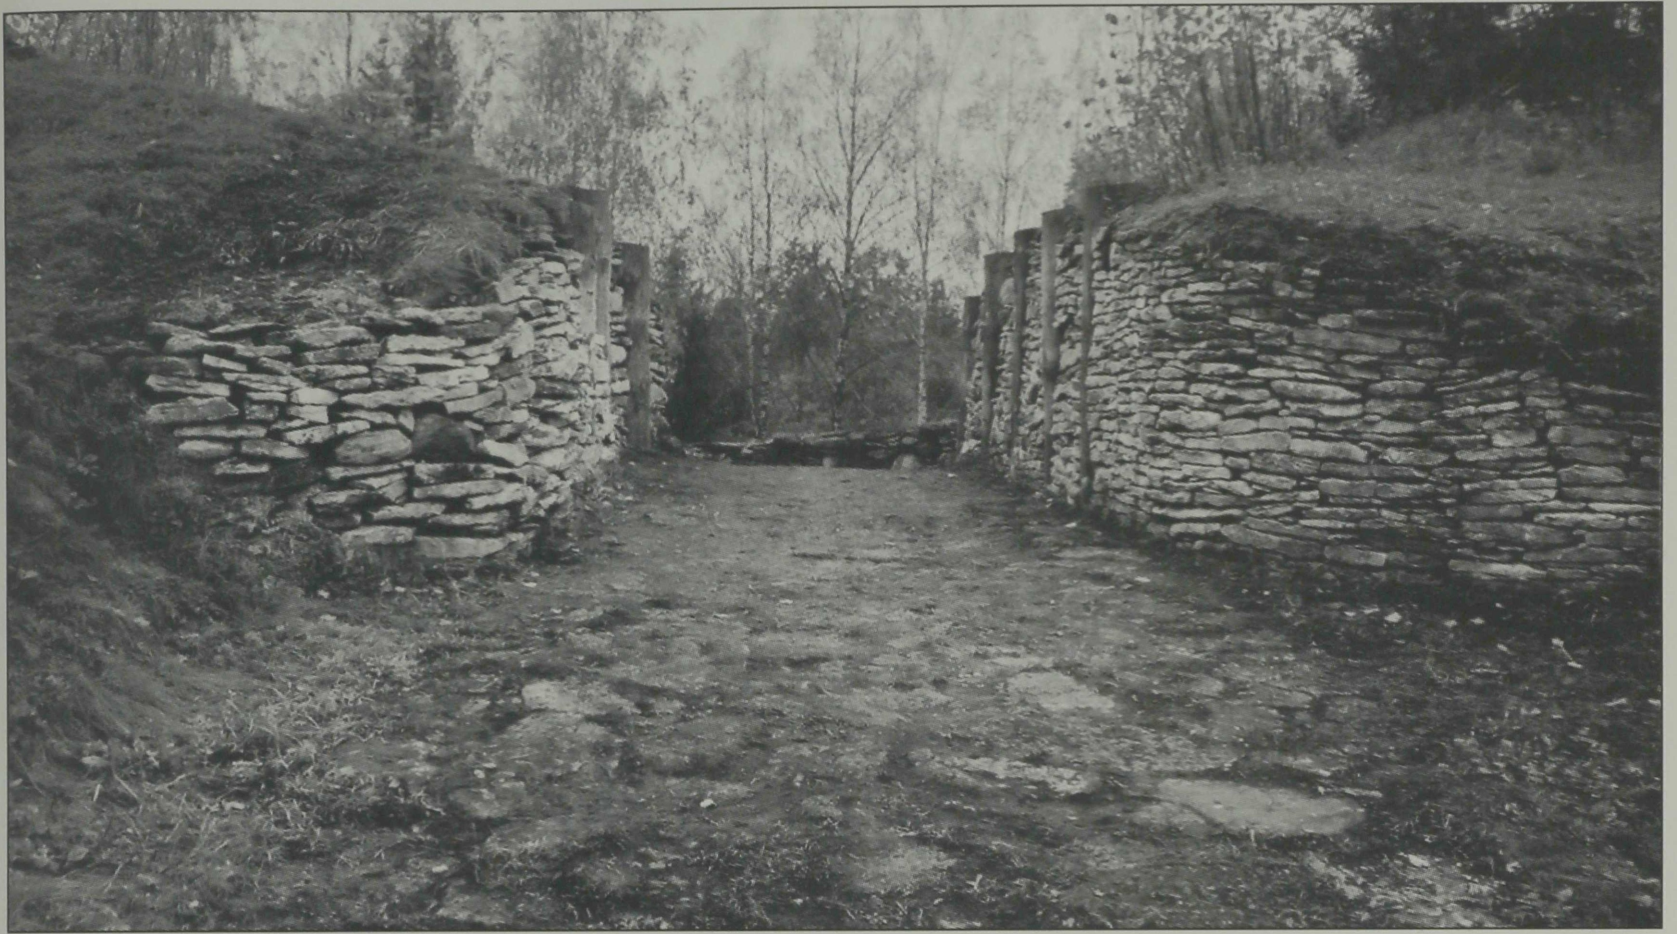
Fig. 8. View to the western gateway after the second restoration from the yard in October, 2006.
Jn 8. Vaade Varbola linnuse õuelt värskelt restaureeritud läänepoolsele väravakäigule 2006. a oktoobris.

The restoration of the gateway was completed by clearing the pavement of the gateway. The crumbled slabs were replaced and the edges of the restored walls were covered with turf. Differently from the first restoration the post tops were not covered with sheet metal this time. After the restoration in 2006 the gateway (Fig. 8) largely resembles the gateway after its first restoration in 1989.
