THE MEDIEVAL AND MODERN ERA BUILDING COMPLEX AT 2 LUTSU STREET IN TARTU

RESULTS OF THE ARCHAEOLOGICAL, ARCHITECTURAL
HISTORICAL, DENDROCHRONOLOGICAL AND
OSTEOARCHAEOLOGICAL RESEARCH

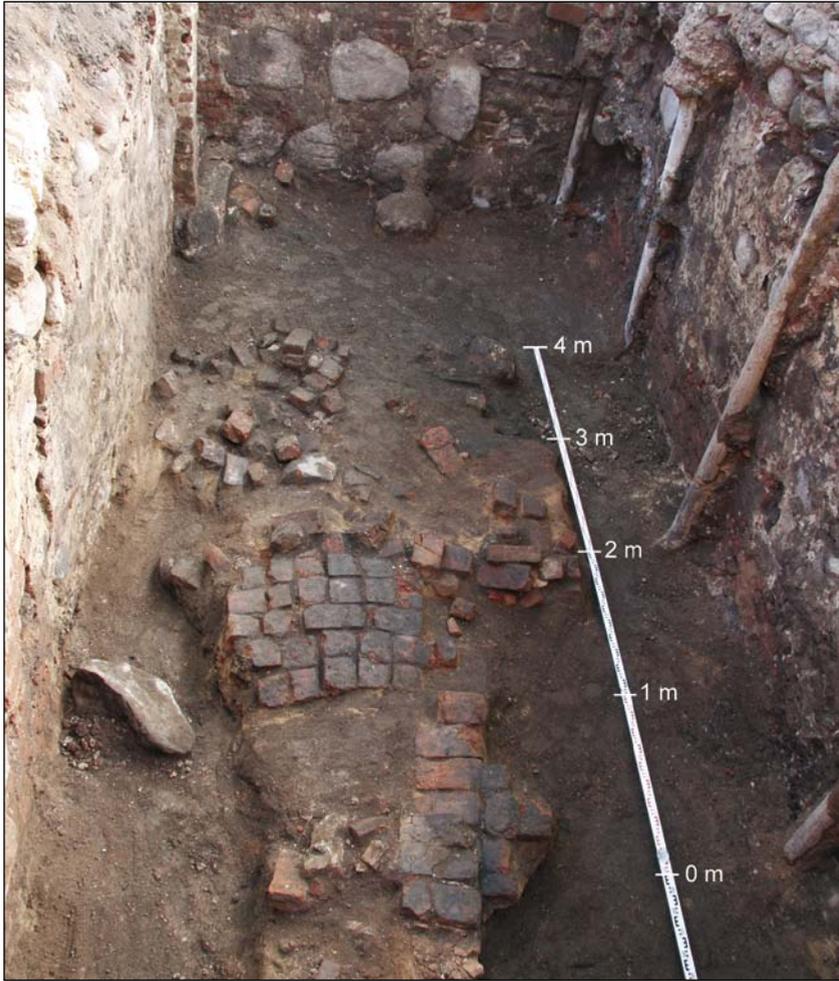
Fig 3. View of room 1 of medieval building I from the northwest. Kristel Külljastinen.

of more than two meters until the supporting structures of the partition joists of the main floor (Fig 3).

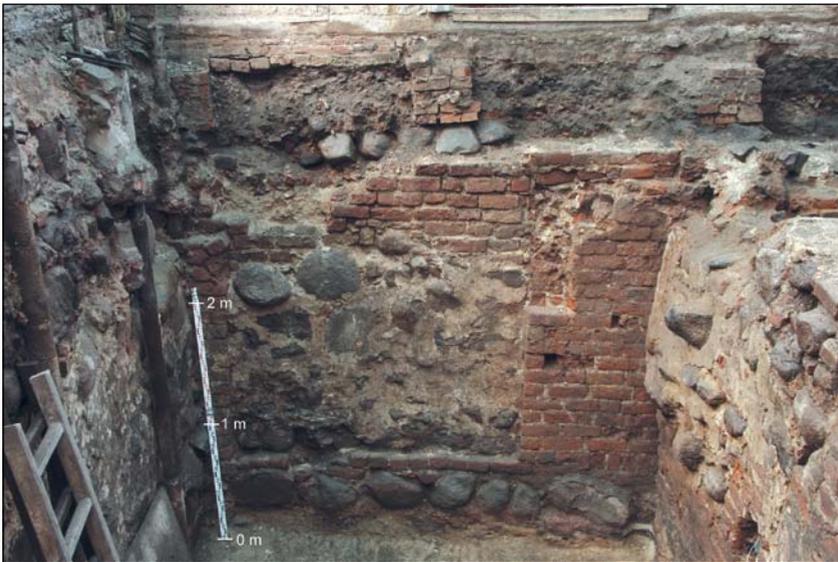
Fig 5. View of the northwestern wall of room 1 of medieval building II from the south-east. Kristel Külljastinen.

The 90–110 cm thick northwestern wall was built on the filling layer, consisting of pieces of bricks against the southwestern wall of room no 1 and continuing towards the northeast into room no 3. The foundation was laid of boulders and the wall of bricks. In the northeastern part of the northwestern wall the section protrudes from the rest of the wall by one vertical brick layer, a probable later inset. A vaulted door (gate?) opening, with a height of 190 cm and a width of 230 cm that was bricked in with boulders with a diameter of up to 60 cm, is located in the southwestern part (Fig 5). The filling was covered with plaster.

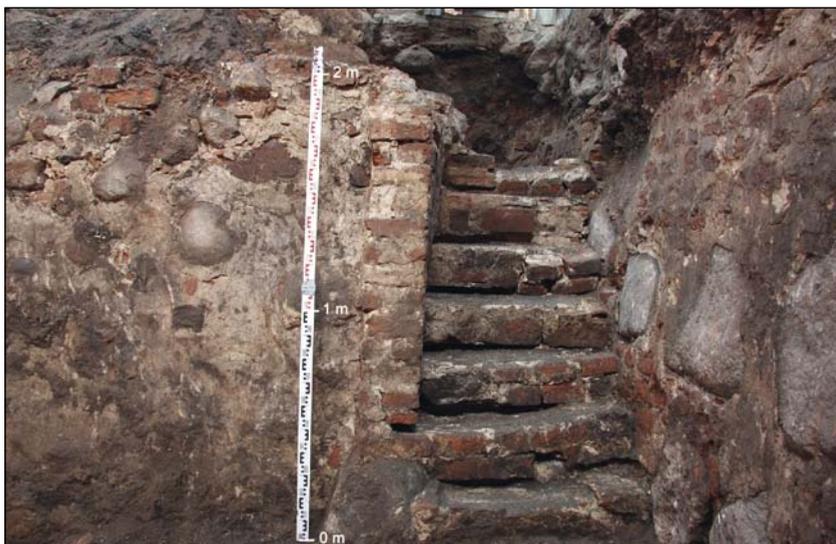
Fig 6. Part of the northeastern wall of room 1 of medieval building I, and a staircase. Kristel Külljastinen.

A 95 cm wide staircase (Fig 6) of bricks is situated in the northeastern wall of room no 1. The staircase has seven preserved steps with a height of 18–24 cm and a depth of 25 cm. The staircase was established against the southeastern wall of room no 1. The northwestern inner side of the stairway, made of bricks, was laid against the second construction stage of the northeastern wall. As indicated by the 7–15 cm deep and 2 cm high gaps in the partition wall and the back wall of the highest step, the staircase was covered by boards. In parts, timber was preserved which gave 1330 ± 70 AD (Tab 1) as the result of the radiocarbon analysis.

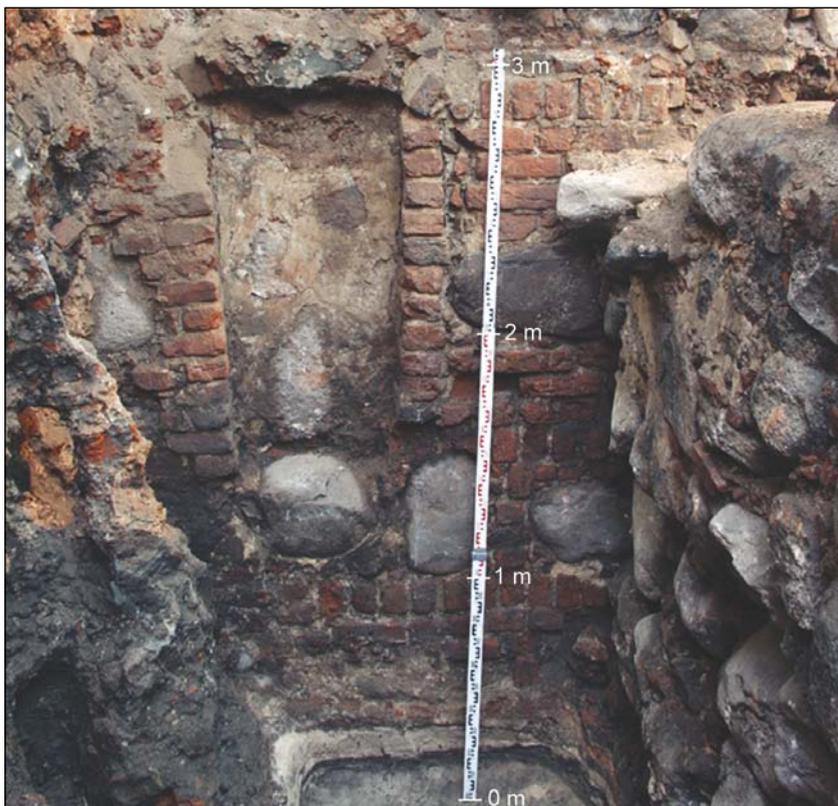
Fig 7. The southeastern wall of room 2 of medieval building I. Kristel Külljastinen.

The southeastern wall of room no 2, only part of which was opened, was established on a dark soil layer deposited on natural travertine. The lower part of the wall consisted of bricks that supported a row of boulders, and the upper part was made of both bricks as well as boulders. Differently from room no 1, this wall in room no 2 has not been daubed, although we are dealing with the continuation of the same wall. An approximately 145 cm high and 65 cm wide vaulted door opening (Fig 7) is situated in the central part of the unearthed wall. The door had been bricked in with boulders and densely covered with plaster.

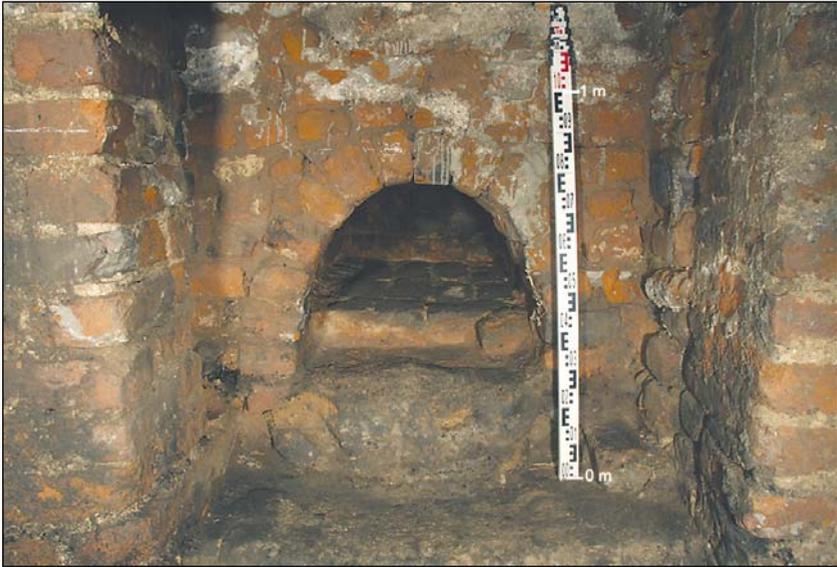
Fig 8. View of the orifice of the stove-hypocaust from the northeast. Kristel Külljastinen.

From the northwestern side, room no 2 was encircled by a stove-hypocaust (Fig 2). The inner dimensions of the hypocaust from the top were 130 cm from northwest to southeast, in the northwestern wall 145 cm, and in the southeastern wall 135 cm from northeast to southwest. The heater cobbles with the diameter of 10–40 cm had been swollen and brittle from the strong heat. The cobbles had been laid on the arches and against the inner walls of the stove so that smaller ones could be situated above with bigger ones below. The inner walls of the stove, laid of bricks and some boulders, were built against the detaching wall of rooms 1 and 2 in a way that indicates that the northeast-southwest directed walls of the stove were established first and the northwest-southeast directed wall with the stove orifice later. Red clay was used as the binder. The up to 52 cm high and 68 cm wide vaulted orifice of the burner of the hypocaust is located in the northeastern wall (Fig 8). A step of bricks and boulders was established by the southeastern, southwestern, and northwestern walls of the stove. The step supported both the two arches that carried the heater cobbles (Fig 9) as well as the heater cobbles themselves (Fig 10). Both the width as well as depth of the heating chamber under the arches is 100 cm, and the height measured from the bottom of the stove up to the center of the arches is 60 cm. The bottom of the chamber was laid of bricks.

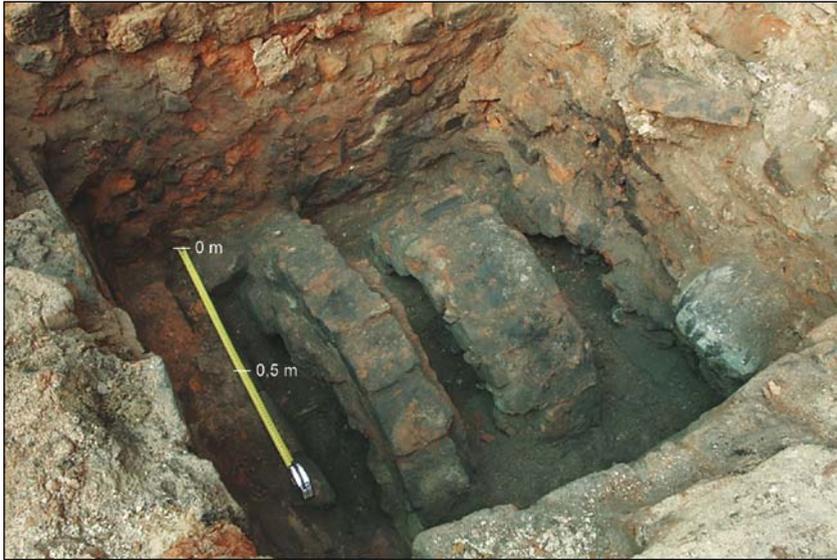
Fig 9. View of the inner vaults of the stove-hypocaust from the south. Kristel Külljastinen.

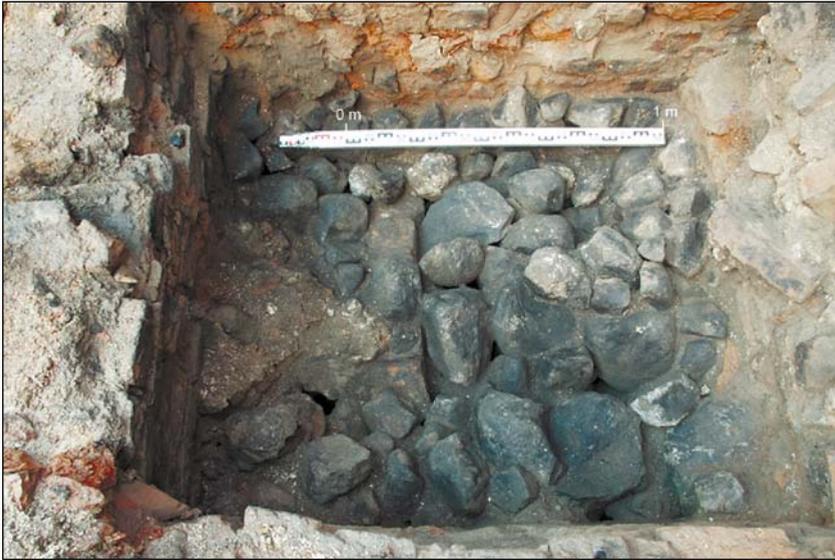
Fig 10. View of the heater rocks of the stove-hypocaust from the northeast. Kristel Küljastinen.

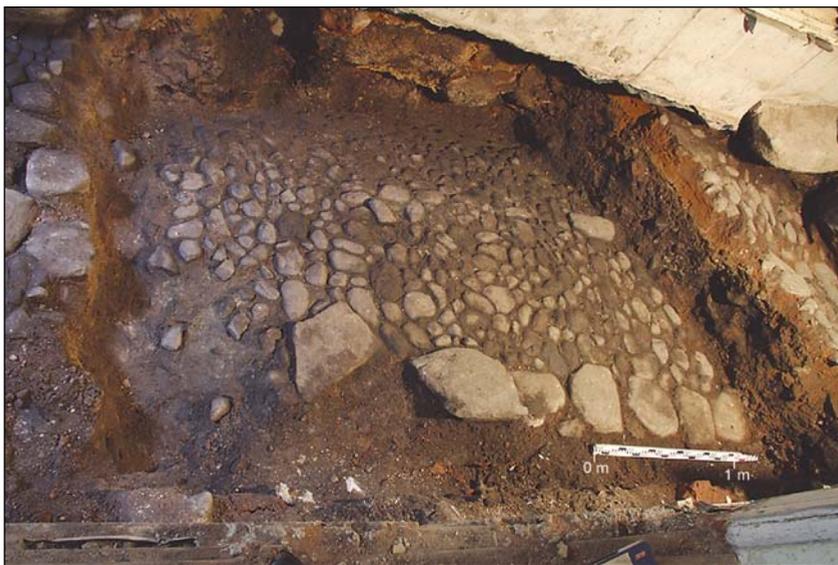
Fig 13. View of the lower paving above room 4 of medieval building I from the south-east. Kristel Külljastinen.

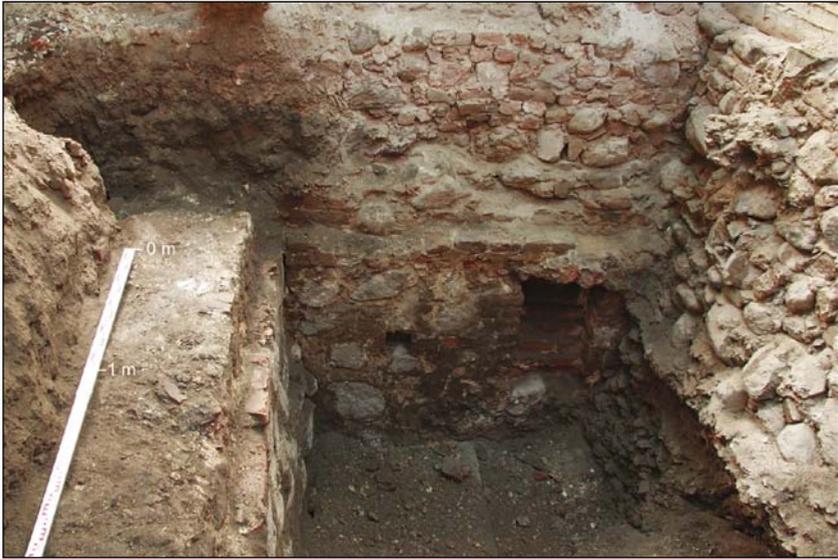
Fig 14. View of the remains of the walls of medieval building II from the northwest. Kristel Külljastinen.

The northeastern and southeastern walls of the ground floor (Fig 14) of the unearthed stone building have been preserved up to a height of 2 m and were simultaneously established on the above-described reddish planning layer. The walls of bricks and boulders were erected on the foundation consisting of boulders. In the upper part of the preserved sections of both walls, there is a 14–18 cm deep step that supported the former ceiling

construction. The thickness of the northeastern wall below the step is approximately 105 cm and above the step approximately 90 cm. A 100 cm high and 55 cm wide shaft (Fig 14 and 15) is situated in the southwestern part of the southeastern wall. Both the edges of the shaft as well as the diagonally risen plane have been laid of bricks. A 15×18 cm big and approximately as deep hole, probably established for the scaffolding, is situated in the northeastern part of the same wall. Both walls were plastered. The initial floor was a 5–10 cm thick layer of light lime mortar of even composition.

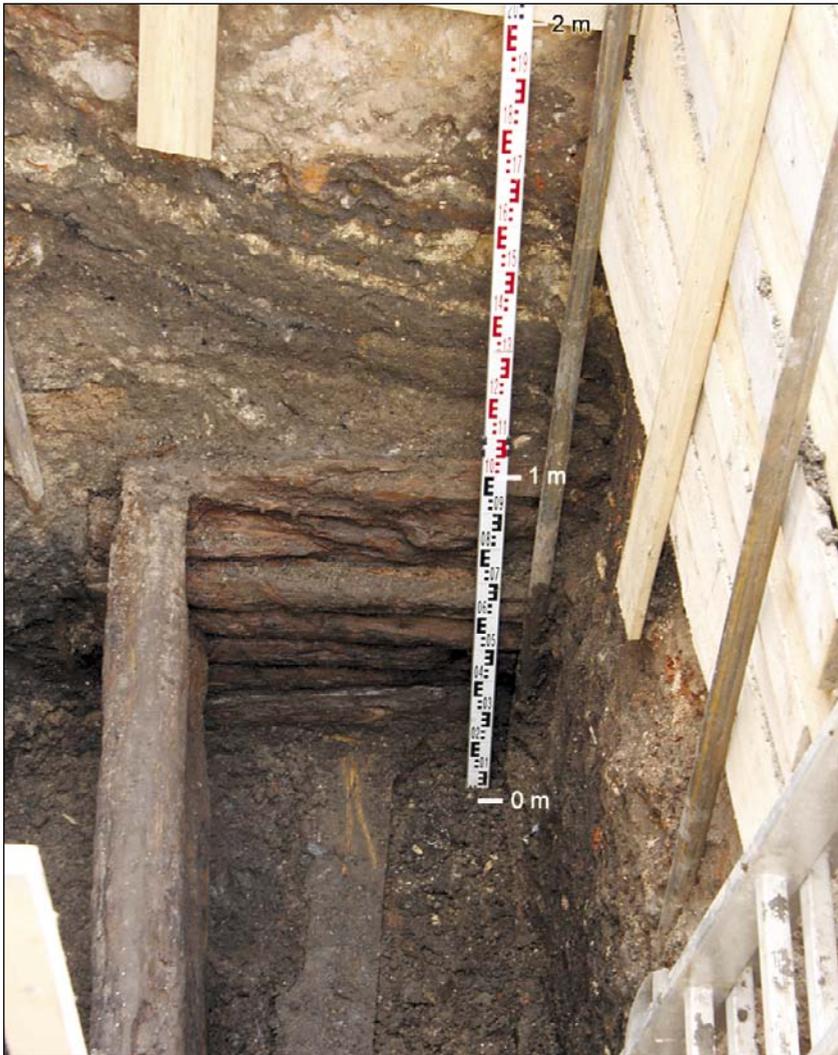
Fig 16. View of the partly excavated latrine bin from the southeast. Kristel Külljastinen.

Outside the building, primarily modern era layers have been investigated in connection to the securing of the foundation, the laying of pipes, and the works in the courtyard. As an exception, a medieval latrine bin was opened up (Fig 16). It was located 1.4 m to the northeast from the center of the northeastern side of the modern building at 2 Lutsu Street. It was possible to investigate the latrine only to the extent needed for construction works. The southwestern side of the bin, 2.4 m long, and partly on the southwestern side (1.15 m) were excavated and cleaned to the depth of seven logs. The bin had been built from unpeeled logs of an average diameter of 10–15 cm, and connected by saddle-notch corners. In the bin there was a dark brown organic-rich layer of soil, from which some leather objects and leftovers from leather crafting (TM A 178: 10882, etc.) as well two pieces of a birch bark vessel (TMA A 178: 10 880, 10 881) were found. Since other latrine bins found and examined in Tartu have been as a rule situated in central parts of the lots in central areas of house quarters,¹³ it is reasonable to assume that the bin at 2 Lutsu Street was also placed in what was previously a courtyard and that similar latrine bins could be found in the proximity.

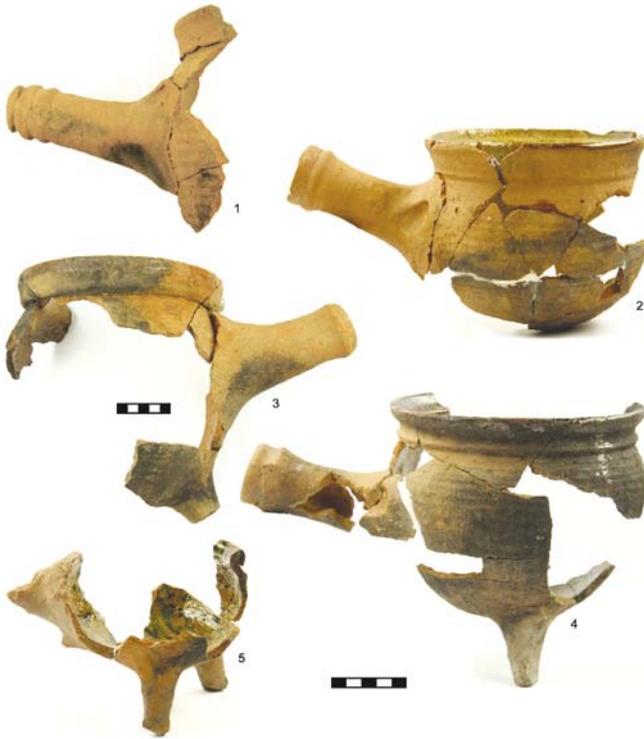
Fig 18. Fragments of tripods from the filling layer of medieval building II (1,2,3,5) and from room 1 of medieval building I (4) (TM A 178: 5694, 5708, 5712, 4829, 6050). Kristel Külljastinen.

The volume of everyday pottery found in the filling layers is different in each room. From the filling of the ground floor of medieval building II many tripods with glaze, probably made in Tartu (Fig 18: 1, 2, 3, 5), as well as fragments of bowls and plates (e.g. TM A 178, etc.) and a complete clay mug were found. There are somewhat fewer examples of imported pottery in the findings; among the material there are fragments of a Frechen stone-ceramic bottle dated to the seventeenth century (TM A 178: 3928) and of a Westerwald jug with blue décor (TM A 178: 172, 3535).¹⁷ There are also pieces of unglazed wheel-thrown pottery, some of which are from the medieval and early modern periods. Some tools – for example knives, scissors, axes – were also found in the filling layer (TM A 178: 6056, 8619). Some findings relate to the practice of war, such as a cross-bow bolt from

The filling layer of building II was rich. The relatively large volume of everyday pottery, which came in large pieces (a few even complete) (Fig 18: 1–3, 5; 19: 1), suggests that the ruins of the building were used for some time as a place for the disposal of waste. Among other things, pieces of tiles dated to the second half of the seventeenth century were found; some of them are the same as those which were found in room 2 of building I.

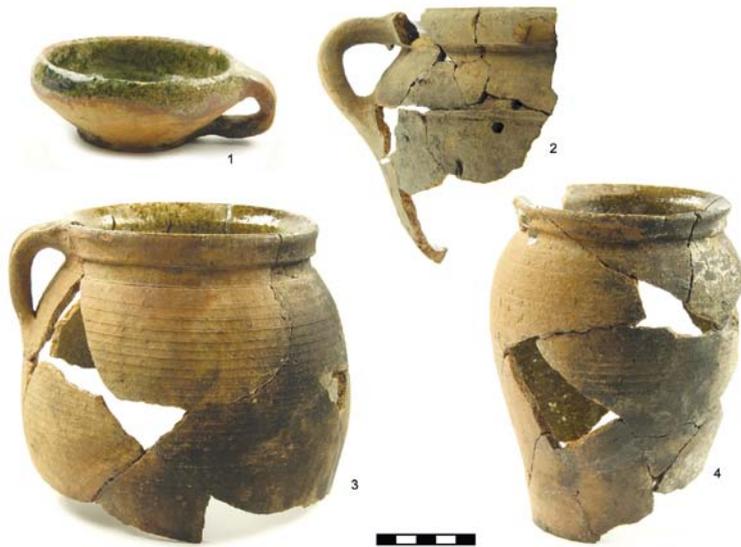
Fig 19. A ceramic cup and fragments of clay pots from the filling layer of medieval building II (TM A 178: 6054, 5710, 5683, 569). Kristel Külljastinen.

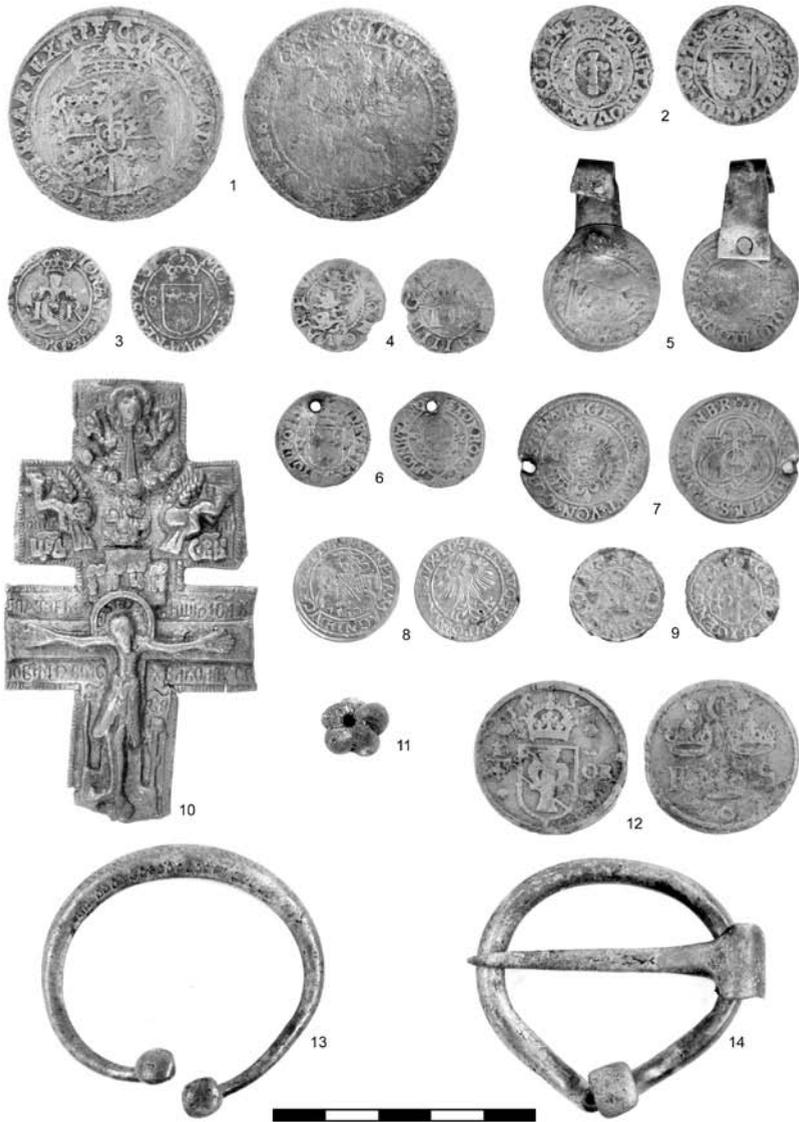
Fig 20. Coins (1–9, 12), an orthodox cross (10), string of beads (11) and penannular brooch (13–14) (TM A 178: 10761, 10770, 10763, 10764, 10767, 10772, 10762, 10766, 10765, 10892, 10773, 10771, 10774, 10769) found at excavations at 2 Lutsu Street. Kristel Külljastinen.

The finding material from the filling layers is rich and diverse, including pieces of buildings (bricks, roof blocks) and everyday pottery (Fig 18, 19), metal tools, coins from Poland-Lithuania, Sweden, and Riga (Fig 20: 1–9, 12), jewellery (Fig 20: 11, 13, 14), seventeenth-eighteenth-century cups and shanks fragment of pipes made from kaolin clay (TM A 178: 164, 5337, 5406, 5431), and animal and even human bones.

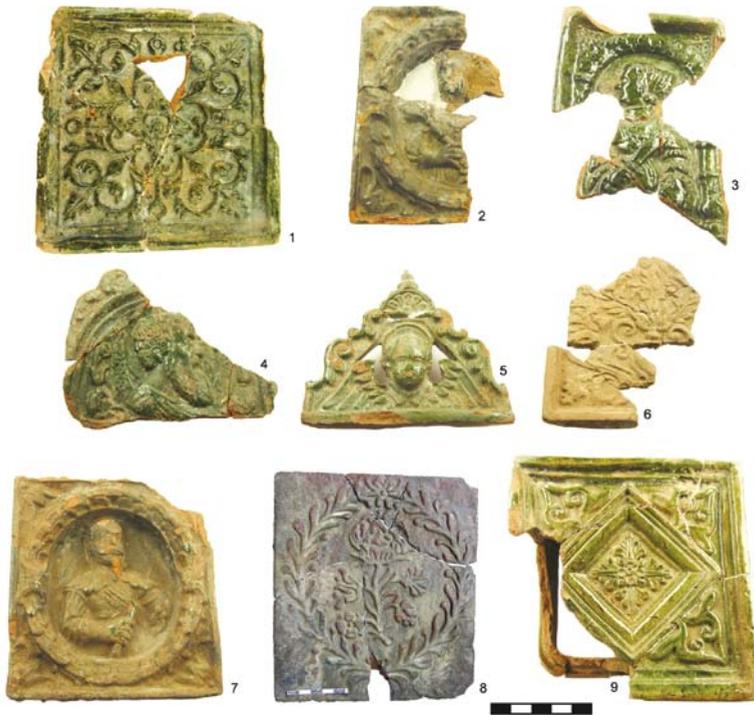
Fig 22. Glazed tiles found at excavations at 2 Lutsu Street (TM A 178: 67, 790/ 816, 3533/3534, 3502/ 3516, 9302, 2018 (1), 783, 768/3392 (1)/4239, 36/9291/9801/9825). Kristel Külljastinen.

The finding material from room 1 in building I contains rubble from the demolition of stoves of different periods. Many burnt fragments of low relief tiles, which probably belonged to a baroque-style green tower oven with plant ornament (Fig 22: 8, 23: 3) from the second half of the seventeenth century, were found from the top layer (about a meter thick) of the filling, but also from the lower layers, and even from rooms 3 and 4 of building I, and from the northeastern corner of room 4, from which the filling was removed only a few dozen centimeters deep. This was probably an oven produced in Tartu in the Swedish period, because the context of findings allows one to connect the oven to the representative low relief massive crest tiles (TM A 178: 1821, 2729, 9221) with a stylized image of the crest of Tartu.

The filling layer from room no 4 of building I, the depth of which was only 2 m, contained more findings in the higher stratum. Tiles originate from about seven ovens. The dark green rosette oven can be dated to the second half of the sixteenth century, the green oven with Moresque ornament (Fig 22: 1) to the second half of the sixteenth century or the first quarter of the seventeenth century,²³ the light green box oven with saints to the first half of the seventeenth century, and the light green A-oven with geometrical ornament (Fig 22: 9), the green B-oven with geometrical ornament (Fig 22: 5), and the light green-greenly brown-light brown E-oven with geometrical ornament to the second half of the seventeenth century. The use of another tile oven can be dated more loosely to the seventeenth century or the beginning of the eighteenth century. Many fragments of the ovens from room 4 have also been found in the filling layer in room 1 (TM A 178: 1995, 1999, 2001, 2002, etc).

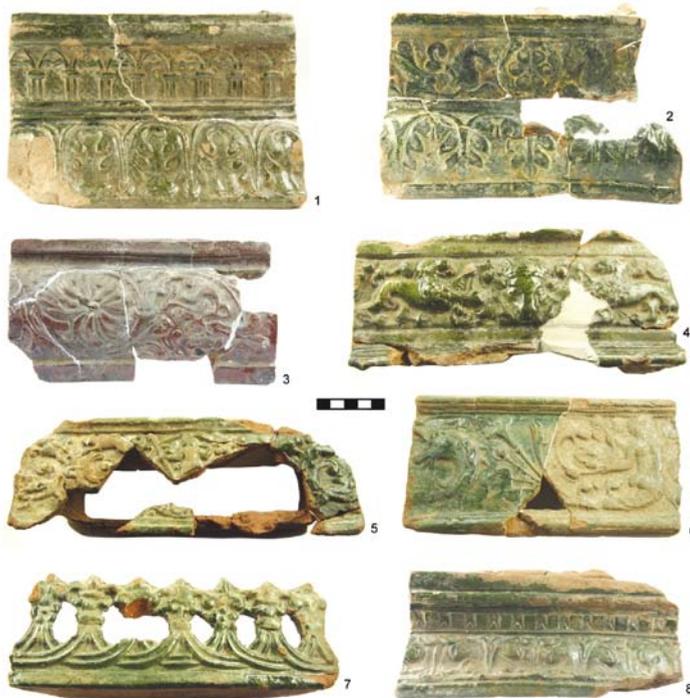
Fig 23. Glazed tiles found at excavations at 2 Lutsu Street (TM A 178: 439/2007, 35, 113/1064/2143, 51/9198 (1)/9198 (2)/10046, 61 (1)/61 (2)/83/360/373, 1994/3677, 9298, 9200/9962/9974). Kristel Külljastinen.
