# ESTONIAN SMALL TOWNS IN THE MIDDLE AGES: ARCHAEOLOGY AND THE HISTORY OF URBAN DEFENSE

Rivo Bernotas

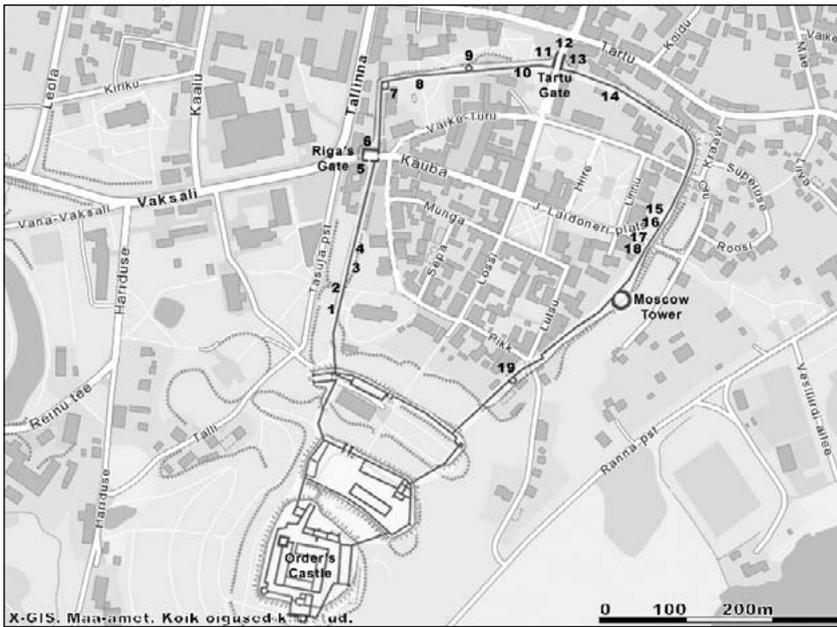
Figure 2. Excavations carried out in the area of the town wall and the approximate location of the town wall of Viljandi (the year marks the publication): 1. Selirand 1982; 2. Valk 1993; 3. Tvauri 1999; 4. Tvauri 1999; 5. Alttoa 1982; 6. Alttoa 1983; 7. Tvauri 1998; 8. Piirits 2008; 9. Tvauri 1998; 10. Tvauri 2010; 11. Freymann 1918; 12. Valk 1994; 13. Alttoa & Moora 1979, Tvauri 1999; 14. Tvauri 2001; 15. Tvauri 2001; 16. Haak & Lätti 2005; 17. Bernotas 2010; 18. Tvauri 2008; 19. Tvauri 2001.

The area of Viljandi was one of the smallest amongst Estonian walled towns in the Middle Ages (see fig. 2).<sup>13</sup> The population was probably between 1000 and 1500.<sup>14</sup> The wall surrounded the 10.2 ha of town which, together with 4.6 ha of the Order's castle, covered 14.8 hectares of protected area.

The town wall of Viljandi is the most archaeologically excavated construction discussed in this publication (see fig. 2). Several archaeological surveys, funded by the city council of Viljandi, were conducted in 1999. The aim of the surveys was to determine the exact location of the remains of the wall. The most thorough publication so far relied on the material gathered from nine test pits excavated in the course of the aforementioned surveys on the different sections of the wall.<sup>54</sup>

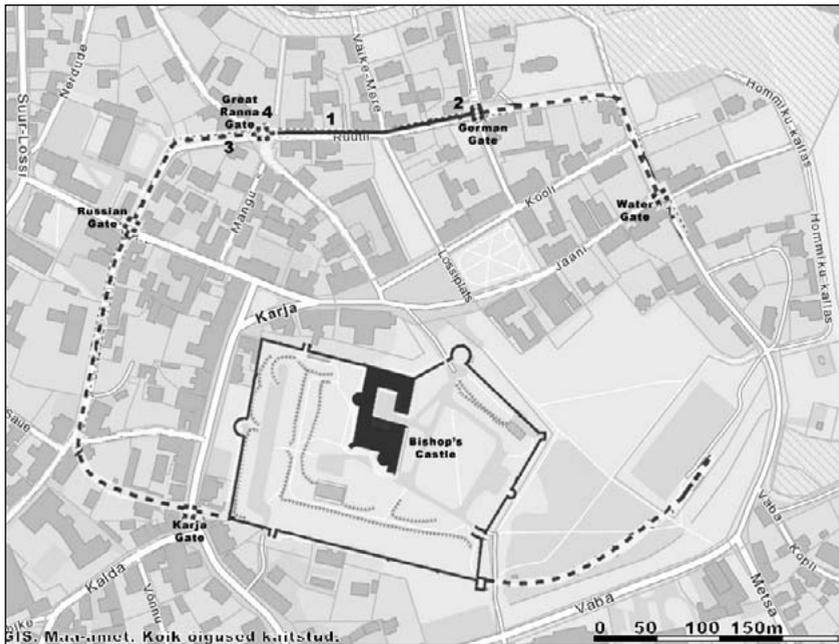
Figure 4. The excavations conducted and approximate location of the town wall on the contemporary map of Haapsalu (according to Russow, “Kaks aastakümnet linnaarheoloogiat Haapsalus”): 1. Raam 1965; 2. Pärn 1996; 3. Russow 2005; 4. Russow 2003.

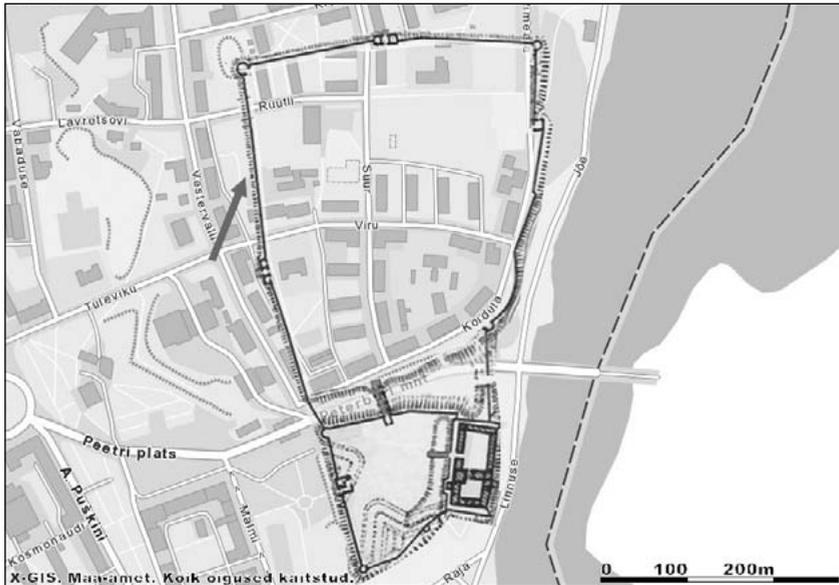
Figure 5. The excavations conducted and the approximate location of the town wall on the contemporary map of Narva (medieval map of Narva according to John Leighly, “The towns of medieval Livonia”, University of California Publications in Geography, 6:7 (1939), 280). The line marks the excavations conducted in 2008.

It has been suggested that around the downtown, the establishment of limestone walls had already begun during the 1370s (see fig. 5). The builders were the townspeople in support of the Order and Tallinn. The wall was completed probably in 1385–90. In 1415–19, the walls were reinforced. Despite the repeated reinforcements, the walls were weak, which was also noted at the Livonian Diet (*Landtag*) in 1518. The total length of the fortification perimeter was 1.58 km. The length of the town wall was 1 km. The

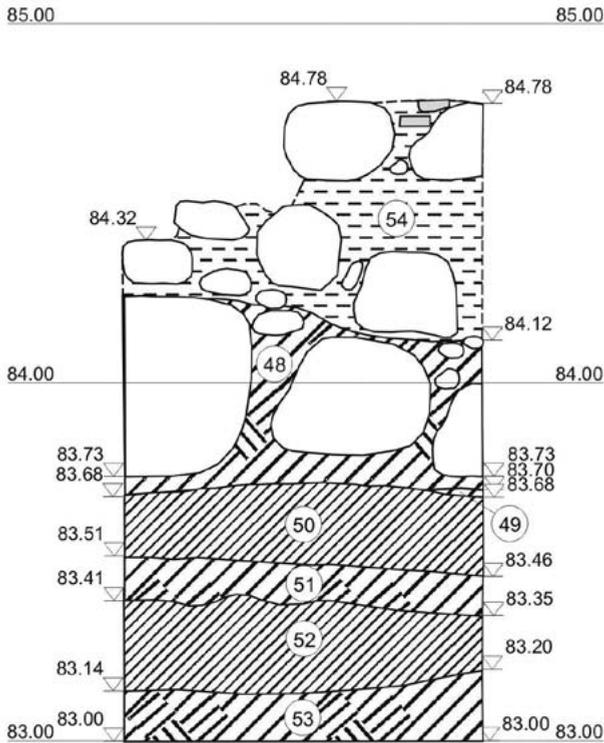
Figure 6. Surface layers under the town wall of Viljandi (according to Piirits, *Arheoloogilised uuringud Viljandis*): 48. beige layer of sandy clay (contained pebbles); 49. beige layer of sandy clay (contained patches of surface); 50. brown layer of clayish sand (contained abundant patches of beige surface, charcoal, pebbles, burned clay, and bones); 51. light brown clayish sand mixed with beige clayish sand (contained burned clay, charcoal, and pebbles); 52. brown clayish sand (contained charcoal and pebbles); 53. beige layer of sandy clay; 54. white lime mortar.

found between two rows of stones. A similar layer of clay extended directly under the foundation (fig. 6 and 7).<sup>68</sup>

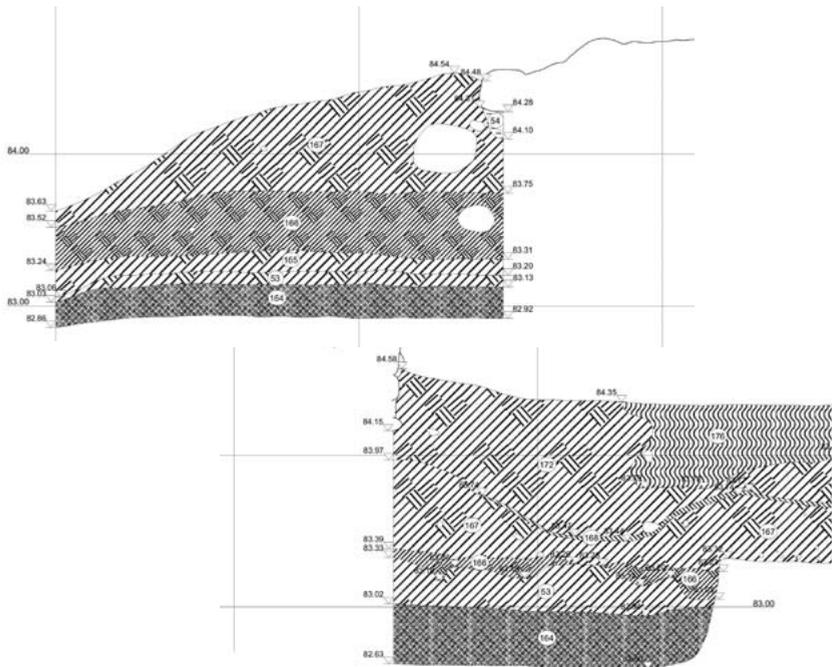
Figure 7. Town wall of Viljandi and the surface layers surrounding it (according to Pii-rits, *Arheoloogilised uuringud Viljandis*): 53. beige sandy clay; 54. white lime mortar; 164. layer of clay (contained patches of beige sand and pebbles); 165. beige sandy clay (contained patches of surface, rotten wood, and pebbles); 166. brown sandy clay layer (contained patches of beige sand, pebbles, brick dust, bones, and charcoal); 167. beige sandy clay layer (contained rocks, branches, and brick dust); 168. line of gray clayish sand (contained brick dust, charcoal, pebbles, rotten wood, patches of beige clayish sand, and surface); 169. light gray layer of clayish sand (contained rocks, beige sandy clay, charcoal, and brick rubble); 170. beige layer of sandy clay (contained rocks, patches of gray clayish sand, brick rubble, and charcoal); 171. gray layer of clayish sand (contained rocks, charcoal, brick rubble, roots, and patches of brown soil); 172. beige layer of sandy clay (contained rocks, pieces of bricks, charcoal, and patches of surface); 173. light brown layer of sandy clay (contained pebbles, roots, brick rubble, patches of surface, and charcoal); 174. gray layer of clayish sand (contained rocks, brick rubble, beige lime mortar, charcoal, and bones); 175. line of charcoal; 176. black-brown layer of soil (contained rocks, pieces of bricks and roof-tiles, roots, charcoal, lime mortar, and modern glass); 177. line of charcoal (contained brick rubble); 178. dark gray layer of clayish sand (contained abundant charcoal, bones, pebbles, brick rubble, slag, and rotten wood); 179. brown line of clayish sand (contained abundantly pieces of bricks, slag, and pebbles); 180. gray layer of clayish sand (contained charcoal; pebbles and pieces of bricks); 181. beige layer of sandy clay (contained rocks, pieces of bricks, charcoal, and patches of surface); 182. dark gray line of clayish sand (contained pebbles, pieces of bricks, and charcoal); 183. layer of mixed red clay (contained pebbles and patches of surface).

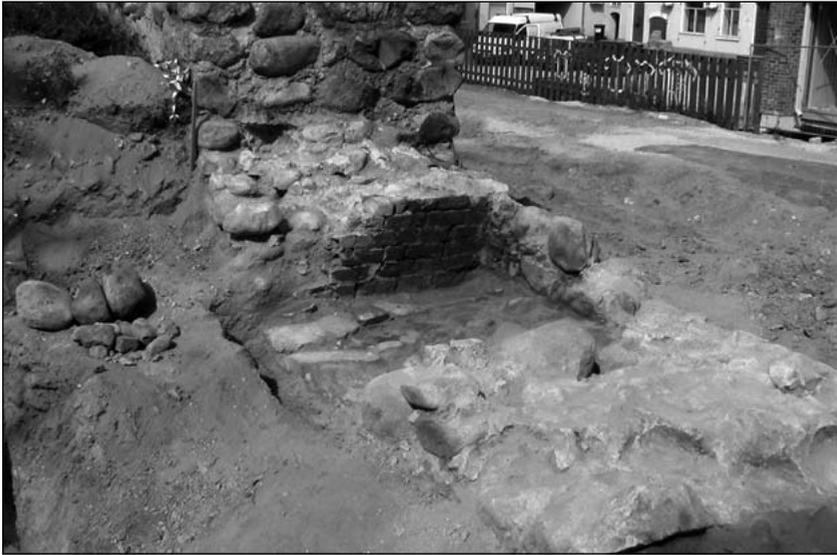
Figure 8. View of the niche in the town wall of Viljandi, view from the southeast. Photo by Peeter Piirits.

The length of the preserved part of the wall was approximately 40 meters and the height was 0.6–0.7 meters. The thickness of the wall was up to 2.3 meters. The wall was made of stacked fieldstones and bound with lime mortar (see fig. 8). The stones of the masonry foundation were packed and on both sides stacked with a natural beige sandy clay layer. This layer likely originated from the natural trench of the moat. The wall was made of fieldstones up to 80 cm that were bound with a solid white lime mortar. The part of the foundation of stones packed with soil projected up to 0.7 meters outside of the wall. Inside of the wall, a niche was discovered (see fig. 8). The width of the niche in the outer part reached 1.4 meters and the inner part was 1.5 meters. The depth of the niche was 1.7 meters. Therefore the scope of the outside of the town wall was only 0.6 meters. The insides of the niche were plastered with bricks and bound with beige lime mortar. The niche is assumed to have been established simultaneously with the rest

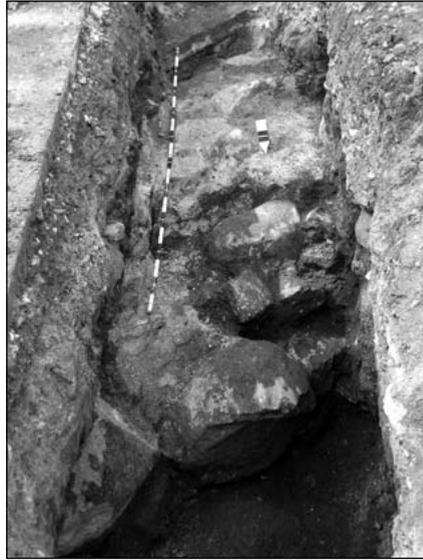
Figure 9. Town wall of Haapsalu at the cross-road of Wiedemanni, Rütli, Suur, and Mere Streets. Photo by Erki Russow.
