THE ARTIST'S FINGERPRINT.
THE MANUFACTURING TECHNIQUE IN
JOHANN KÖLER'S FRESCO
COME UNTO ME, ALL...

In 2013, a technical examination was made and conservation-restoration work carried out on the altarpiece by Johan Köler in the apse of

HILKKA HIIOP: THE ARTIST'S FINGERPRINT. *THE CONSERVATION AND TECHNICAL EXAMINATION OF JOHANN KÖLER'S FRESCO COME UNTO ME, ALL...*

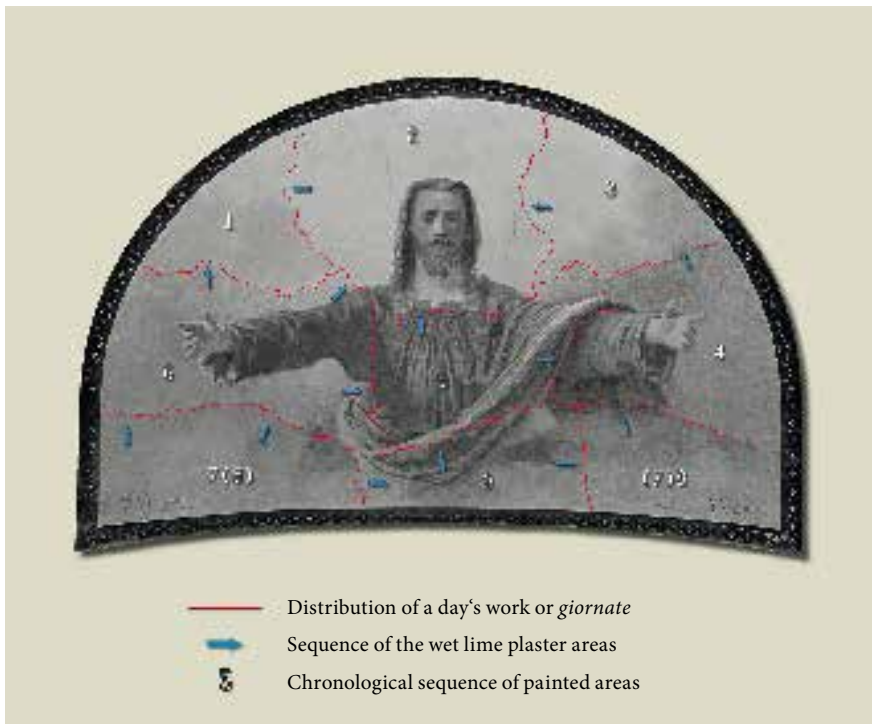
Fig. 1. Diagram of the working sequence

Based on the overlapping of the plastered areas, it was possible to diagram the distribution of the areas painted by the artist in one day, or the *giornate*, as well as the sequence of the wet lime plaster areas utilised for fresco painting. The information on the pace of completing the painting, which was previously based on written sources, was confirmed – the painting process took nine “days of work”. The painting sequence corresponded to that of a classical fresco – moving from the top down (in order to prevent plaster and paint from spattering on the area that had already been painted) and starting in the upper left corner. The painting process ended in the middle of the lower edge. In order to visualise the sequence, it was mapped in a diagram:

Although the artist was proud of the extraordinary pace of his painting (according to documentary information, the painting was executed in 10 days; the mapping of the *giornata* areas confirmed the data based on the written sources, alluding to nine *giornata* areas: see above), this is also the reason for the lack of binding agent and the durability problems. It is probable that the area prepared for one day's work was so large that by the end of the day's painting process, the plaster had already started to dry and lost its ability to bind the pigment. Therefore, the calcium carbonate layer on the surface is uneven and corresponds very closely to the *giornata* distribution.

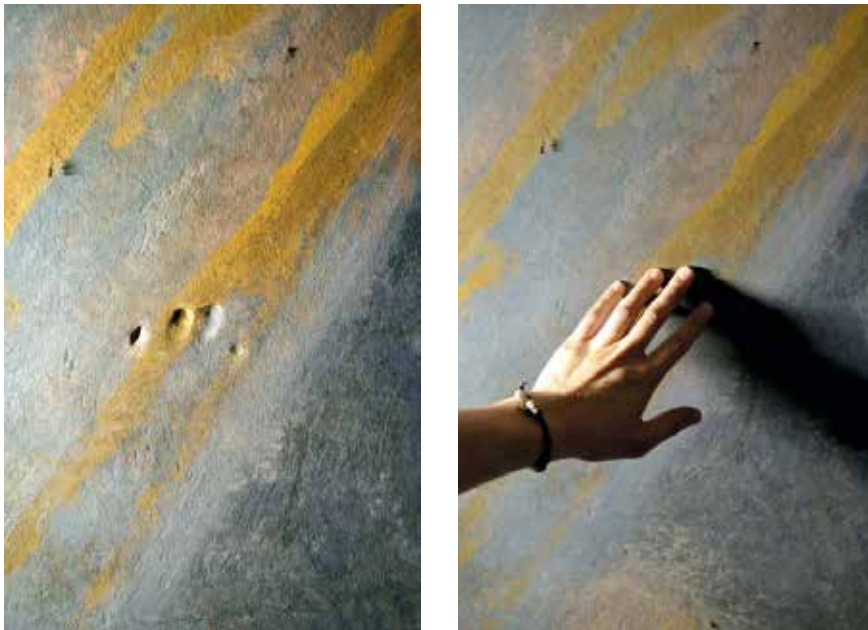
The artist's fingerprints and nail prints: probably in order to maintain his balance, the artist (or the plasterer assisting him) supported his fingers against the wet plaster surface, and therefore, several of the artist's fingerprints are visible when the surface is seen in raking light. In addition to individual fingerprints, an entire (left) handprint can be identified as a charming detail.

Fig. 2 a,b. Johann Köler's fingerprints in the wet layer of plaster. Photo: Peeter Säre

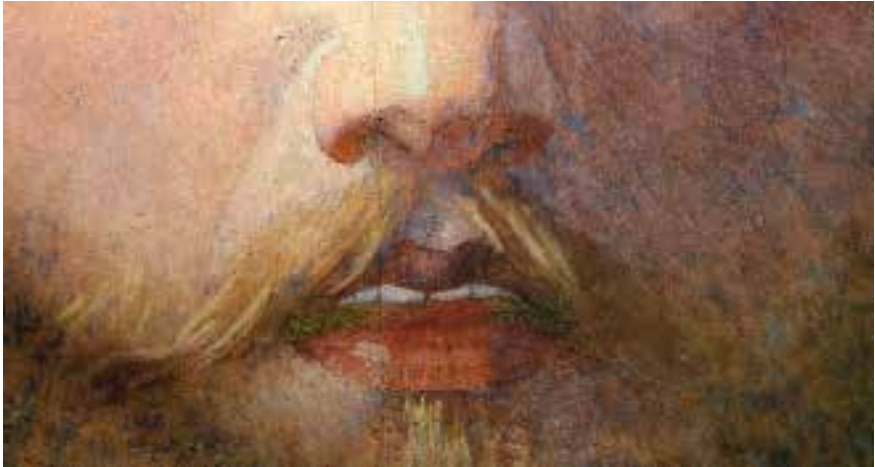
Artists have historically used the nail of the left-hand pinkie to support the hand holding the brush.²⁸ Köler also employed this technique when painting Christ's hands and face. An especially dense network of nail prints is visible on the area of Christ's face when seen in raking light. This area clearly required the greatest degree of detailed painting, i.e. the surest support for his hand.

Fig. 3. The network of prints of the left-hand pinkie's nail, which was used to support the hand holding the brush, and the vertical structural line that passes through the centre of Christ's face. Photo: Peeter Säre

Structural grid of the composition: in order to mark off the initial structural lines of the giant composition, the artist pressed a straight vertical line into the plaster that passes through the centre of Christ's face and the arch connecting his outstretched hands, which is marked on the plaster surface as impressed lines and holes. The use of initial structural lines is a common practice in the case of such a large painting, since it is easy to lose track of the entire placement when one is close to the surface.

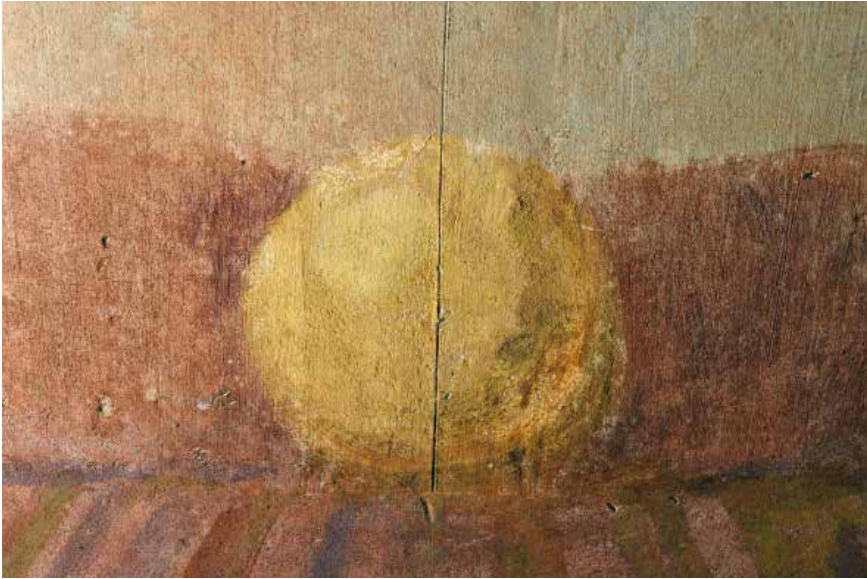
Fig. 4. The preparatory vertical axis that passes through the centre of the composition.
Photo: Peeter Säre

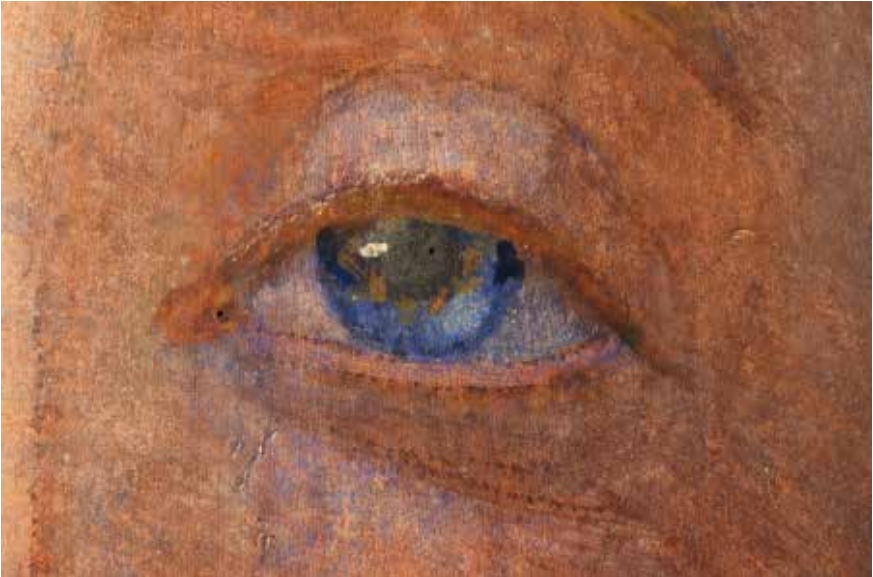
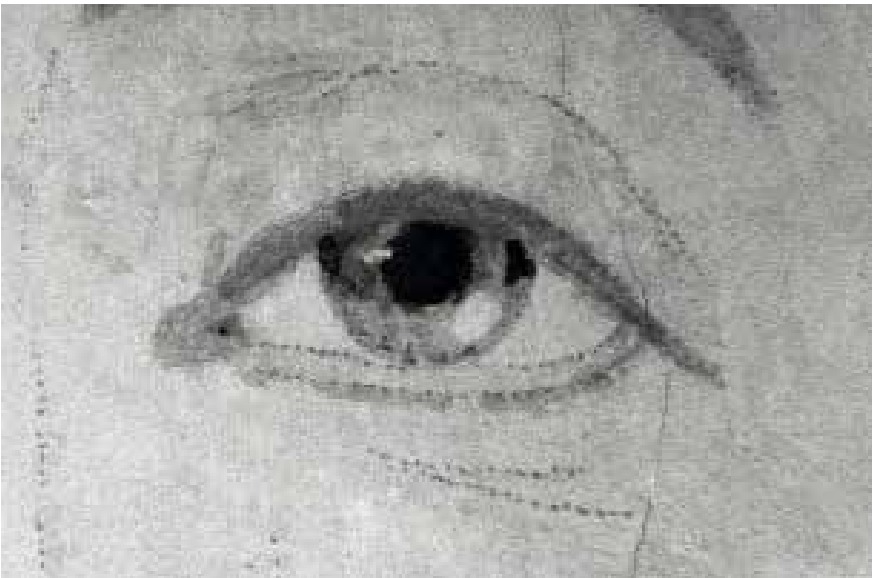
dabbing the holes with dry pigment dust. This method is visible under the pigment layer in the area of Christ's face. The artist probably chose the pouncing method for this area because the subsequent layer of paint hides the pigmented row of dots of the preparatory drawing.

To better visual the impression (row of dots) created by the pouncing, infrared reflectography was used to highlight it. Unexpectedly, it revealed a much denser network of dots that was visible to the naked eye.

Fig. 5 a,b. The pigmented row of dots that was created by transferring the 1:1 cartoon using the pouncing technique, which is visible through the paint layer (photo a), but is very clearly visible with the help of infrared reflectography (photo b)

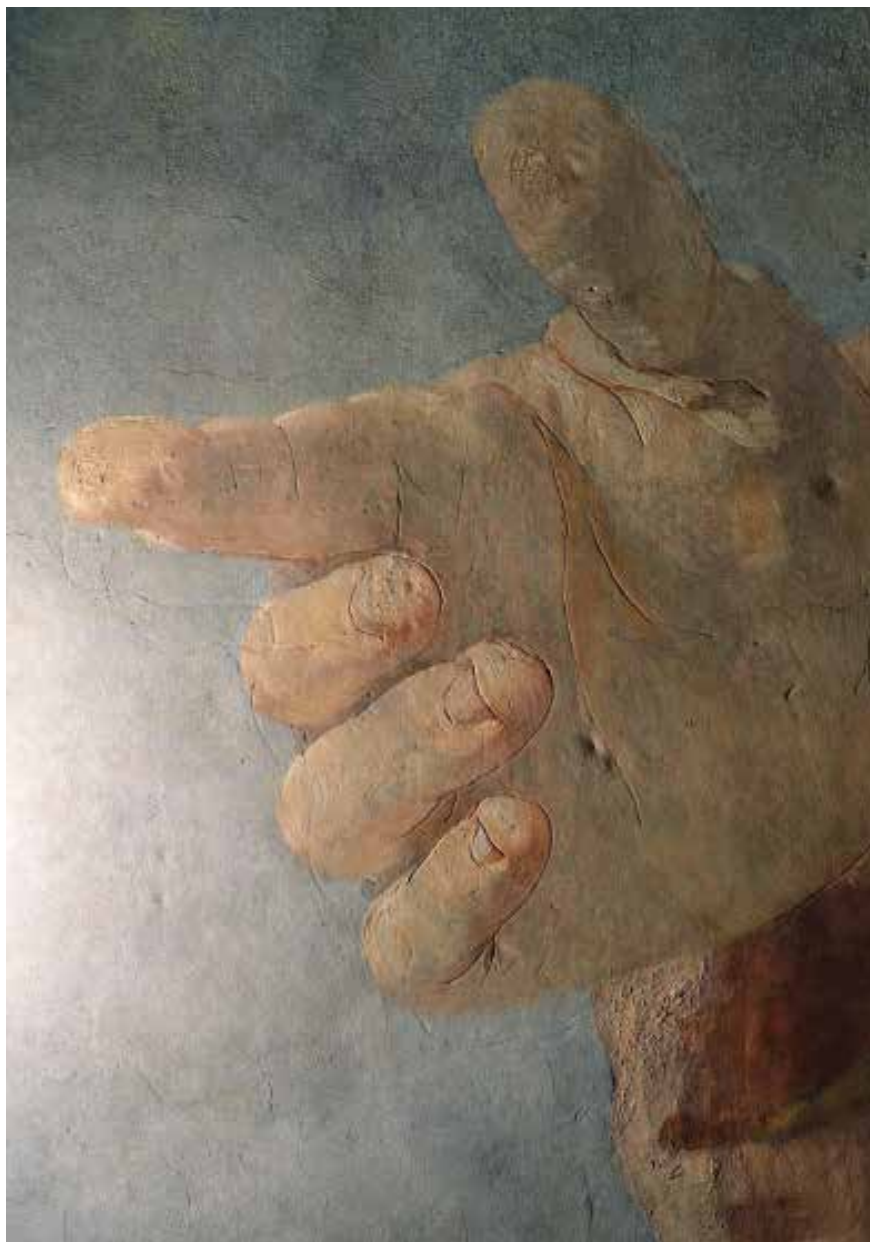
Transfer of the cartoon with the help of an outline pressed into the wet plaster. This method takes considerably less time than pouncing, and leaves an imprint that is visible until the end of the painting process. Köler used this method to transfer the contours of the hands.

Fig. 6. The 1:1 transfer of the cartoon with the help of an imprint pressed into the wet plaster. The photo also shows the *pentimenti*, or artist's own alterations, of the composition – the imprint of the preparatory drawing is located several centimetres away from the final painting. Photo: Peeter Säre

Pentimenti or alterations to the composition made by the artist: The position of Christ's right hand was changed in the course of the painting process by the artist – the initial imprint of the underdrawing is located several centimetres away from the final painted hand.

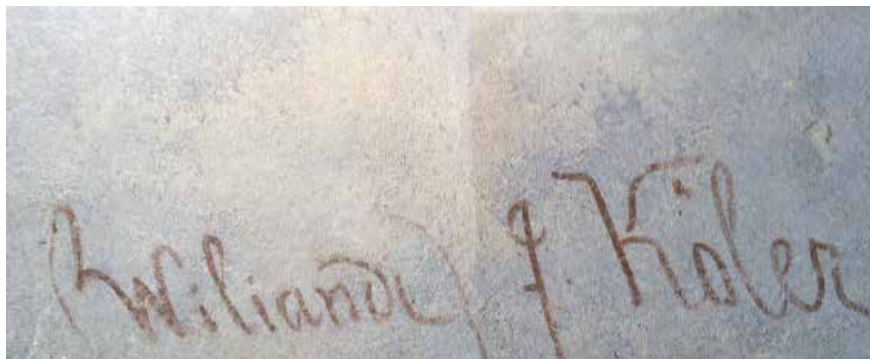
Fig. 7. Köler's signature on the lower right hand corner of the work: *Wiliandi J. Köler*; and an example of the removal of the surface dirt. Photo: Peeter Säre

Considering its location in a densely polluted environment and the fact that the church had been heated with coal for a long time,³⁶ the painting had become very soiled during the 135 years since it was painted. However, while removing the pollution dirt, an attempt was made to find a cleaning state that would leave a homogeneous patina across the entire surface of the painting. The veil of dirt on the painting had become part of the historical value of the work and if the cleaning resulted in a very contrasting result it would dim its historical authenticity. Simultaneously, the powdered pigment was fixed to make it considerably safer to clean the painting in the future.
