## A NEWLY CONSERVED PLAFOND PAINTING ENRICHES THE OLD TOWN OF TALLINN

An exquisite Baroque ceiling panel has been restored and conserved at Rahukohtu 5 on the Patkul viewing platform in the old Town of Tallinn after more than a decade of being exposed to poor conditions. In 1997, an architectural historical investigation was completed in the building. During the field work, one of the largest glue-bound paintings of the Old Town was discovered on the ceiling panels of the first floor.<sup>1</sup> The exposed mural was in an unacceptable state in an uninhabited room<sup>2</sup> until construction work began as late as in 2012.

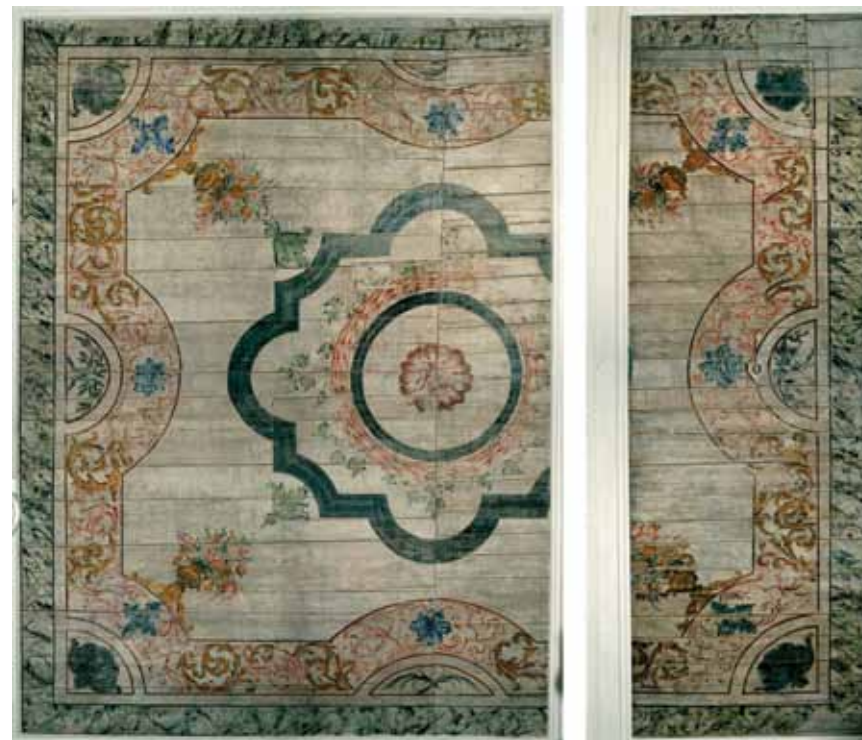
Fig. 3. Rahukohtu 5 ceiling after conservation. Photo Peeter Säre

was to preserve and display both historical layers – the eighteenth century painted ceiling panelling, and the nineteenth century division of space with the exuberant dentil cornice – simultaneously. Promoting the perception of aesthetic composition in its unity, a display area is placed within the dividing wall. Such decision emerged as a compromise between the reality of a historical artefact and contemporary needs of its inhabitants. The final solution won out among all parties and enabled the owner of the estate to open the artistic monument for wider public: the painting can now be

The retouching of the mural is based on the theory of restoration by Cesare Brandi: for him, the history of artwork and its aesthetic unity are equally valued.<sup>12</sup> As a guiding principle, substantial losses in painted surface and wood are not reconstructed and maximal amount of original substance in its historical authenticity is retained. Only the geometry of central, architectonic elements of the composition is reconstructed. Small losses in the paint layer are reduced to the background through neutral tone retouching, allowing the viewer to optically recreate the intactness of the mural and in this manner simultaneously perceive the original work and the beauty of history.

In parallel to the conservation of the panelling, the Late Classicist dentil cornice is restored in both rooms<sup>13</sup> but based on another idea: all missing details are reconstructed using the original as a model. When co-exhibited, a curious synergy appears at the cross-section of two periods in history: the conserved restored ceiling takes on a role of a panel painting and the surrounding exuberant cornice becomes a framing.

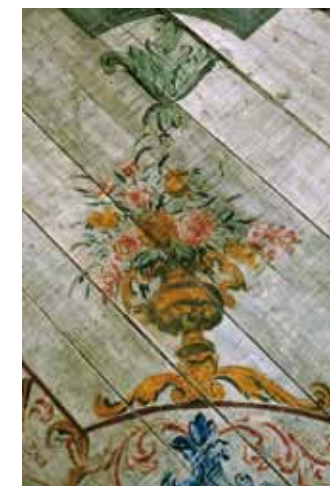
Fig. 4. Rahukohtu 5 ceiling. A detail after conservation. Photo Peeter Säre
