Kaire Tooming

## LATE MEDIEVAL DECOR AT ST MARTIN'S CHURCH IN MARTNA

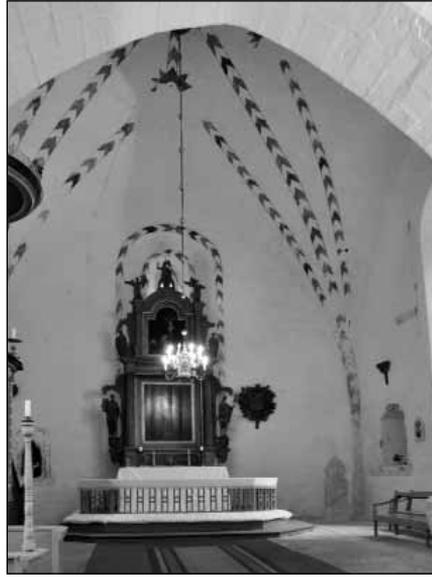
Fig. 2. The choir of St Martin's of Martna. Photo by Tõnis Padu.

stellar vault, but on the springing points of the vault the upper layers had flaked off, with the original décor of the choir exposed. On the groins of the choir, around the windows and in the area of the triumphal arch, the red paint was cleaned off to the point where it would be possible to get as integral a picture of the painting as possible. At the same time, the opening was so small that it did not disturb the general design of the choir. The result achieved makes it possible to observe all three layers of painting that have decorated the choir of St Martin's through history.

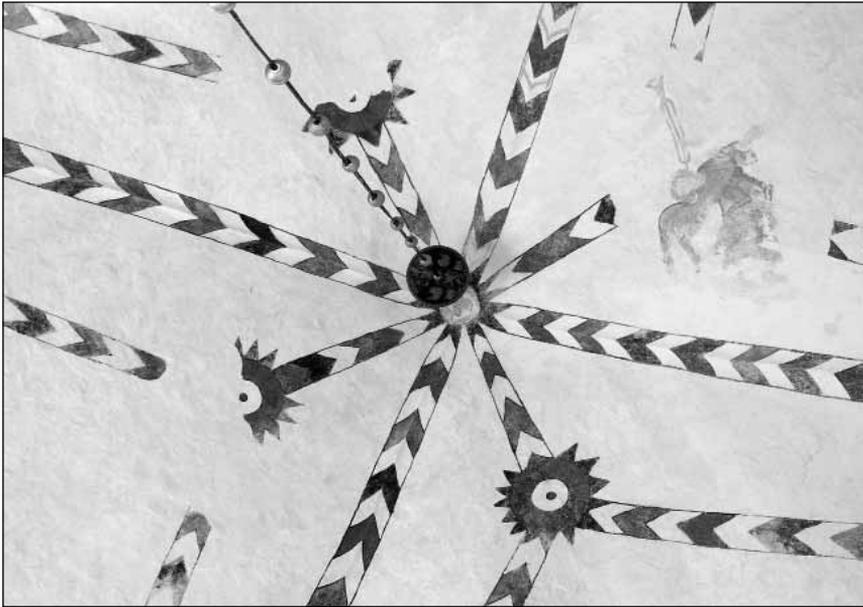
Fig. 3. Three layers of paintings on the vault of the choir. Photo by Kaire Tooming.

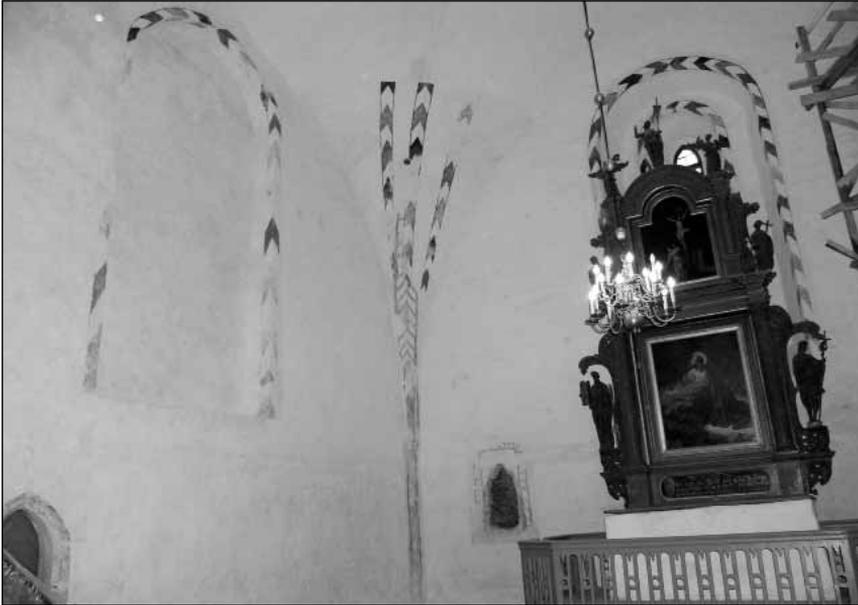
*Fig. 4.* Two late medieval paintings in the course of conservation work. Photo by Kaire Tooming.

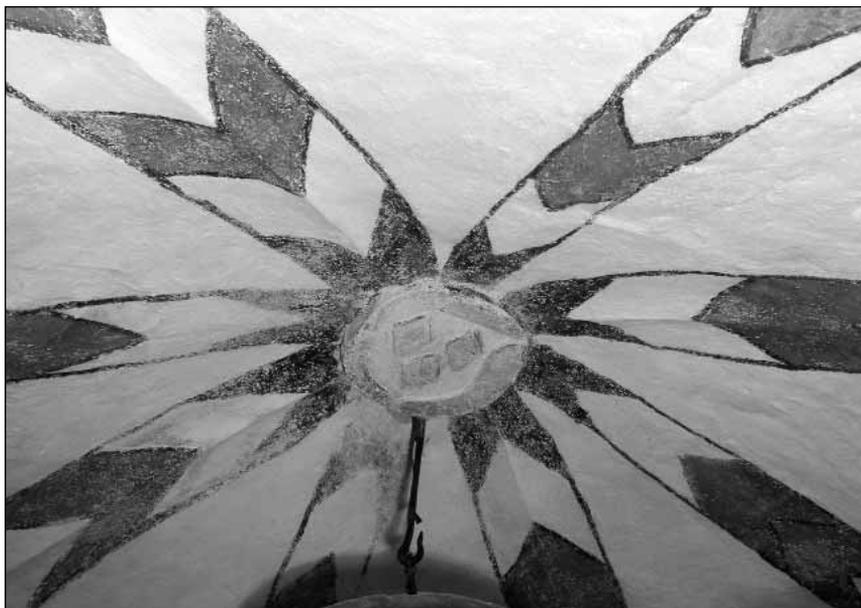
*Fig. 5. Boss with Bishop Orgas' crest at the crown of the vault in choir. Photo by Kaire Tooming.*

choir applied to the plaster at the time of construction. The décor of the corner posts supporting the springing points of the vaults has largely been destroyed or has become indistinguishable from later layers; the impostes were red. The red herringbone pattern marked with red outlines runs in a narrowing fashion higher along the groins of the vault from the impost to the boss bearing the coat of arms of the building master, Bishop Orgas. The sides and the upper surface of the boss were red, while the crest with lozenges was white.

**STELLAR VAULT.** The second late medieval painting lies immediately on the red herringbone pattern. It represents the stellar vault, marked with a herringbone pattern of grey, red and black segments for tiercerons and liernes, and large red and white stars with black points for bosses. A characteristic black outline surrounds all the motifs and the coloured segments of the herringbone pattern alternate with white ones. The corner posts were grey with black lines running in their interior corners. The impostes were red with black outlines. The herringbone patterns marking the tiercerons rise from the impostes and run along the groins to the boss and in the direction of the centre of the coping. At the crossing of the two tiercerons, there are red-and-white stars with black points marking the bosses of the stellar vault. The black points form a segment of the herringbone pattern. The liernes end with black segments and this gives the impression of a shaft of rays surrounding the boss. The edge of the boss is black and its upper surface red. A black line runs along the edges of Orgas's crest. The crest itself is black, with grey lozenges edged in black.

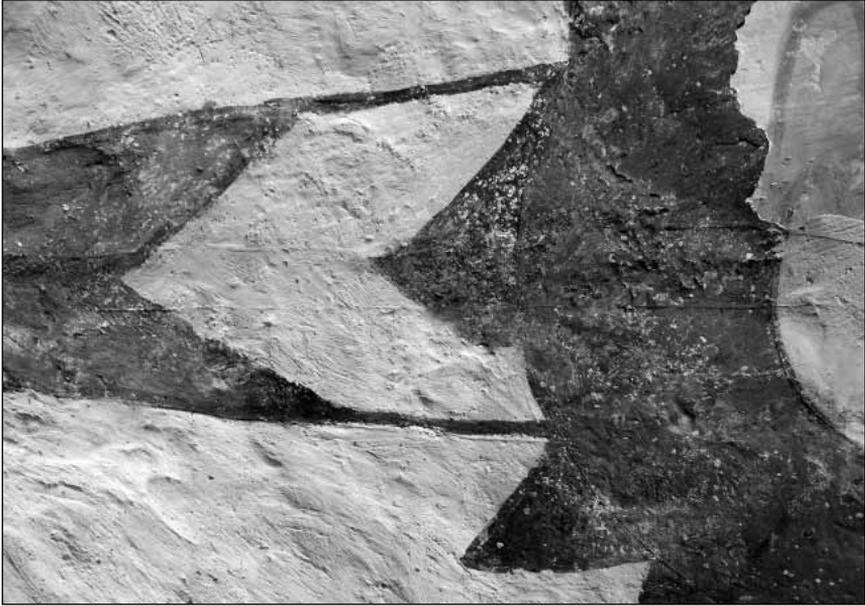
*Fig. 6. Sketch under painting depicting stellar vault. Photo by Kaire Tooming.*

Before the actual painting, a sketch was made on the surface of the vault. In places it only served as a rough guide for a better composition of the painting. The herringbone pattern, representing tiercerons and liernes, is a freehand drawing that was applied to the surface of the still wet primer

with a blunt-tipped tool. The drawing that remained under the black outline was applied to the surface with red pigment. The central line aligning the tips of the points of the herringbone drawing is colourless. The stars were drawn using compasses.

The compositional basis of the painting is the boss and the stars around it, situated at 180–185 cm from the crown. All the stars are of the same size, with a radius of 31.5 cm. The location of the stars was established first and the pattern representing tiercerons and liernes were later adapted to the given system. The structure of the tiercerons and of the liernes is flawless – the segments of the paintings are of the same size and the sequence of the colours is regular. The alternation of grey, red and black is the same everywhere but, in the case of the tiercerons of the west and north copings, the alternation of the colours is not from the impost to the star but proceeding from the star, as a result of which these herringbone patterns have a “backward order” of colours. But that slight misfit in the painting is hardly noticeable. The problem caused by finding the right rhythm of the coloured segments of the liernes on the north and the south copings is slightly more conspicuous.

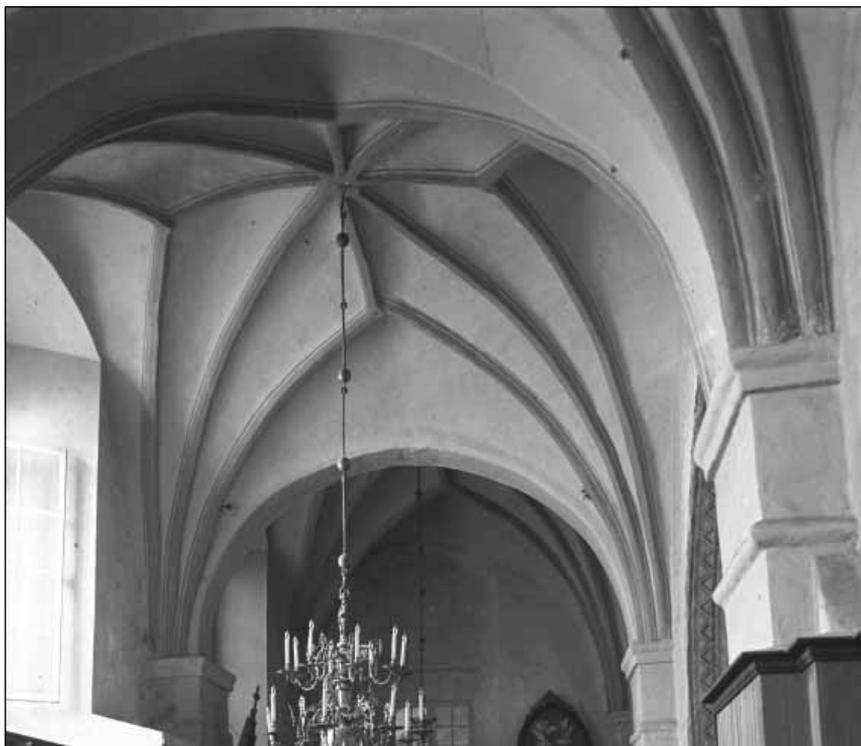
*Fig. 8.* Stellar vault at St Nicholas' Church in Pärnu. Photo by Armin Tuulse, 1943 (Art Historical Photograph Collection of the University of Tartu).

We find the nearest stellar vault, in terms of both geography and time, in the Church of St Nicholas of Pärnu (which has perished), where stellar vaults had been built in the nave, under the supervision of a Tartu mason, by 1529, in the course of restoration work after a fire in 1524.<sup>27</sup> Uus-Pärnu,

As a result, looking for parallels to the paintings in the choir of St Martin's of Martna, we should not overlook St Nicholas's of Pärnu as one of the most impressive ecclesiastic buildings in the region. The influence of the stellar vault of the nave of St Nicholas's of Pärnu on the vault in the choir of St Martin's of Martna seems quite likely, considering the importance of Uus-Pärnu in the area. The nave of St Nicholas's of Pärnu, of a novel and grand design, is quite suitable as an example for the painting in Martna's church.

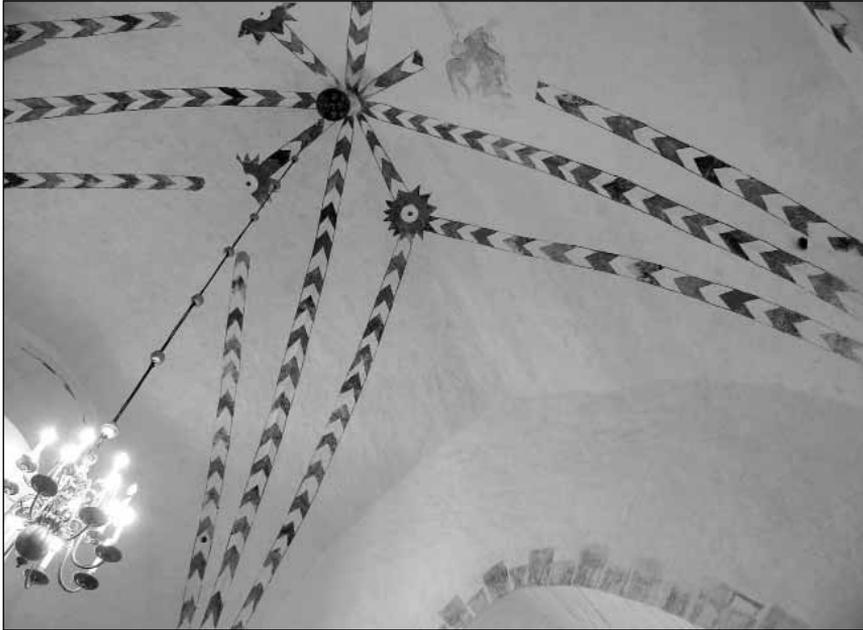
*Fig. 9. The imitation of the stellar vault on the vault of the choir. Photo by Kaire Tooming.*
