## **RESCUE EXCAVATIONS IN TALLINN VABADUSE SQUARE AND INGERMANLAND BASTION 2008–2009**

VILLU KADAKAS, RAGNAR NURK, GAREL PÜÜA, GUIDO TOOS  
 OÜ Agu EMS, Roosikrantsi 17, 10110 Tallinn, Estonia; villu.kadakas@thu.ee  
 LEMBI LÕUGAS, SIRJE HIIE, KERSTI KIHNO  
 Tallinna Ülikool, Ajaloo Instituut (Tallinn University, Institute of History)  
 Rüütli 6, 10130 Tallinn, Estonia

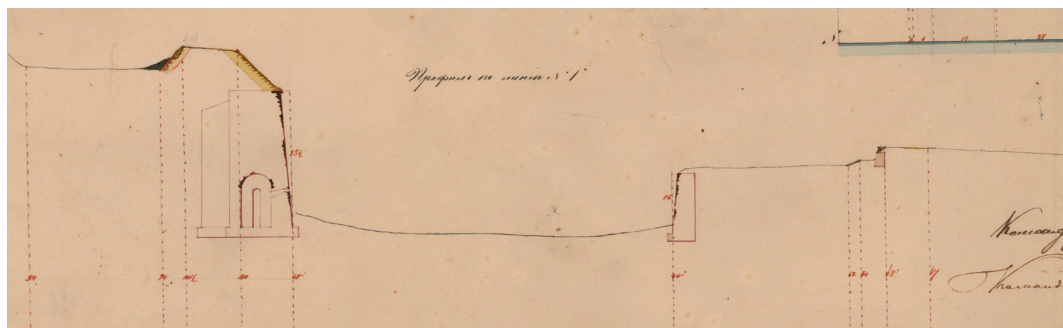
Fig. 3. Section south of Ingermanland bastion, drawing 1847. Elements of rampart fortifications (from left): scarp wall of bastion, moat, counterscarp wall, covered way, the inner supporting wall of glacis, glacis.

in the exterior side as a slope and in the interior side step by step. According to historic maps and cross-sections the wall should have inner buttresses or counterforts (Fig. 3), but probably the excavation was not deep enough to reach them. The top part of soil was removed from the whole eastern flank of the bastion, making a small square for the column, positioned on this terrace. It appeared, as predicted by preliminary excavations already, that parapet, the upper part of the bastion exterior edge with embrasures for cannons (Fig. 3), had never been built of stone, but in a form of an earth rampart. Surprisingly, a network of thin limestone walls (*ca.* 60 cm wide) were found from this area, covered with later park soil and directly not depicted on historic plans of the bastion (Fig. 2; Oras *et al.* 2009, fig. 4). The wall parts parallel to the scarp walls had probably a function to support the earth rampart of the flank from the inside. The inner edge of the rampart had been probably formed as a flat platform (*ca.* 7 m wide) for cannons, with a surface *ca.* 1.5 m higher from the rest of the flank's surface. The two sets of short parallel twin walls may have been supporting the inclined paths for rolling the cannons from the lower surface of the flank to their shooting positions on this upper platform or *terreplein*.<sup>4</sup>

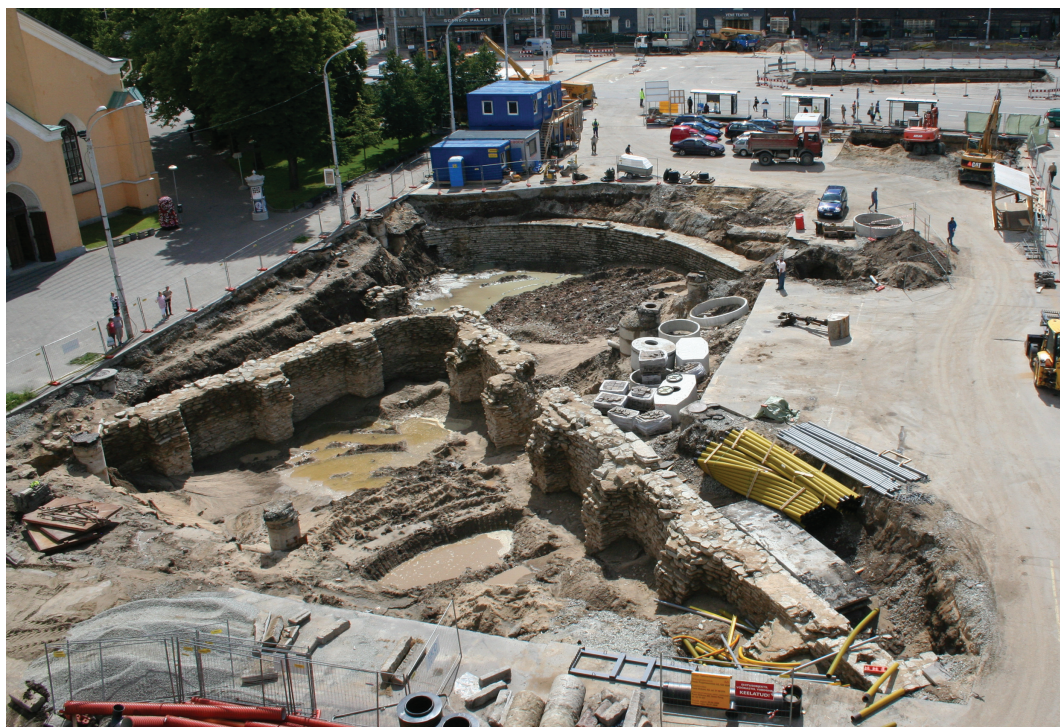
Fig. 4. Vabaduse Square in July 2008 from north. Tenaille scarp and counterscarp walls.

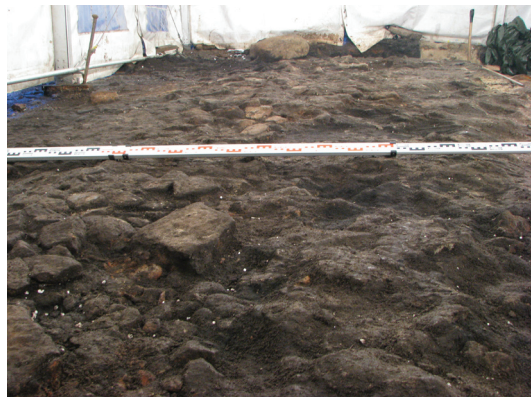
Fig. 6. Vabaduse Square. Rubble pavement of the Pärnu road.

According to town topography it was previously known that one of the major roads approaching the town from the south, has been running through the present Vabaduse Square, marked as Roosikrantsi street in the south and Harju street in the north in the present street network (Fig. 1). This road accessed the town through the Harju Gates, which have been standing right north-west of the present square. As already mentioned above, the gate was closed in 1538 and opened again in 1767 in connection of building the tenaille in front of it. The exit through the glacis for this new gate was situated in the triangular part of the glacis in the eastern edge of the present square, i.e. the old road was never used again. In accordance, right on the eastern side of the pedestrian tunnel, partly destroyed while building it, a rubble pavement of a *ca.* 10 m wide road, running in north – south direction, was discovered on natural sand, *ca.* 2.5 m deeper from the present street level (Fig. 6).

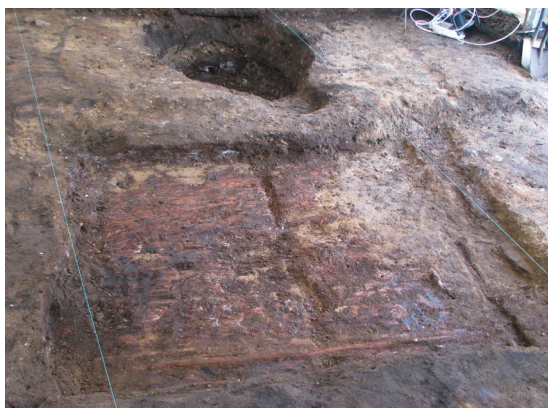
Fig. 8. Vabaduse Square. Timber cellar A.  
Jn 8. Vabaduse väljak. Puust kelder A.  
Photo / Foto: Villu Kadakas

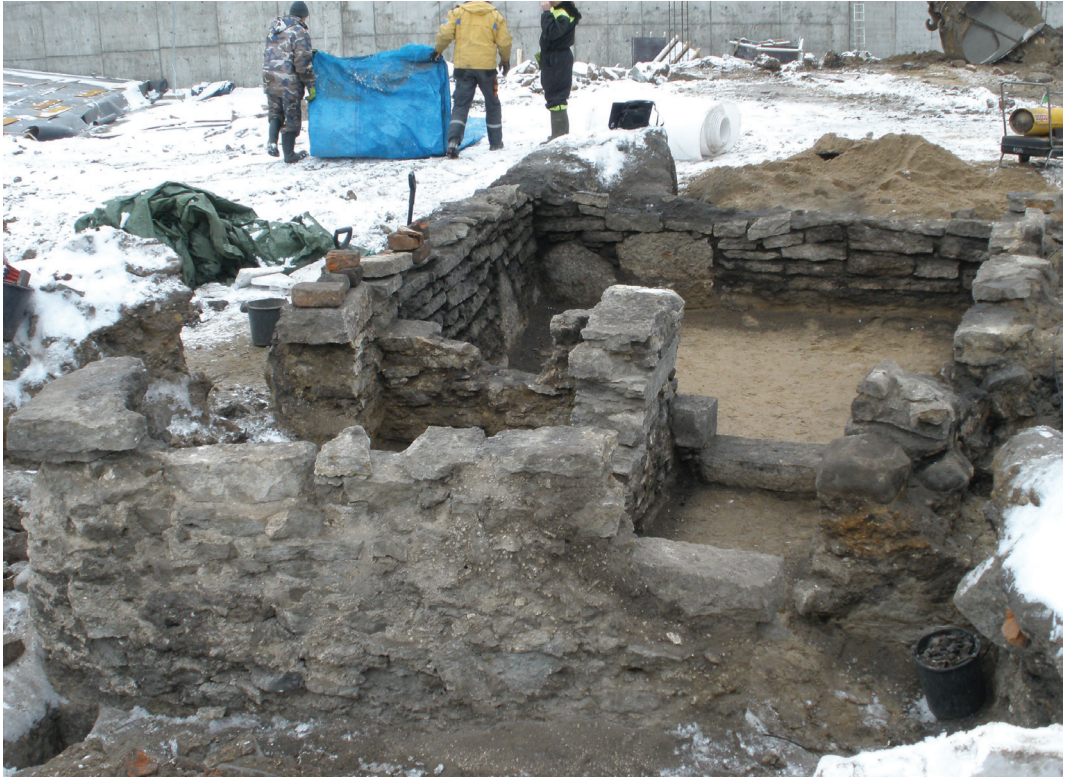
Fig. 9. Vabaduse Square. Stone cellar of building B.

The most elaborate of all the buildings was B: a combination of a timber cellar (320 × 295 cm) close to the road and a limestone cellar (620/635 × 355/405 cm) behind it (Figs. 1, 9). The timber part was built of horizontal planks supported by four thick vertical posts (ca. 25 × 15 cm) in the corners. The corner posts had been so massive that it is possible that these could have supported not only the cellar walls but the upper storey(s?) as well. Remains of a timber floor of planks, resting on 5 joists was recorded. The stone

cellar was a rather sophisticated building. It had a masonry portal and a barred window like the houses inside the medieval town, connecting it to the timber cellar or leading to a staircase between the two cellars.<sup>10</sup> In the north-west corner of the stone cellar was a (hypocaust?) oven, probably for heating the main floor and rebuilt several times. The house layout resembles a typical *diele-dornse* house in the Old Town of Tallinn: a *diele* with a chimney and fireplace close to the street and a slightly smaller *dornse* in the back of the house, heated with a hypocaust oven in the basement floor. There were dozens of artefact pieces – mostly ceramics but also metal household instruments – lying on the floor of the stone cellar datable to the 17th century. These can be probably connected with the last usage period of the same household, although it cannot be excluded that some artefacts have eroded into the cellar from the surrounding cultural layer. This house had gone through at least some major buildings periods: e.g. at some time the timber cellar close to the road had been filled and a stone floor for the main storey laid upon it. It was difficult to date the cellars – there were very few datable finds which could have been firmly connected with the original construction activities.

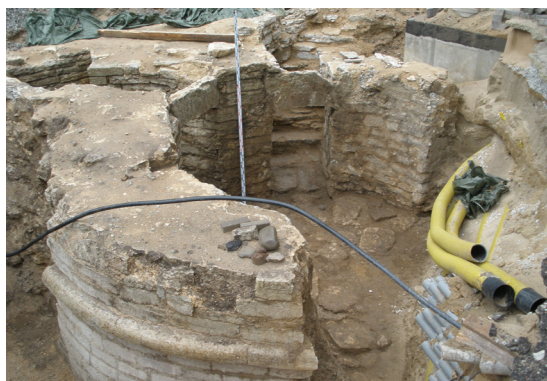
Fig. 10. Walls of the south-eastern tower of the Harju Gate's later barbican.

Harju Gate's barbican (Figs. 1, 10–11). The foundations of the southern twin towers of the second barbican were first revealed while replacing electric cables during already the summer of 2008.<sup>13</sup> Digging for replacing the heating pipes started on April 23 and was finally finished by July 16 in 2009. It appeared that the foundations of the gate walls had been preserved surprisingly high – in some points even *ca.* 25 cm below the pavement. A solution for changing the new pipeline location project was worked out upon the initiative of the archaeologists, according to which the preserved gate walls were not disturbed.

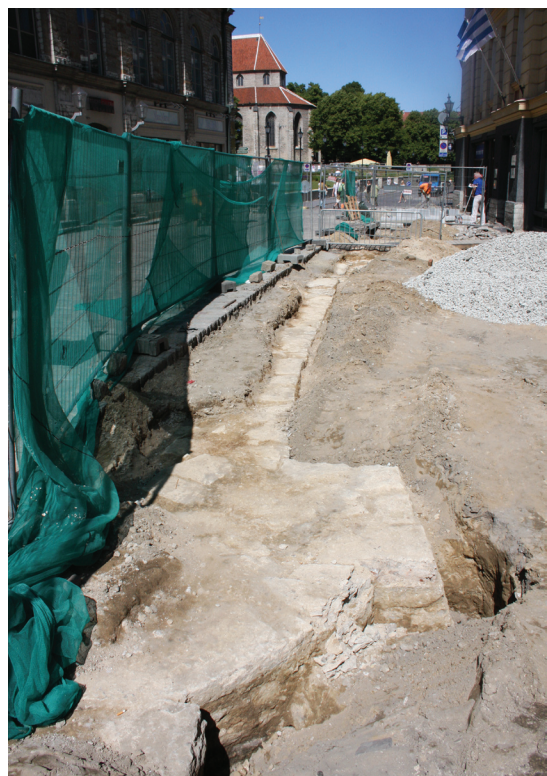
Fig. 11. East wall of the earlier barbican of the Harju Gate. Foundation of the round tower in foreground.

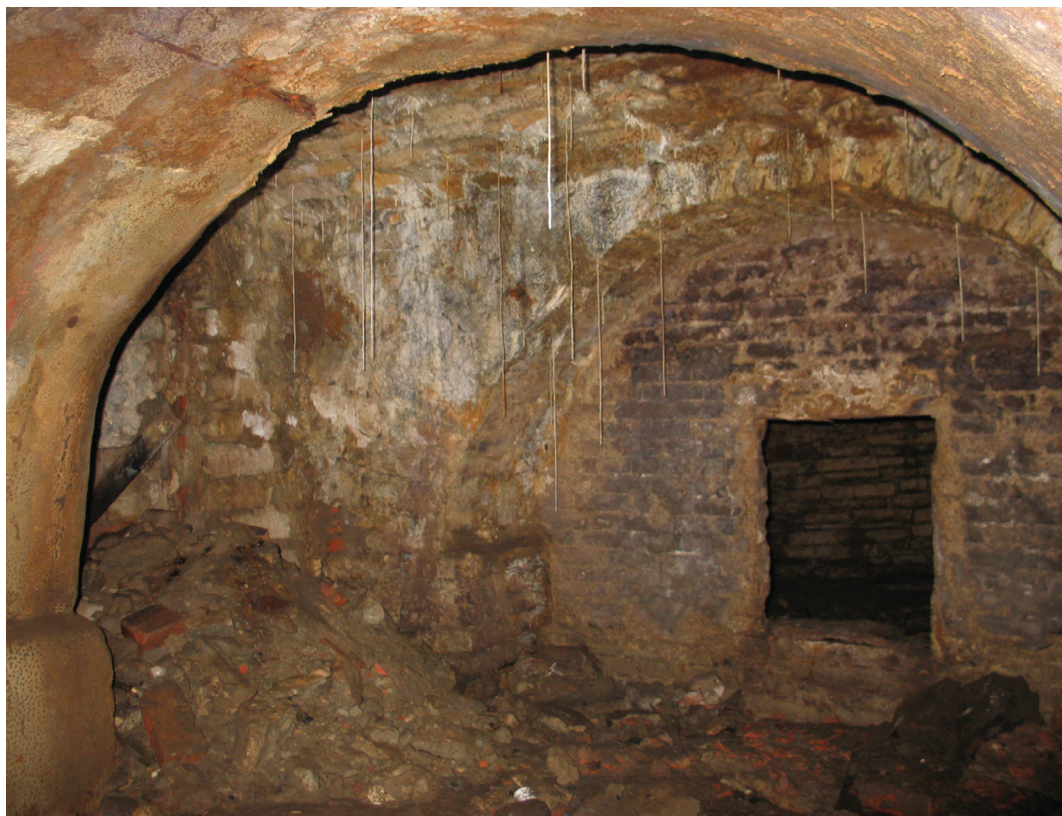
Fig. 12. Vaults of Harju watermill's cellars under Harju street.

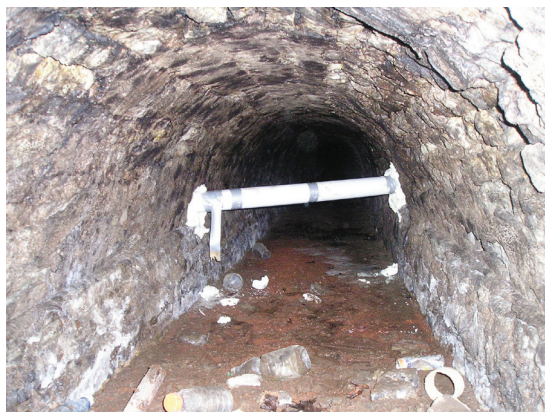
Fig. 13. Limestone water conduit for the drinking water from Lake Ülemiste.

In the moat, outside the borders of the main excavation area, south of the Ingermanland bastion, during pipe trench monitoring in April 2008 Garel Püüa discovered a vaulted limestone water conduit (Fig. 13; Püüa *et al.* 2008), which supplied the Harju mill's pond, the public wells and the moat with water from Lake Ülemiste since the middle of the 14th century (Zobel 2008, 153–154).

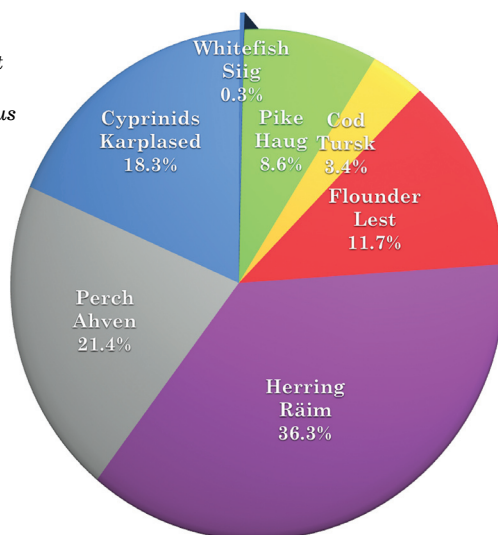
Fig. 14. Relative distribution of bones of different fish together in assemblages A and B.

better for identification as seen in the percentage of successfully identified bones in the A assemblage. As expected, the assemblage B contained much more bones of smaller fish. Based on NISP the relative importance of different fish species is demonstrated in figure (Fig. 14). The figure does not show the importance by biomass.
