**ARCHAEOLOGICAL
FIELDWORK
IN ESTONIA**

ARCHAEOLOGICAL INVESTIGATIONS IN KÜÜNI AND VANEMUISE STREETS IN TARTU

EERO HEINLOO

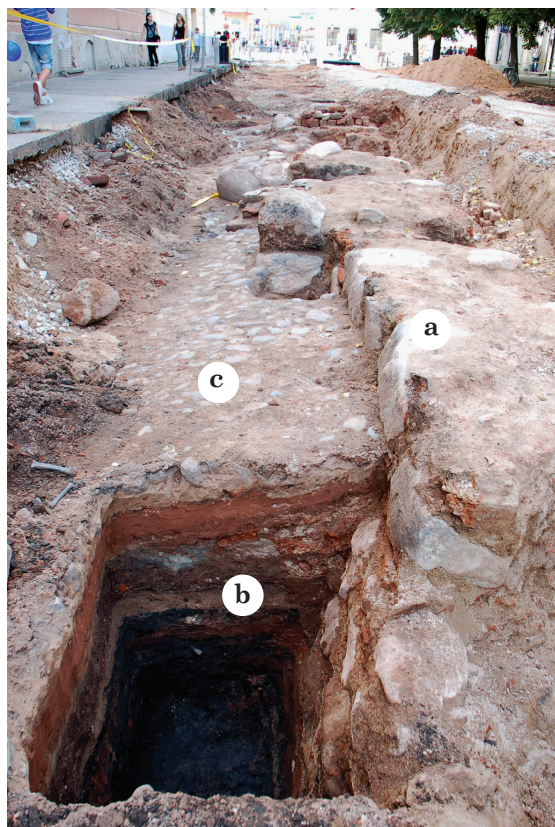
Fig. 4. Boulder wall marking construction front before 1775.

wall (Fig. 3: 4: a) belongs to a building destroyed in the Great Fire, it is a boulder wall bound with lime mortar (Fig. 4: a) with its inner side properly laid of bricks (the size of bricks $9/10 \times 14/15 \times 30$ cm). The thickness of the wall in the southern end is 100–105 cm, however, towards the north the western protrudings of the wall can be seen that made the thickness of the wall in places extend to 1.6 m. The preserved building remains have a more distinguishable 85 cm wide stepped opening for light, an alcove covered with cobblestones that has been created from a bricked-in (door) opening, and a doorway with a threshold (Fig. 5). In the edges of the threshold there are boulders with 22 cm wide carved-in gutters that were probably meant to fix the wooden threshold. Altogether the preserved wall could be followed in the length of 11 m. The width of the street preceding the Great Fire of 1775 at the given spot is about 4.5–5.1 m.

at the eastern edge of Kööri street. Namely, the ground was levelled before erecting the building, and a 10 cm thick light brownish sand layer (Fig. 4: b) was amassed on top of the earlier organic-rich layers (associated with wooden edifices). Similar developments could be observed in the northern part of the main excavation plot for the central heating pipeline as well as with the walls detected in the additional trench (Fig. 3: 1). Several pottery finds suggest that the planning of the sandy ground level, which could be also observed in the trench established for rainwater sewerage pipeline at the western side of Kööri street (Fig. 3: 2), may date from the end of the 14th century or from the beginning of the 15th century.¹ The nature of the light brown sand layer might be associated with the sand cushion below the cobblestone pavement. However, clear evidence like cobble stones, could unfortunately not be found. In conclusion,

*a – boulder wall; b – sand layer;
c – cobblestone pavement.*

A regular cobblestone pavement with thick charcoaly debris deposited directly on it runs against the western side of the boulder wall (directly next to the walls at the absolute height of 37.60–37.65 m, strongly slanting towards west) (Figs. 3: 5; 4: c). Characteristic finds gathered from the rubble (fragments of stove tiles with dark glaze) can be dated to the second half of the 18th century and thus the debris can be associated with the levelling layer after the Great Fire in 1775.

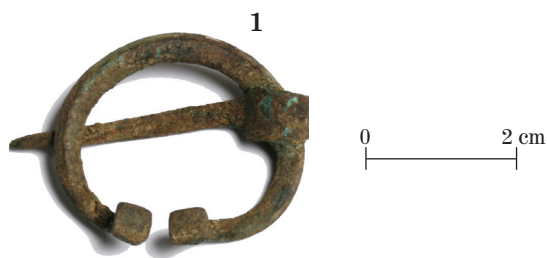
Fig. 9. Finds from Küüni street. 1 – penannular brooch; 2 – mould with engraving of a circular cross pendant.

The find material gathered in the course of excavations reflects characteristically the nature of the cultural layer, the most remarkable finds being a small penannular brooch (Fig. 9: 1) dated to the 14th century by accompanying finds and a mould with the engraving of a circular cross pendant (Fig. 9: 2). The mould was obtained from the cultural layer dated to the end of the 14th or to the 15th century.

Kultuurkihi kaevamist teostati nii sadeveetrassi Küüni tänav läänekülje põhjapoolses osas kui ka idakülje lõigul, mis ulatus Küüni tänavast Raekoja platsini. Kultuurkihti iseloomustas valgele lubjakihile ladestunud tihke hallikas või tumehallikas, kohati kivi- ja muinaskiht (paksusega kuni 30 cm), millest saadud vanimad leiud on 11. sajandisse dateeritavad joon- ja lainornamendiga kedraeraamika katkendid. Muinaskihil asusid keskaegsed tumepruunikad orgaanikarikad ja laastused kihid, millele omakorda järgnesid liivasemad kivisillutiste padjandid, maapinnatasandid ning ülas osas rusused täitekihid. Tänav alal keskaegsetele puitsillutisele viitavaid konstruktsioone ei täheldatud. Kaevamiste saadud tähelepanu-väärsemateks esemeteks on pisike nuppotstega sõlg (jn 9:1) ning 14. sajandi lõpu – 15. sajandi kultuurkihist pärit valuvorm (jn 9: 2).
