## **INVESTIGATIONS IN THE COURTYARD OF ESTONIAN STATE PUPPET AND YOUTH THEATRE**

RAGNAR NURK, VILLU KADAKAS, GUIDO TOOS

From October 2008 to March 2009 archaeological monitoring was carried out in Tallinn Old Town, in the courtyard of Estonian State Puppet and Youth Theatre. The work was brought about by the construction of the tunnel connecting the buildings at Lai St 1 / Nunne St 4 and Nunne St 8 and rooms beneath the new stage. For that purpose an excavation with an area of about 150 m<sup>2</sup> was dug in the rear part of the courtyard (Fig. 1). Most of the excavated soil consisted of the debris from the demolition after the fire of 1902 in the Tallinn German Town Theatre, formerly located on the site. Although the excavation generally did not reach the depth of the cultural layer of archaeological interest, dozens of foundations' and walls' fragments dating from different periods came to light. The documentation and interpretation of these constituted the greater part of the fieldwork.

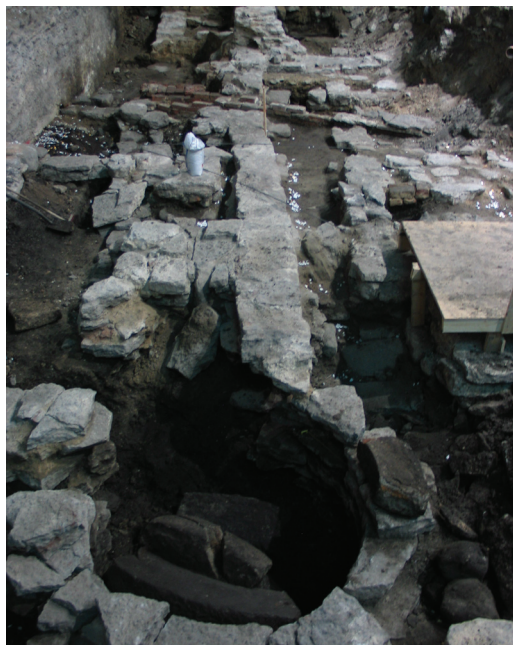
Fig. 2. On-site situation: in the forefront the well together with the curb stones found in it. View from north-west.

The most remarkable structure discovered in the course of monitoring was the large circular limestone well with the inner diameter of about 150–180 cm (Figs. 2–3). Finds from the filling of the well included several hewn stones, which had formerly covered the top edge of the well. This is the first known medieval hewn well curb in Tallinn, and therefore it is really surprising that it was found from quite an ordinary property, at least as much as we know, not from a more impressive place (e.g. town square, monastery). The neatly hewn curved stones with plain quadrangular cross-section were

32 cm wide, 26 cm thick and up to 118 cm long. Two stones, which were obviously the last that were pushed into the well, lay upon the filling of the well, still united by an iron clamp that had held them together in the curb. The curb stones were exposed on the edge of the restored well. The finds recovered from the well date the filling to the 17th century. Among them special mention should be made of some stove tiles. One of them, preserved almost intact, depicts Adolf Friedrich I, Duke of Mecklenburg-Schwerin (reigned in 1592–1628). The finds also included some unglazed stove tiles or ceramic details of the decorated fire place (?) with traces of polychromy, two of them with mascarón-like lion heads (Fig. 4). A few metres south-east a smaller well was discovered, with the inner diameter of about 60 cm. The material from the wells is incomplete, because neither of the wells was excavated to the bottom.

Kõige tähelepanuväärsemaks järelevalve käigus leitud üksikkonstruksiooniks oli suur ümmargune paekivist kaev sisemise läbimõõduga u 150–180 cm (jn 2–3). Kaevu täitekihist saadi mitu varem kaevu serva katnud tahutud kivi. Puhtalt välja tahutud kaarja kujuga lihtsa nelinurkse löikega kivid olid 32 cm laiused, 26 cm paksused ja kuni 118 cm pikkused. Kaks ilmselt kõige viimasena kaevu lõkatud kivi lebasid kaevu täitepinnaal, olles jätkuvalt ühendatud neid koos hoidnud raudklambriga. See on Tallinna teadaolevalt esimene keskaegne tahutud kividest servaga kaev, mistõttu on ootamatu, et see leiti täiesti tavaliselt kinnistult, mitte mõnest esinduslikumast kohast. Kaevu täitest kogutud leiud (jn 4) dateerivad selle kinniajamise 17. sajandisse.

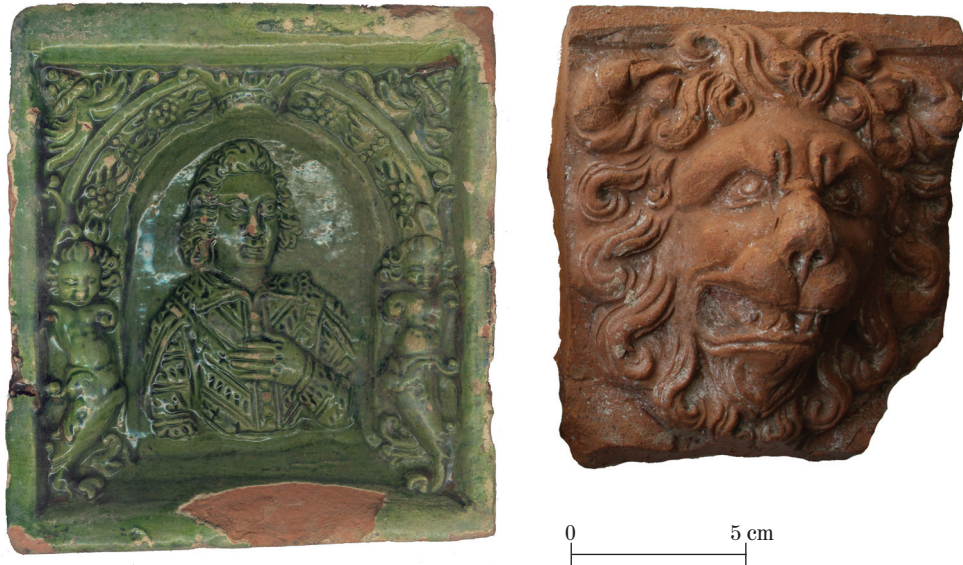
Fig. 4. Finds from the larger well. The left one depicts Duke of Mecklenburg-Schwerin Adolf Friedrich I (r. 1592–1628).
