## ARCHAEOLOGICAL STUDIES IN PADISE MONASTERY

**VILLU KADAKAS**

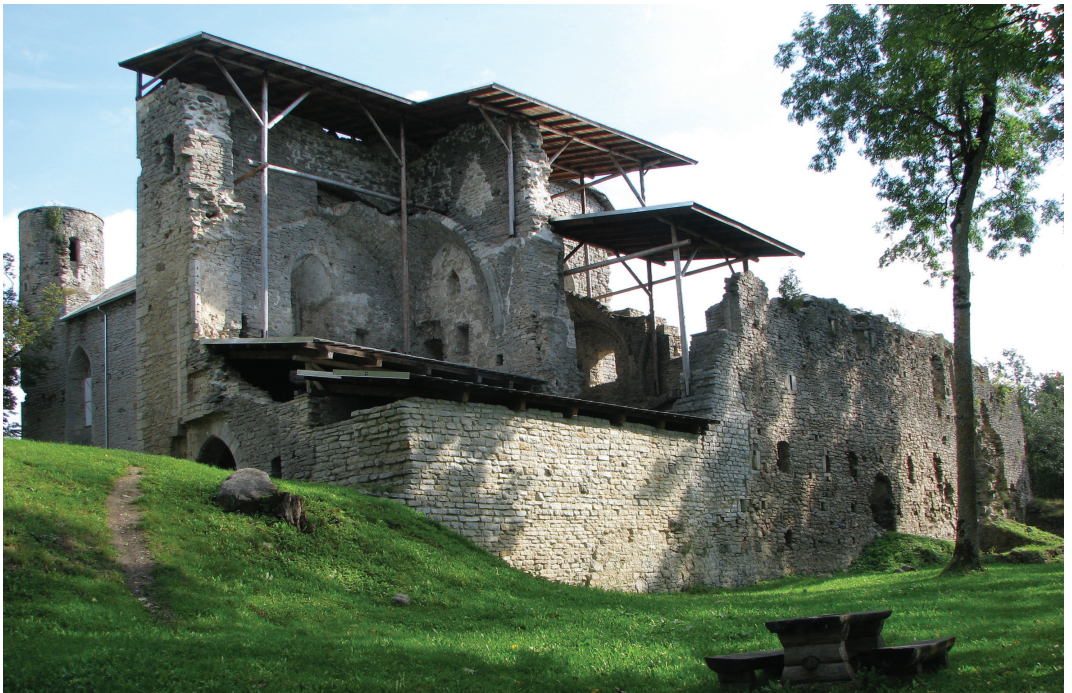
*Fig. 1. Ruins of Padise monastery in 2010. View from the north-west.*

The ruins of the medieval Padise monastery (Fig. 1) stand on the bank of River Kloostri (Fig. 2: 8) ca. 50 km south-west from Tallinn. This building complex of the fortified Cistercian male abbey is a rather well-preserved monument and has a remarkable position in the study of medieval architecture of Estonia. The joint international project between the Municipality of Padise and City of Vantaa<sup>1</sup> has enabled to continue the long ago ceased archaeological study of the ruin led by Agu EMS OÜ in the summer of 2010 and 2011. In two seasons the joint team of Finnish and Estonian archaeologists were

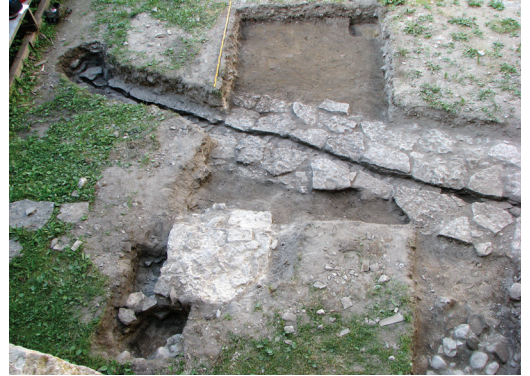
Fig. 4. Rainwater gutter and foundations of two pillars in the eastern part of inner courtyard.

The much narrower, *ca.* 15 cm wide gutter uncovered in the inner courtyard (Fig. 3: 8; 4; Kadakas 2012, figs 27, 30) obviously gathered rainwater from the roofs of all four ranges and led them under the cellar in the western end of the southern range. A much wider, *ca.* 40 cm wide channel continued under the southern range westwards, probably taking also waste water from the kitchen<sup>7</sup> along and led it towards the river in the west. The most logical place for a lavatory would have been at the end of the channel, right before flowing into the river. There is yet no data about using the river water in Padise for flushing the lavatory, as was rather common in many Cistercian Abbeys in Western Europe (Kinder 2002, 274–275; Gaud & Leroux-Dhuys 2006, 47). At least rainwater collected in the inner courtyard has been used periodically, depending on weather, to flush the kitchen waste and possibly also the lavatory.

The water gutter (Figs 3: 8; 4), built of limestone, discovered originally in 1962 (Raam 1963, 45–47), was disclosed again in two parts for two reasons. The gutter had not been measured properly and not been depicted on any plans. The dating of this structure had to be specified also. Both the location and date of the gutter are

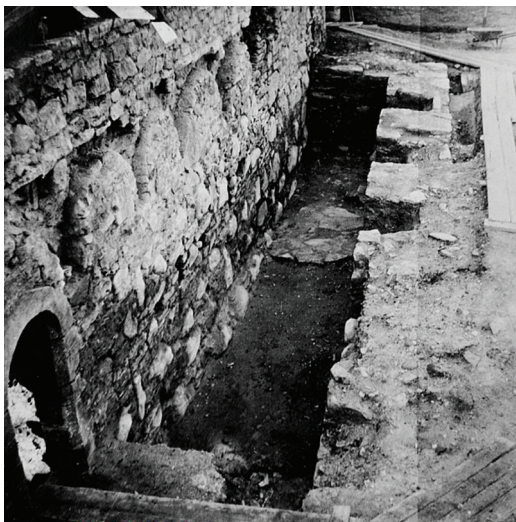
Fig. 5. Area of the western cloister excavated in 1961: to the left the eastern wall of the western range with restored niches for cloister vaults, to the right remains of the eastern wall of an older building, on top of which a wall or pillars of the later cloister were set.

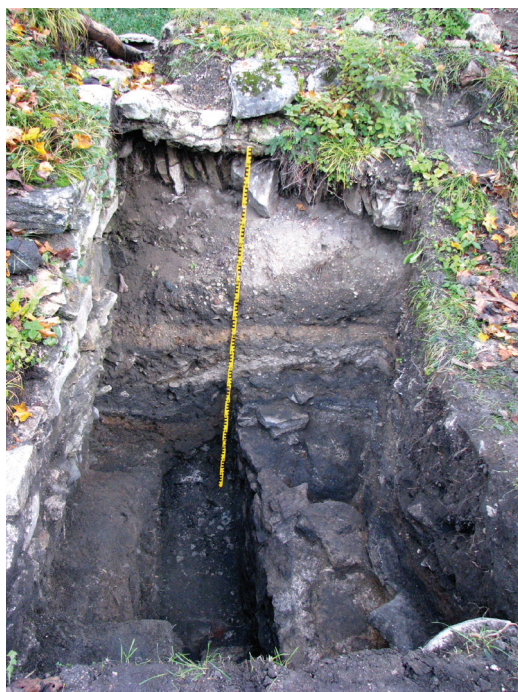
Fig. 6. Northern outer wall of the northern courtyard (top) has been erected secondarily next to the eastern wall of the building of irregular plan (left). Both have been built on top of thick filling deposits covering the remains of a previous structure, probably an oven (right below).

Almost nothing can be said about the interior or function of the building, except it has had some kind of an oven in the northern part of it. Thirdly, the northern wall has been erected next to the described building (Fig. 6). In the beginning of the project it was presumed that between the northern wall and the moat there is a lot of collapse debris, which can be removed to better expose the wall from outside. Surprisingly it appeared that it has not been a freestanding wall at all. There was no collapse debris but rather a rampart which has been planned and built together with the wall, which had a function to support it from inside the courtyard. The stratigraphic sequence between the northern and eastern walls and the gun tower was not possible to specify because the tower has been heavily restored. Probably the building history in this area has been complicated as well, as indicated by a shift in direction in the middle of the eastern wall of the courtyard directly south of the L-shaped foundation (Fig. 3). This suggests that the eastern wall has been built in two stages, which is one of the main further research issues in the area.

These deep filling layers (Fig. 6), containing very few 14th century stoneware shards, are very similar in all areas of the northern courtyard. Probably they have been deposited in a single construction period when large masses of soil, mostly natural deposits, have been removed from somewhere. There are two most likely candidates – either the northern moat or the pit for the basements of the northern and eastern ranges, all dug deep into the natural deposits. There is too little data to make final conclusion in this matter, but the early dates of the very few finds suggest that perhaps the extensive filling layers have been deposited as a result of building the basements of the monastic quadrangle – its northern, eastern and possibly also southern ranges. In any case the foundations of the outer walls of the northern courtyard, the building with irregular plan in the north-western area and probably the round gun tower as well, have been erected on top of these deep filling layers (Fig. 6). Thus the activities in the area can be divided into two distinctive periods i.e. before and after depositing the filling layers.

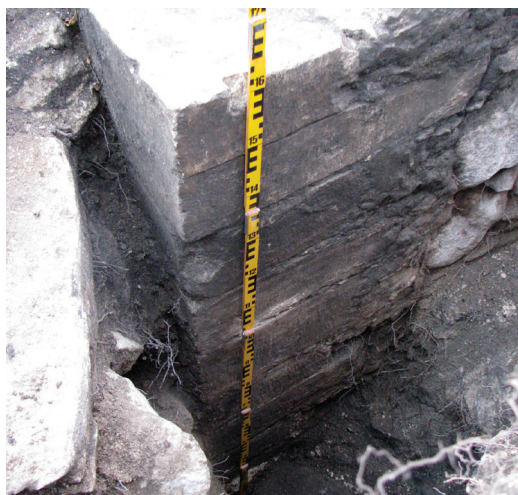
*Fig. 7 South-eastern corner of the square building, probably a tower in the northern part of the eastern courtyard.*

Several unexpected walls were discovered east from the gun tower. Walls of an almost square shaped building (measuring *ca.* 9 m outside), most probably a tower are the most remarkable among these (Fig. 3: 17). Its northern wall has mostly collapsed into the

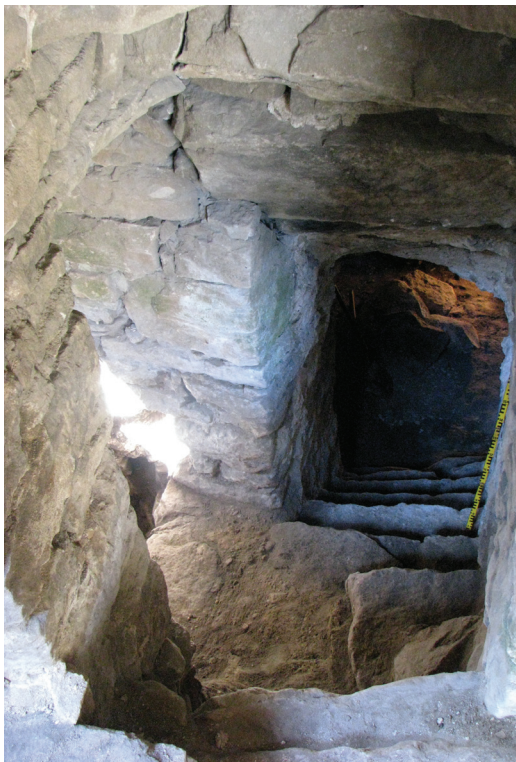
Fig. 8. The reopened stairway from the cellars of the gate tower to the western courtyard.

Much less was previously known about the two westernmost rooms. The south-western room was totally inaccessible – the branch of the diverging stairway was discovered starting from the staircase connecting the eastern cellars and the western courtyard. Obviously the south-western room has been used for heating two hypocaust type ovens (Fig. 3: 10), accessible from this cellar. The southern oven has been mostly destroyed, but the northern one has fully preserved with limestone rib vaults carrying the stones for

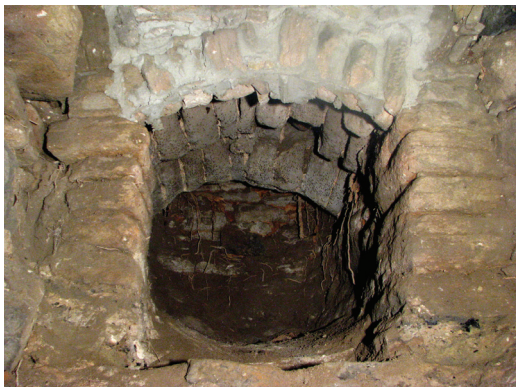
Fig. 9. Hypocaust oven between the two westernmost cellar rooms of the gate tower.

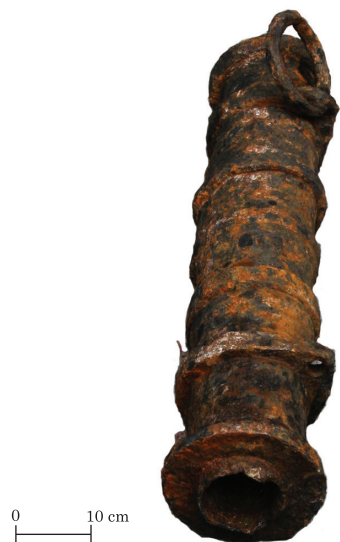
Fig. 11. 16th century cannon found from the gun tower on the south-western corner.
