PRELIMINARY ARCHAEOLOGICAL INVESTIGATIONS IN THE AREA OF THE MEDIEVAL AND POST-MEDIEVAL HARBOUR OF TALLINN

RAGNAR NURK

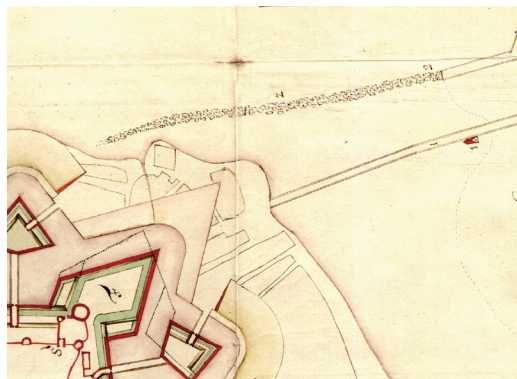
Fig. 3. Tallinn harbour on the fortification project by Paul von Essen from 1683.

The earliest maps (e.g. Fig. 3) and town views depicting the surroundings of the harbour show a very dense suburb around it. It is possible that the situation at the end of the Middle Ages did not differ much. This area was generally characterised by an irregular, probably sporadically developed net of streets and by small plots. We can imagine that it could have looked similar to a later view of fishermen's settlement Kalaranna (Fig. 4) – slightly westwards from the site. This was painted by a local 19th century artist Carl Friedrich Christian Buddeus, who is well-known by his lively and realistic town-views. Here, close to the harbour, stood probably inns, craftsmen's workshops, storehouses belonging to merchants, and maybe also

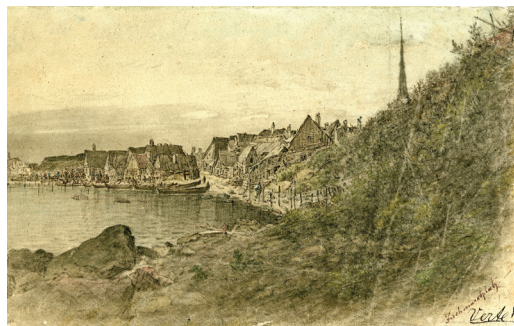
Fig. 4. C. F. C. Buddeus. Fishmarket and dwellings in Kalamaja. First half of the 19th century, coloured drawing.

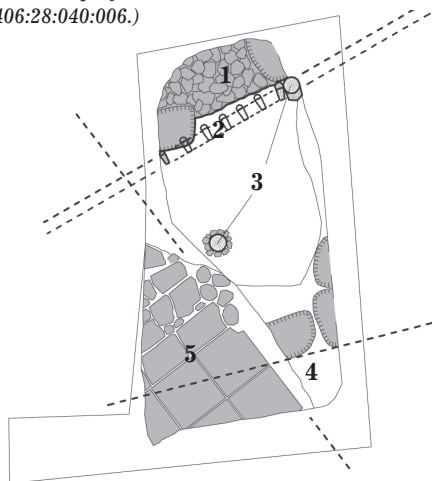
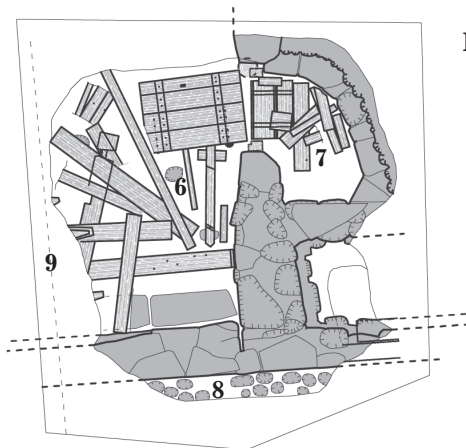
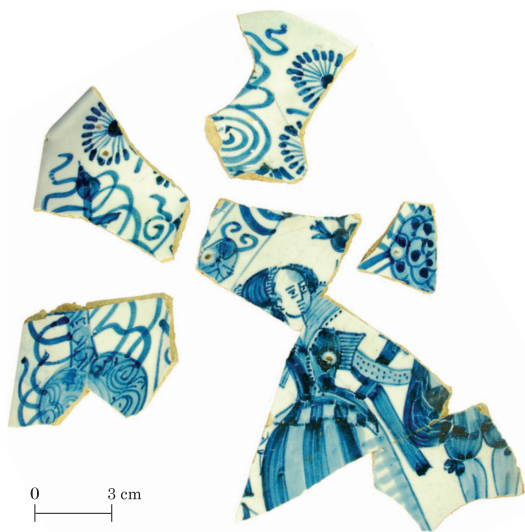
Fig. 5. Plans of test pits (see location at Fig. 2). I – test pit no. 1.

1 – presumable landfill-retaining structure of stones, 2 – supporting wall of small split posts, 3 – thick posts of indistinct purpose, 4 – large granite stones and the remains of a wooden floor south of them. II – test pit no. 3. 5 – late pavement of limestone slabs, 6 – cellar, 7 – stairway to the cellar, 8 – cobblestone pavement, 9 – eastern edge of the later cobblestone pavement. III – pit of Põhja Ave. 31. 10 – wooden barrel (cesspit), 11 – stakes, 12 – loose planks.

it was known from ca. 50 m west of the site. These were identified in late February 2005 by archaeologists Villu Kadakas and Guido Toos (OÜ Agu EMS) in a single pit at Põhja Ave. 31 (Fig. 2: A). A profile and structures in the pit were cleaned and recorded. Part of a wooden fence and a wooden barrel (Fig. 5: III), originally probably buried underground to be used as a cesspit, containing 17th and 18th century finds¹ were discovered. It included sherds of faience plates (Fig. 6), glazed redware pipkins and bowls, also fragments of a single clay pipe, a full wooden spoon and some remains of leather footwear. The lowermost deposit in the profile contained two pre-Livonian War (1558–1583) ceramic finds – sherds of 15th–16th century Siegburg stoneware and a local earthenware pot.

In the first pit (Figs 2: 1; 5: D) we came across the southern edge of a construction consisting of loose stones, with posts supporting them on the land side (Fig. 8). The presumable landfill-retaining structure, running more or less in the same direction as the coastline, consisted mostly of smaller granite and limestone pieces, but there were also some large granite stones. Among the stones an impressive collection of stove tiles³ from the first half of the 17th century⁴ (Fig. 9) was recovered. These might even be the fragments of the same stove, brought for instance from the Old Town. Soil deposits on the southern side of the construction were characterised by the alternation of humus-rich layers (including dung) with

In the second pit (Figs 2: 2; 5: II), dug in the south-eastern part of the site, we came across some mixed limestone and granite walls of a building, at a depth of about 1.5 m from the present-day ground (Fig. 10). These were bound mainly with clay and only the uppermost parts were

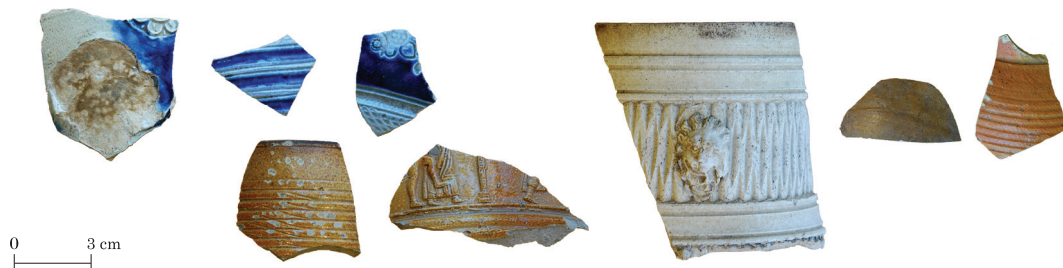
Fig. 7. Some sherds of 15th–17th c stoneware from Mere Ave. 8–10 archaeological supervision.

Further away, about 250 m southwards of the discussed site, a small-scale excavation was carried out in late November 1997 at Mere Ave. 8/10 (Mäll & Toos 1998) (Fig. 2: B). Due to bad weather and a water pipe accident, research conditions were severe and most of the finds² were collected from the soil after it was removed from the original context by an excavator. Besides various glazed redware, fragments of 16th–18th century stoneware from Siegburg, Westerwald, Frechen, Waldenburg and Duingen (Fig. 7) were gathered. Two Waldenburg sherds seem to come from the 15th century, and some local earthenware might be of medieval origin. Therefore it was supposed that the bottommost deposit might have developed in the Middle Ages, although it cannot be excluded that even most of the material was indeed brought from the Old Town and dumped at the site.

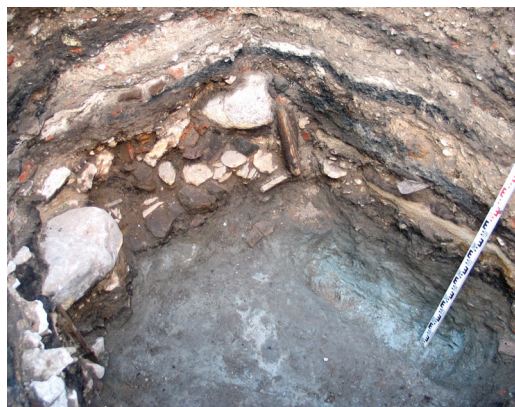
Fig. 8. The southern or landward side of presumable landfill-retaining structure in test pit 1. Some posts have been already removed during the excavation.

sea sand, which suggests recurrent submersions. The southern, landward side of the stones was supported by a row of split posts with a diameter of about 10 cm. Two larger, nearly vertical posts, with a diameter of 15–20 cm, were also discovered in the excavation. By visual estimation they were of pine wood.⁵ One of these posts was in the same row with the small split posts, but the other was located about 1 m landwards from the stone structure. It seems likely that these larger posts were supporting a pier or some similar construction, but it is impossible to fathom its precise nature without more extensive excavations. In the same pit, a little higher, some large granite stones lay side by side, and to the south of these a layer of decayed wood was preserved. This suggests the existence of a wooden floor or platform. Finds discovered upon this layer dated approximately from the 18th century. The pavement of rectangular limestone slabs at a depth of about 1.5 m from the ground belonged most likely to the 19th century.

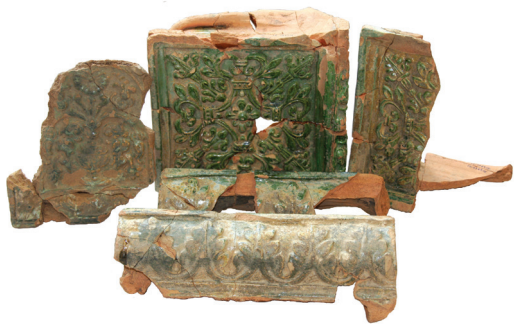
Fig. 9. Selection of 17th century stove tiles from test pit 1.

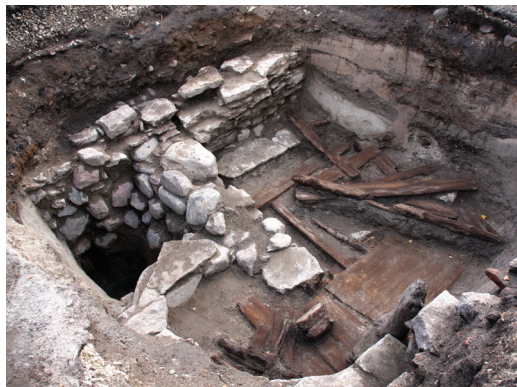
Fig. 10. Building walls and wooden details in test pit 2. View from the north-east.

partly covered with lime mortar. The foundation of the southern wall of the building ran across the whole excavation, with another wall running northwards from it. To the west of the transverse wall was a part of the semi-basement and to the east was a small stairway leading to the cellar. The floor of the cellar had been about 70 cm below the level of the same-time cobbled street or courtyard, which was well preserved south of the building. The small scale of the test pit does not allow to detect reliable connections with the maps yet. The orientation of the building correlates with the direction of Sadama St., but the house is relatively far from it, remaining more likely inside the former block.

In both rooms a lot of remains of wooden constructions were discovered, including presumable floor and stair fragments, but also a small door (125 × 88 cm) with doorposts and a sill between the two rooms. Some of the timber was of secondary use, which was suggested by nails and cut-in tenons. Two square beams were probably preserved in their

original position as part of the floor construction of the cellar. One tenoned beam, thrown carelessly on the bottom of the cellar at the time of filling it up indicates that the over-ground part of the building was made of wood. East of the north–south directional wall a curving stairway came to light in the excavation, where a wooden staircase had led up to the ground floor or directly to the street or yard. Basement walls and the foundations of the building were preserved 2 m high in the ground and were built upon a raft of beams lying in the same direction with the wall. The raft, in its turn, was built upon a dung layer containing a few finds from the second half of the 17th century e.g. a fragment of a clay pipe. As dendrochronological dating of wooden details was not possible four samples for radiocarbon dating were taken.⁶ According to the calibrated datings three samples from wooden details with different location (raft, floor construction and loose tenoned beam) gave very similar results, belonging most likely to the period *ca.* 1461–1697 cal. AD. The most probable calibrated dating of one beam under the floor which had even visible marks of secondary use as part of a roof-construction was 1415–1530 cal. AD. Despite the early radiocarbon dates of some details, the find material and stratification suggest that the house was most probably built during the second half of the 17th century.

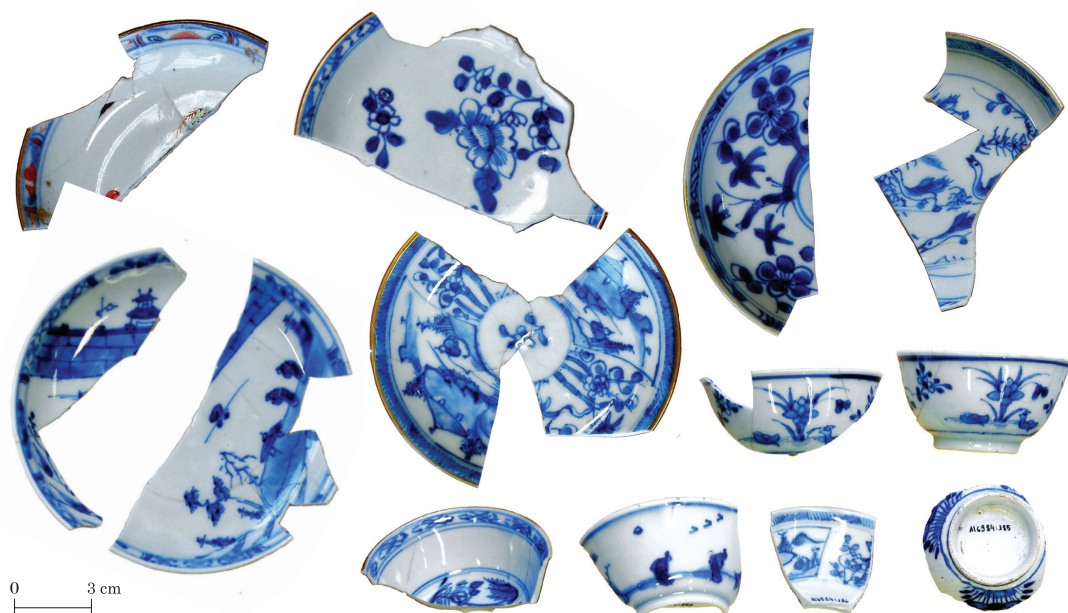
Fig. 11. Sherds of 17th–18th century Chinese porcelain tableware from the fill of the cellar in test pit 2.

From the bottom part of the sandy soil filling the cellar, and particularly from between and upon the wooden details, an impressive collection of finds from the 17th century – first half of the 18th century was recovered. These included porcelain (Fig. 11) and faience, a great number of clay pipes with different master's marks, and also a bird-shaped whistle of clay with coloured paintings. Other finds included also a Russian *denga* minted in 1712. Sporadically

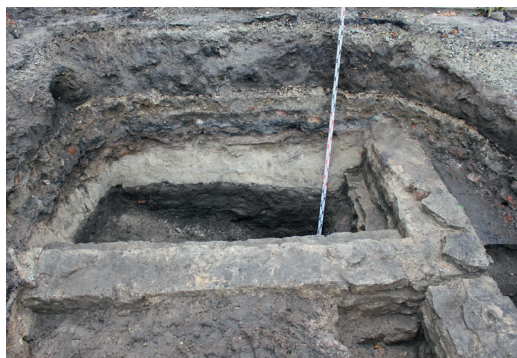
Fig. 12. Building walls discovered in test pit 3, built in two stages. View from the north.

The third pit (Fig. 2: 3) was dug in the north-eastern part of the site in front of the stairs of Linnahall. This revealed a limestone building. The foundation part in the excavation was the north-western corner of the earlier phase of the building. Later, an extension had been built to the northern side (see Fig. 12). Although the building had no cellar, its foundations had been built upon a wooden raft deep upon natural sand. Dung beside the foundations, probably brought for fill while building the house, contained finds from the

17th–18th centuries. Thus the building may be dated to the end of the 18th or beginning of the 19th century. At the western side of the excavation a pavement of large rectangular limestone slabs was preserved, which may be contemporaneous with the building. The thick charcoal layer upon the walls suggests a fire accompanying the destruction. While clearing the walls, a *kopek* of Nikolai I (reigned 1825–1855) came to light among other finds. Still, as a building of the same shape is continuously depicted on maps after the Crimean War (1853–1856), it cannot be probably connected with the war events. More likely the fire took place at the end of the century or the beginning of the next.
