ARCHAEOLOGICAL EXCAVATIONS ON THE VAULTS OF MIHKLI CHURCH, PÄRNU COUNTY

AIN MÄESALU and MARTIN MALVE

INTRODUCTION

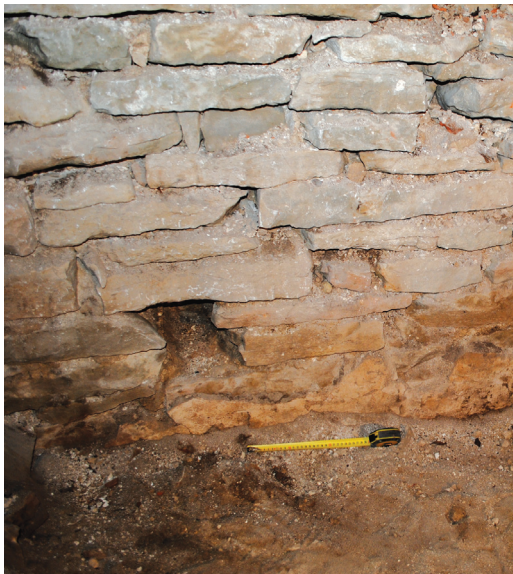
Fig. 1. Holes for beams in the southern wall of the church and remnants of plaster revealed under the holes.

The removal of the layer of debris and soil from the arches has brought to light new data about the construction phases of the church. The excavations confirmed that before the arches were built, the church was covered with a simple ceiling of wooden beams indicated by the holes discovered in the limestone walls (Fig. 1). Remnants of plaster appeared on the inner walls of the church immediately under the holes for the

beams, which shows that already then the interior church walls were plastered. On the eastern wall of the church we discovered two windows, with the size of 70×70 cm that had been walled in during the construction of the arches and must therefore have been part of the older stone-building (Fig. 2). On the western wall of the church we found holes for wooden beams stretching through the walls of the church, which hint to the existence of a balcony or even a possible hoarding on the outer western wall already in the earlier period of the construction.

Kaevamistel selgus, et enne võlvide ehitamist oli kirik lihtsa talalaeaga, millele viitasid paekiviseintes avastatud avaused ja vahetult nende all kirikumüüride siseküljel olevad krohvi jäänused (jn 1). Kiriku idaseinas paljastasid kaks varasemat 70 × 70 cm suurust aknaava (jn 2), mis olid võlvide rajamisega kinni müüritud. Kiriku lääneseina nurkadest avastati läbi müüri ulatuvad puittalade augud, mis viitavad, et lääneseina välisküljel võis juba kiriku varasel etapil paikneda rõdu või koguni kaitserõdu.

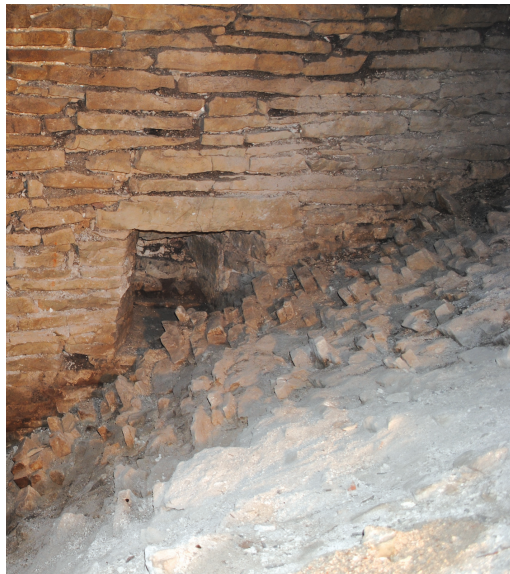
Fig. 2. One of the windows that had been partly walled in with the construction of the arches, found in the eastern wall of the church.

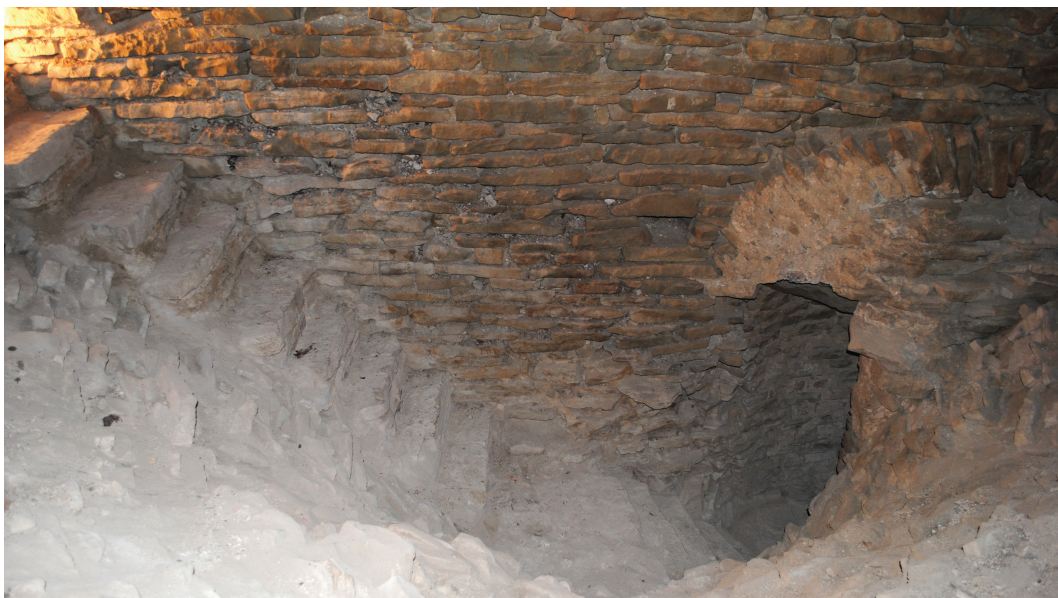
Fig. 3. The excavated passageway and stairs leading on top of the arches in the northern wall of the church.

During the excavations a 2 m long passageway was uncovered inside the northern wall of the church. This also hints to the defensive functions of the Mihkli church. The passageway led to the top of the initial wooden ceiling. Later, with the construction of the arches, limestone stairs were laid on top of the arches (Fig. 3). The aforementioned passage was only accessible from the choir-room of the church through a doorway approximately 4 m higher from the floor. This meant that one had to use a ladder.

Kiriku kaitsefunktsioonile viitab ka tema põhjaseina ülaosas 2 m pikkune käik müüri sees (jn 3). Käigu kaudu sai minna esialgse talalae peale, võlvide ehitamisel tehti sinna lisaks paeplaatidest trepp. Käiku pääses vaid kiriku kooriruumi seinas oleva ukseava kaudu, mis paiknes põrandast 4 m kõrgusel ja ilmselt oli selleks vaja kasutada redelit.

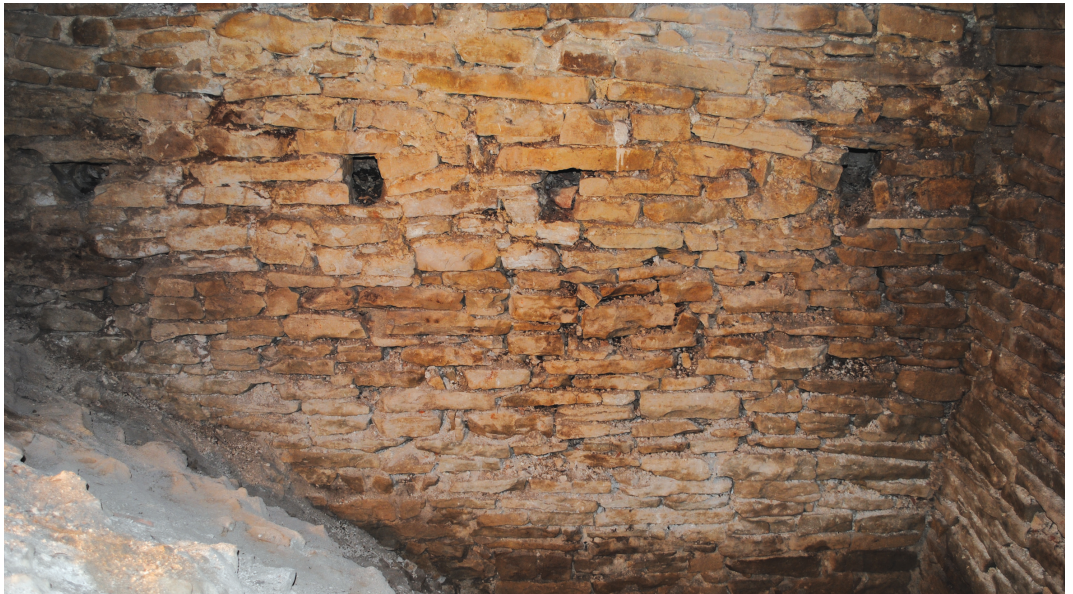
Fig. 4. Holes discovered in the northern wall of the church.

There were holes at irregular intervals (1–3 m) through the over 1 m thick wall. These were located 80 to 90 cm lower from the top of the northern and southern walls of the church (Fig. 4). The shape and size of these holes allow us to believe that round logs up to 15 cm thick were placed therein. Their function is unknown. These logs through the walls could have been used to secure scaffolding during a construction phase or they could have supported a wooden hoarding on the outer walls of the church. For example, in 2001 when the Jõhvi church in north-east Estonia was studied, similar holes were associated with a 16th century hoarding (Kadakas 2007, 98–99).

Kiriku põhja- ja lõunamüüri pealispinnast 80–90 cm allpool asusid ebakorrapärase vahedega (1–3 m) läbi seinte ulatuvad augud (jn 4), milles võisid kunagi paikneda kuni 15 cm jämedused ümarpalgid. Pole teada, kas need palgid olid kiriku mingil ehitusjärgul seotud tellingutega või toestasid nad hoopis kirikumüüri välisküljel paiknevat puidust kaitserõdu.

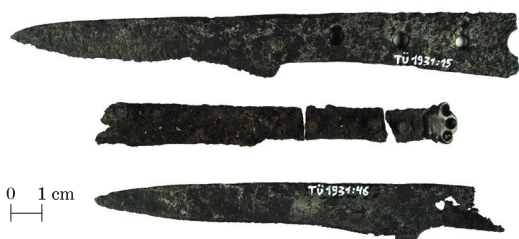
Fig. 5. Knives.

about 1630 (Valk 1991, 186; 2001, 49). All three knives represent a type common from the 15th to the 16th century that had flat shafts to which the bone parts of the handle were connected by rivets. One of them, whit decorations on the handle (Fig. 5), is similar to two knives associated with two 16th century women burials found in the rural cemetery of Makita in Tartumaa (Valk 2001, 55, plate XVIII: 14).

55 finds¹ were gathered in the excavations on top of the arches of the Mihkli church. Some of them were grave goods brought up to the attic along with the soil and the bones. A bronze ring, three iron knives (Fig. 5), an iron belt-buckle and four silver coins are some examples of the finds. A significant find was a ring with a convex/concave middle spiral part made from a strip of bronze. This type of ring was common in Estonia mainly from the 15th to the 17th century, but mostly they have been found in burials from about 1450 to

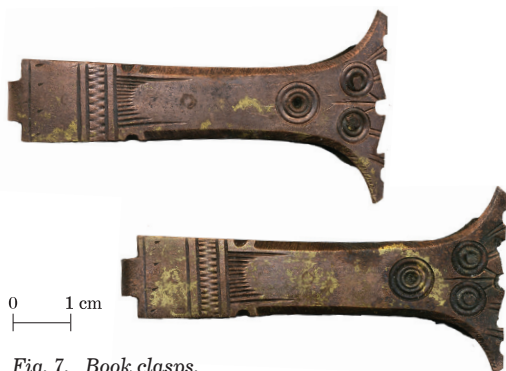
Fig. 7. Book clasps.

26 shards of window-glass, some with traces of painting (Fig. 6), were also found in the soil on the arches. They were probably remnants of the church windows. The rarest of the finds were two book clasps, with an ornament on their surface (Fig. 7). Patches of traces of gilding have been preserved on the surface of the book clasps. These finds are similar to the type of book clasps used in the 16th century.

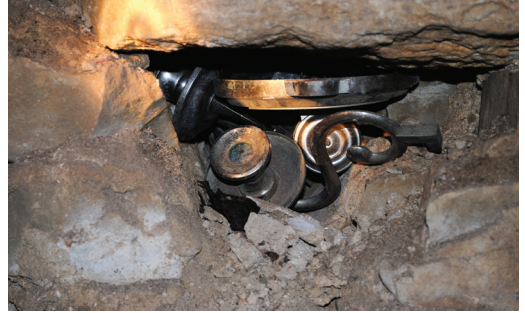
Fig. 8. A dismantled scone inside a hole in the northern wall of the church.

Three three-ponged sconces produced at the end of the 19th century were found in the holes in the walls located 80–90 cm below the top of the northern and southern walls of the church (Fig. 8). According

to the local people, the scones were taken apart and hid in these holes in 1943 during the World War II.

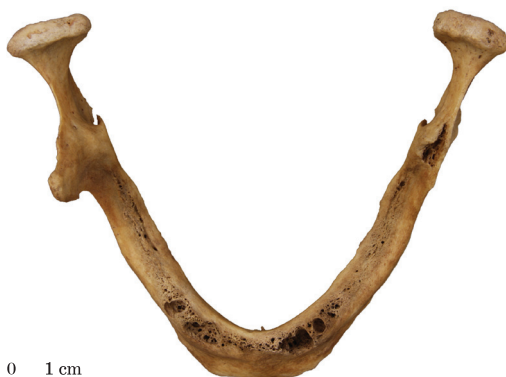
Fig. 10. Lower jaw of an adult male (age 45+ years) with almost all the teeth lost ante mortem.

Dental diseases included caries (Fig. 9), alveolar reduction, hypoplasia and tooth abscesses. Several upper and lower jaws showed *ante mortem* teeth loss (Fig. 10). In one case a canine of right mandibula of an adult man (age 45+ years) was formed, but had not been erupted.
