## **MEDIEVAL AND EARLY MODERN SUBURBAN SITE IN TALLINN, TARTU ROAD 1: CONTEXTS AND STRUCTURES**

**ULLA KADAKAS**

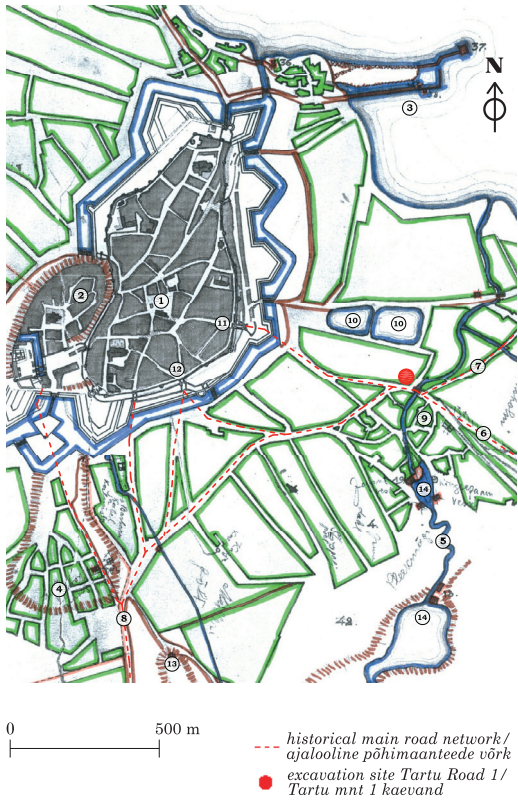
**Fig. 1.** Tallinn suburbs in the 17th century. Situation plan of the excavation area Tartu Rd 1. 1 – Town Hall Square, 2 – Toompea hill, 3 – harbour, 4 – Tõnismägi hill, 5 – former River Hārjapea, 6 – road to Tartu, 7 – medieval road to Narva, 8 – road to Pärnu, 9 – medieval St. John’s hospital, 10 – clay pond, 11 – Viru gate, 12 – Karja gate, 13 – medieval execution site, 14 – mill pond.

The plot is situated near the edge of the Tallinn Bay coastal plain on the left bank of the former Härjapea River (Fig. 1). In the beginning of the 13th century the shoreline and the estuary of the Härjapea River were about one km to the south from the current

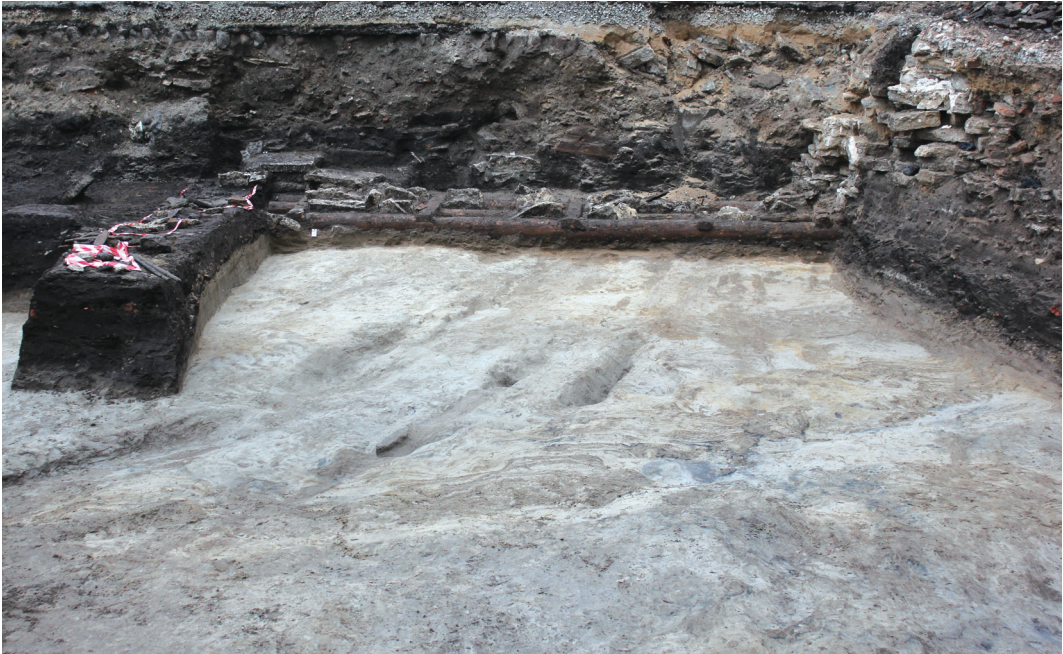
*Fig. 4. Supposed road, wheel tracks. View from west.*

In the excavation area, the natural land surface – light yellow or greyish yellow sand, rose from the sea by the 13th century – reaching the present absolute height of 1.6–2 m above sea level. In the north-western and south-eastern parts of the excavation area the natural deposits reached the highest. The original ground level was not even but as characteristic to coastal areas, gently undulating. With a distance of 5 m to each other two, in parts three natural depressions, 2–3 m wide and reaching 0.5–0.75 m deeper than the rest of the surface, run through the excavation area in the north-eastern–south-western direction. The earliest traces of human habitation were located right on top of the natural sand surface: some post holes in the north-eastern part of the excavation area and probable wheel tracks in the south-eastern part (Fig. 4). It was not possible to determine whether these were marks of the earliest Tartu road, or of

a local track inside the plot; but deciding on the position of the marks on the ground, the vehicles that left the tracks headed towards or came from the location of the later stone bridge.

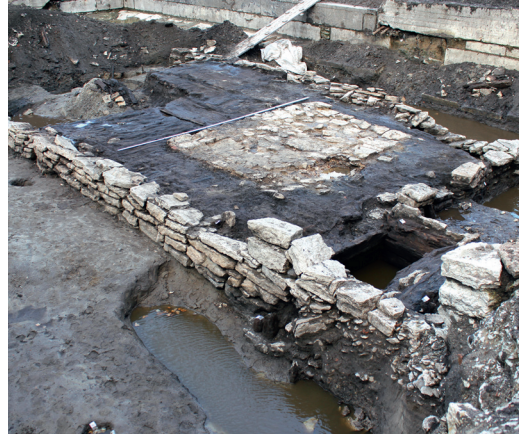
Fig. 5. The earliest building stage of the medieval house. View from south-east.

A building with dry limestone foundations (Fig. 5) was erected in the northern part of the excavation area after the plot had been filled and flattened. The building was 9.3 m long and 7 m wide with a wooden floor partially preserved in its interior. In the eastern part of the building the floor built of boards laid perpendicular to the

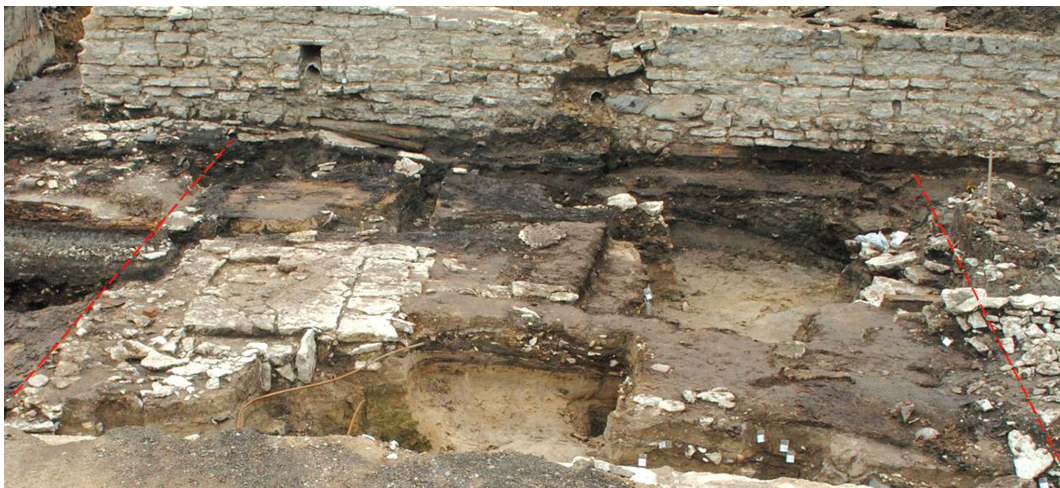
Fig. 7. The western part of the medieval house. Foundations of an oven. View from west.

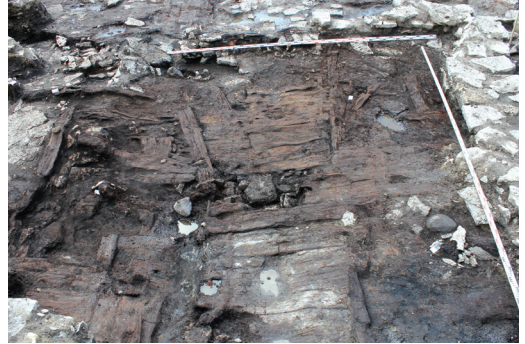
Fig. 8. Remains of a 17th century dwelling house in the north-eastern part of the excavation area. View from east.

On top of the eastern part of the previous medieval house, completely destroyed by that time, somewhere during the beginning of 17th century a building with a wooden floor (two layers) and an oven was constructed (Fig. 8). The location of walls and foundation was not identified as those had been completely destroyed in the course of building the basements of later houses. The room with the wooden floor was at least  $5.8 \times 5$  m big, however all the contexts related to the building were observable on an area of approximately  $9.6 \times 8.5$  m.

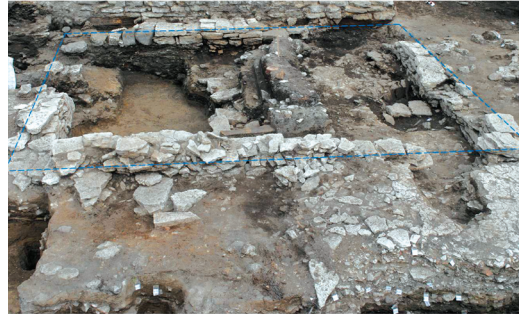
Fig. 9. A limestone foundation bound with clay. View from west.

During the 17th century two small buildings were erected of which cellar walls built of limestone were preserved. One of these (Fig. 9) was situated in the north-western and the other one (Fig. 10) in the south-eastern part of the excavation area. The foundation stones of the first structure had clay between them, but the second was bound with moss. Fragments of some small wooden above-ground buildings from the same period were also discovered. Stone foundations had been usually preserved, the above-

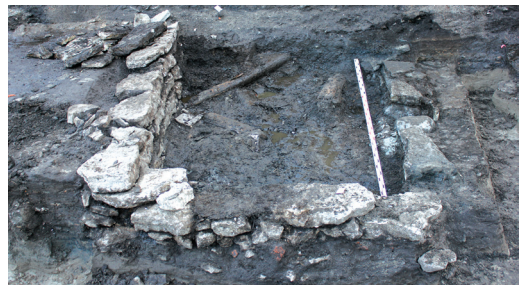
Fig. 10. Limestone foundation caulked with moss. View from west.

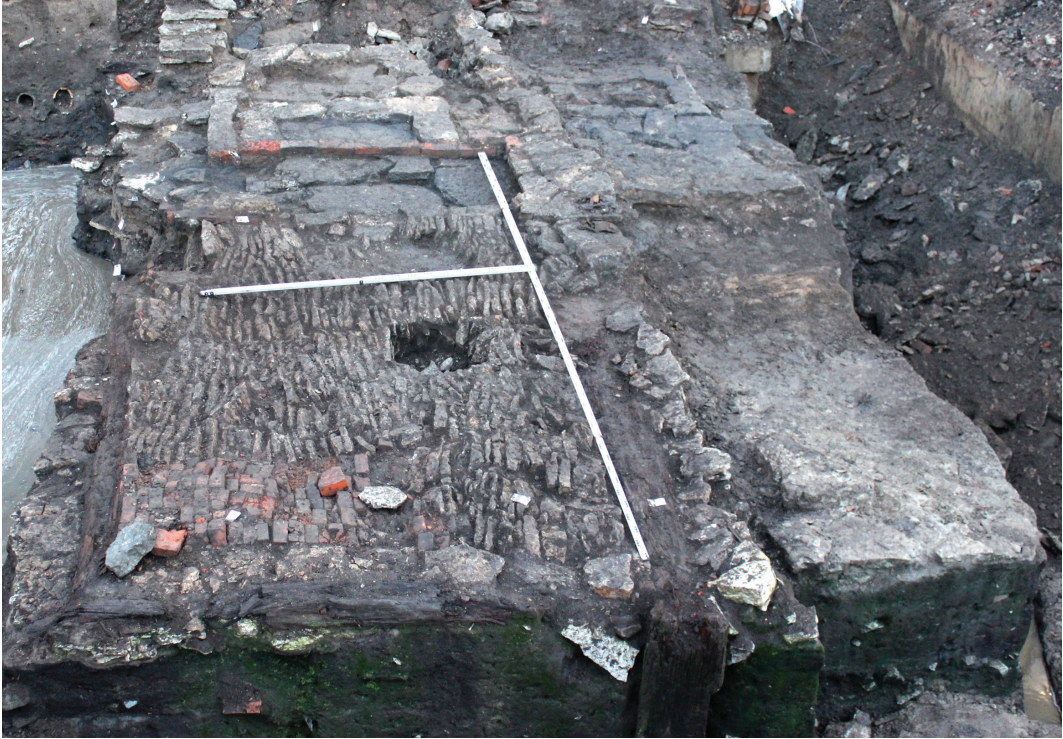
*Fig. 11. A dwelling built in the end of the 17th century beside Tartu road. View from north.*

Somewhere in the end of the 17th century a building at least partly constructed as a timber-framed structure was erected near the southern edge of the excavation area (Fig. 11). The structure had been rebuilt multiple times; it had also been expanded. In the interior various floors of timber and limestone, also of brick and upright limestone and partition walls as well as oven foundations were recorded. The building had been demolished or abandoned somewhere around the first half of the 18th century; based on the coins found from the debris layer it might have happened during the reign of Empress Elizaveta Petrovna (1741–1762).
