## ARCHAEOLOGICAL STUDIES IN HANILA CHURCH AND KARUSE CHURCHYARD

**VILLU KADAKAS**

**GUIDO TOOS**

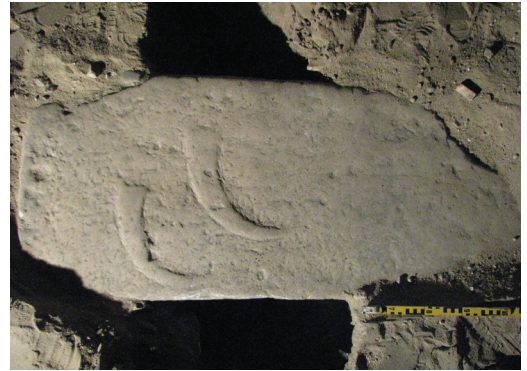
Fig. 3. Hanila church. Trapezoid grave slab with two horns.

In Hanila church the site of a slab with images of two horns (Figs 2: 10; 3), located in the middle of the eastern vault of the nave was studied after its removal. An awkward position more or less in the north-south direction had already indicated a secondary location. Before the removal a shallow and narrow trench was dug crosswise under the slab to insert a rope for lifting. The soil immediately under the slab was studied with the help of a metal detector with an objective to check if it contained any easily datable finds from a later period than the 14th century, theoretically the latest possible date of the slab. Just 10 cm deeper from the slab a Swedish schilling minted in Old Livonia in the 1660s was obtained. As the slab is thick (*ca.* 30 cm) and heavy, thus being rather difficult to use in building a floor, it may have just been sunk into the soil in this place beneath the floor to get rid of it. Another slab, with an image of a ringed cross (Figs 2: 8; 4), located right under the western portal, was also removed, but the location above the doorsill excluded the possibility of the original location.

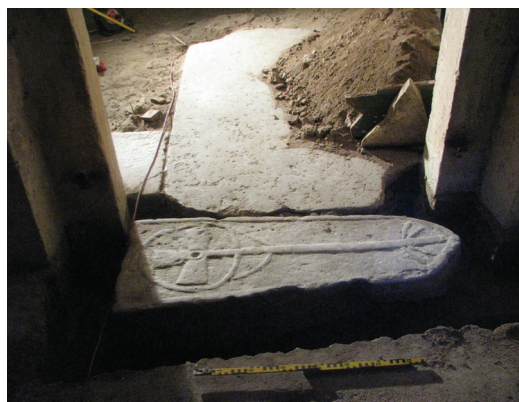
Fig. 4. Hanila church. Trapezoid grave slab with a ringed cross (foreground) and a supposed altar mensa (background).

After the removing of the grave slab with the depiction of a ringed cross from under the western portal (Figs 2: 8; 4), the bottom of the pit was cleared in small scale to expose the portal sill, which had been buried under a debris layer. The sill was rather poorly preserved *ca.* 20–25 cm below the present floor level. The eastern profile of the pit was cleaned on request of Rev. Lembit Tamsalu who had a hypothesis that the adjacent large rectangular limestone slab (*ca.* 140 × 234 cm) without any images or inscriptions (Fig. 2: 9) might be an overturned grave slab. Cleaning the edge of the slab revealed that it has a nicely worked concave profile, very unlike any tombstone typically has. The downside has no traces of working at all, proving that the slab has not been turned over. The smooth and flat upper surface indicates that the slab has not lost its inscriptions due to wear, but was without any. The profiled edge and the size of the slab point that it has rather been an altar mensa than a tombstone. The slab lacks any consecration crosses, otherwise typical to altar mensa, but these might have been on corners, which have all broken off before laying the slab in its present place.

Searching for the original place of the supposed altar mensa, it must be considered that the existing main altar in the chancel is most probably the original one together with its mensa. In a visitation record of Hanila church from 1641 it was required to demolish two side altars inside the church (Kilumets 1992, 22; see also Randla 2002, 22). Their location is not known, but it is probable that these have been in the eastern corners of the nave, as has been discovered recently in Risti church (Kadakas 2012, 182). The possibilities to find the remains of them in Hanila were limited because the trapezoid grave slabs discovered in 1990 had been repositioned in two rectangular areas (Fig. 2: 6) right where the side altars have most probably been located. Small test pits on the eastern sides of the grave slab areas revealed no masonry structure, indicating that the side altars have not been located immediately next to the eastern wall of the nave. Thus the provenance of the supposed mensa as well as the exact location of side altars remain a research questions for the future. The supposed mensa was left in its place in the floor.

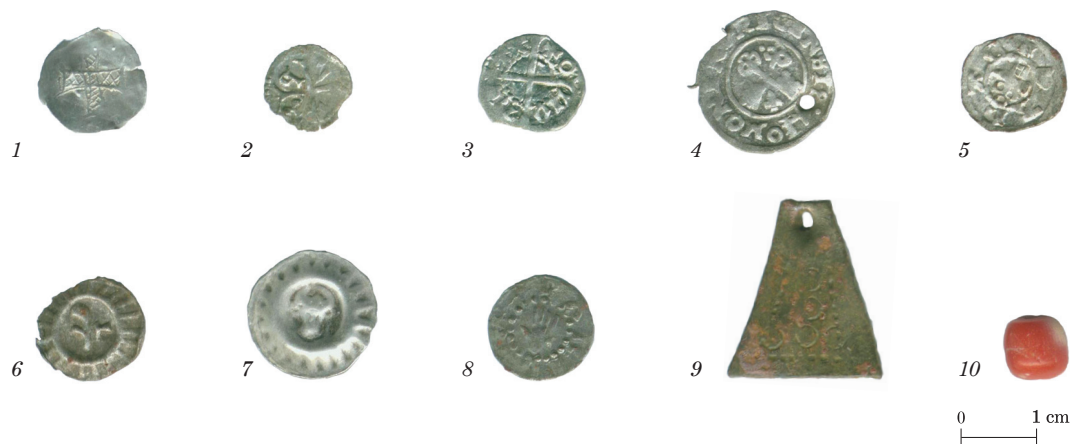
Fig. 5. Hanila church. Finds.

(HM 9183: 4, 8, 9, 12, 16, 18, 19, 20, 44, 50.)

Altogether 55 artefacts, including 43 coins were gathered – the first archaeological finds from the site (Fig. 5). The material included among others a small trapezoid bronze pendant (Fig. 5: 9), a bronze brooch pin, some small bronze plaques, an orange glass bead (Fig. 5: 10) and a piece of painted window glass. The discovered coins cover a period from the start of the parish in the 13th century up to the beginning of the 19th century. Among the total of 43 coins only 8 were Swedish (5) and Russian (3) copper coins from the 17th and 18th centuries. The early modern age silver coins were represented by one schilling of the free city of Riga (1577), five Polish (1610–1621) schillings minted in Riga and eight Swedish schillings (1560–1660) minted in Tallinn, Riga or elsewhere in Livonia. No local coins, e.g. from the short final period of minting in the Saare-Lääne bishopric by bishop Magnus (1560–1578) were discovered.

esindatud 7 (jn 5: 2–4) ja Tartu piiskopkond 7 hõbemündiga (jn 5: 5, 6, 8). Neist 9 esindavad väga lühikest ajavahemikku vahetult enne 1422/1426. a mündireformi – 15. saj I veerandit. Kõige tähelepanuväärsemad on viis Ojamaal löödud penni (jn 5: 1), mis arvatavasti pärinevad 13. sajandist. Nende valmistamise ajajärgu lõpp vastab umbkaudu Hanila kivikiriku ehitusajale u 1250–1270. Ei saa välistada, et osa neist on pinnasesse sattunud juba oletatava puust algkiriku ajal. Arvestades kaevatud pinnase ruutmeetrite vähesust, võib järeldada, et Hanila kirikus kaotatud või ohverdatud müntide hulk ja tihedus on küllaltki suur. Eesti kirikute senist uurimisseisu arvestades on erakordne 13. saj Ojamaa müntide suur hulk ja osakaal leidude hulgas.
