PRELIMINARY ARCHAEOLOGICAL INVESTIGATION IN FRONT OF ANIJA MANOR HOUSE

ANNELI KALM, KAHRUT ELLER and GUIDO TOOS

2012 PRELIMINARY ARCHAEOLOGICAL INVESTIGATIONS

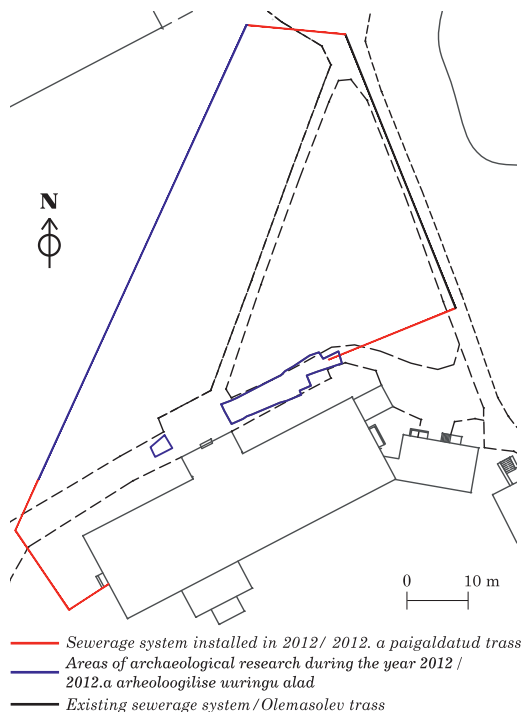
Fig. 1. Location of trenches investigated in 2012.
 Jn 1. 2012. a kaevandite asukohad.
 Drawing / Joonis: Anneli Kalm

Two pits (Fig. 1: 1–2) had been dug in front of the main building of Anija manor by the workers placing the sewerage system. Trench 1 (*ca.* 70 m²) was situated in front of the northeast wing (*ca.* 5 m to the northwest) of Anija manor house. Multitude of wall fragments and other stone constructions was detected there. The main aim was to document as much as possible without damaging the building remains. Therefore the remains were not demolished and natural sand layer was reached only in a few test pits. Trench 2 (*ca.* 8 m²) was situated in front of the southwest wing (*ca.* 6 m to the northwest) of the main building. In that trench no building remains were discovered. Trench 3 was dug through the park situated in front of Anija manor house after the building remains (except a potential limestone pavement) discovered in trench

1 were found to be valuable. No building remains or cultural layer were detected in that trench, except the remains of one probable late limestone pavement or wall *ca.* 50 m to the north from the east wing of Anija manor house. Based on that it is likely that settlement(s) predating the current manor house might be located mainly near the northeastern wing of the manor house.

Kanalisatsioonitorude paigaldamisel avati Anija mõisa hoone ees kaks ala – kaevand 1 (mõisahoone kirdeosa ees) ja kaevand 2 (mõisahoone edelaosa ees). Lisaks kaevati eeluuringute ajal läbi mõisahoone esise pargi kraav (kaevand 3), et paigaldada torustik ehitusjäänustest eemale (jn 1). Kaevand 1 oli u 70 m² ala mõisa peahoone idatiiva ees, kus paiknes arvukalt erinevate kivikonstruktsioonide jäänuseid. Kaevanditest 2 ja 3 ehitusjäänuseid ei leitud (v. a võimaliku paekivisillutise jäänused kaevandis 2 ja oletusliku hilise paekivimüüri või sillutise jäänused kaevandis 3) ja pinnasekihid olid looduslikud.

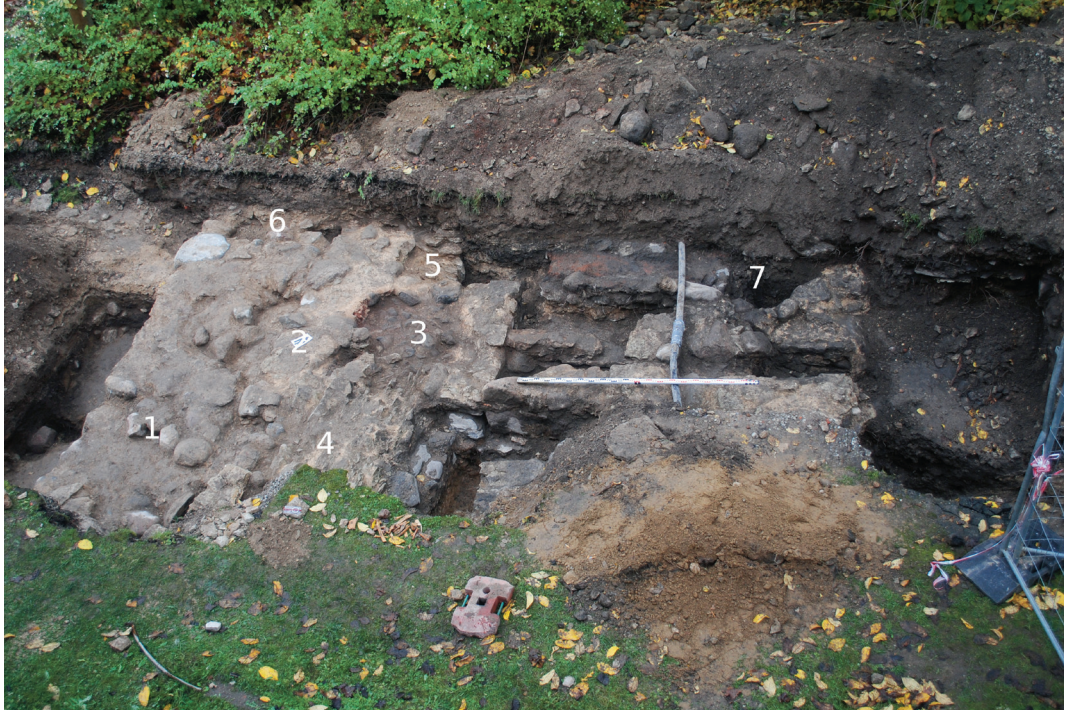
Fig. 2. Fragments of structures discovered from the middle and eastern part of Trench 1. 1 – middle main wall fragment (Fig. 4: 2), 2 – secondary wall fragment (Fig. 4: 8), 3 – remains of the heat storage hypocaust (Fig. 4: 7), 4 – arch fragment (Fig. 4: 4), 5 – arch fragment (Fig. 4: 5), 6 – secondary wall fragment (Fig. 4: 6), 7 – wooden pole remains (Fig. 4: 9).

Jn 2. Kaevand 1 kesk- ja idaosast avastatud rajatiste fragmendid. 1 – keskmine põhimüür (Jn 4: 2), 2 – sekundaarne voodermüüritis (Jn 4: 8), 3 – kerishüpokaustahju jäänused (Jn 4: 7), 4 – võlvi fragment (Jn 4: 4), 5 – võlvi fragment (Jn 4: 5), 6 – sekundaarne voodermüüritis (Jn 4: 6), 7 – puidust posti jäänused (Jn 4: 9).

Even though the area researched was quite small, a large number of building remains was identified (Figs 2; 5): 13–15 wall fragments from different phases of construction; *ca.* 9 remains of stone floors or pavements; 2 probable wooden floor remains; 2 remains of arches and 3 probable oven remains. Due to the limited nature of research the floor plans of the rooms did not become clear in their full extent. Some of the building remains were also destroyed already in the course of installing sewerage system in the 20th century, which in turn obscured understanding of the building remains.

The largest stone constructions found were three walls (Figs 2; 4: 1, 2, 3), that were oriented approximately in northwest-southeast direction and which were secondary to no construction. Due to the similar orientation and massive dimensions (width 1.10–1.35 m; height 0.6–0.9 m) of the walls it is likely that these might have been outer walls of (a) building(s). The most northeastern wall (Fig. 4: 1), was partially destroyed by the installation of 20th century sewerage system and also in the course of installations of sewerage system in 2012. That wall differentiated from the two others as it was composed of large granite stones, which were bonded

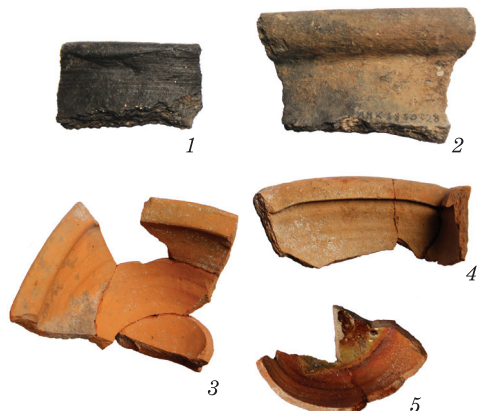
Fig. 3. 1–2 – fragments of 13th – 14th century pottery, 3–5 – fragments from vessel-tiles with quadrangular mouth and a flat round base.

Jn 3. 1–2 – 13.–14. saj kohalik keraamika, 3–5 – tasase põhja ja nelinurkse suudmega ahjupottide katked.

The earliest identified cultural layer was a dark brown soil layer deposited directly on top of the natural soil. That layer was stratigraphically older than all the building remains and from the same layer also five fragments of local pottery possibly dating to the 13th – 14th century¹ were found (Fig. 3: 1, 2). This could be connected to the Anija village mentioned in the 13th century in *Liber Census Daniae*. About half a km to the east of Anija manor house archaeological research on a prehistoric cremation burial site at Partsaare has been conducted. Those burials are believed to be connected to the Soodla and Anija prehistoric villages dating to the Late Iron Age (800–1200/1250 AD) (Kiudsoo *et al.* 2012). During the 2012 preliminary research of Anija manor, no finds datable to the prehistoric period were found.

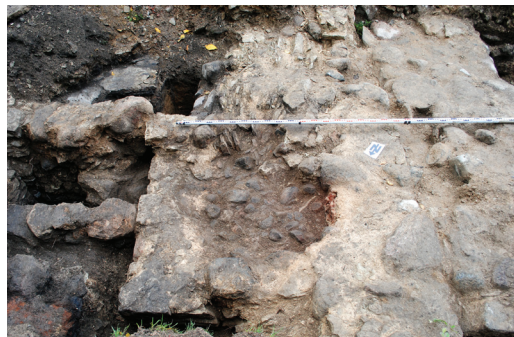
Fig. 5. Remains of a supposed medieval hypocaust furnace.

Jn 5. Oletatava keskaegse kerishüpokaustahju jäänused.

In the central part of the researched area a rectangular stone construction (Figs 4: 7; 5) could be distinguished, in the middle of which a large number of burnt heat accumulating stones were found. On the southeastern side of the stone construction an arch (Fig. 4: 4) was situated. This indicates a typical medieval heat storage hypocaust that was located in the basement and heated the room above it (for other Estonian examples, see Tvauri 2009). This hypothesis is further supported by a fragment of a typical hot plate with perforated air vent (Fig. 6) found from late demolition debris. These types of the hypocaust are common in medieval urban and manor houses and are dated to the 14th – 16th century (Tvauri 2009).

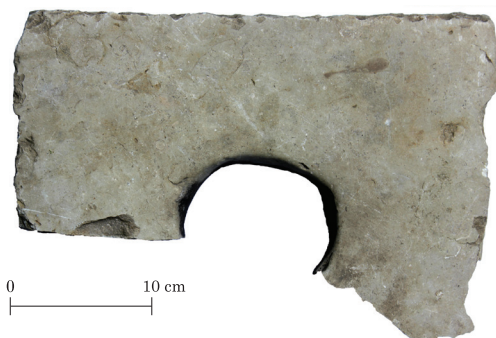
Fig. 6. A fragment of a plate of hypocaust furnace.

Jn 6. Kerishüpokaustahju katteplaadi tükk. (HMK 8850: 132.)

Kaevandi kirdeosas paiknes arvukalt (vahe)müüre ja muid rajatisi, mille omavahelisi seoseid ei õnnestunud eeluuringute piiratud mahu tõttu selgitada. Kaevandi keskosas paiknes võlv (jn 4: 4), millest loode poole jäid oletatavad keskaegse kerishüpokaustahju jäänused (jn 4: 7; 5). Hüpoteesi toetab hilisest lammutusrusust leitud hüpokausti katteplaadi tükk (jn 6).

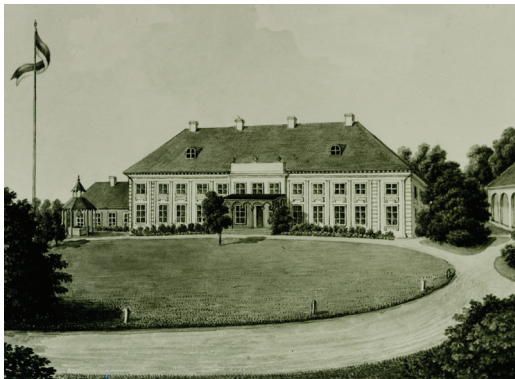
Fig. 7. Glass plate negative of an aquarelle of Anija manor house from 20th century by H. Martinson.

Jn 7. Klaasnegatiiv H. Martinsoni akvarellist Anija mõis 20. saj algul.

Fill layer (consisting of demolition debris) directly beneath the current park path and turf is likely connected to the construction of the current manor house and the oval square in front of the house (Fig. 7) was probably created together with the main house in the beginning of the 19th century. Wooden pole remains (Fig. 4: 9) discovered near the northern edge of the excavated area could belong to one of the poles that bounded the oval square in front of the manor house.
