Archaeological monitoring at the central part of New Pärnu

INTRODUCTION

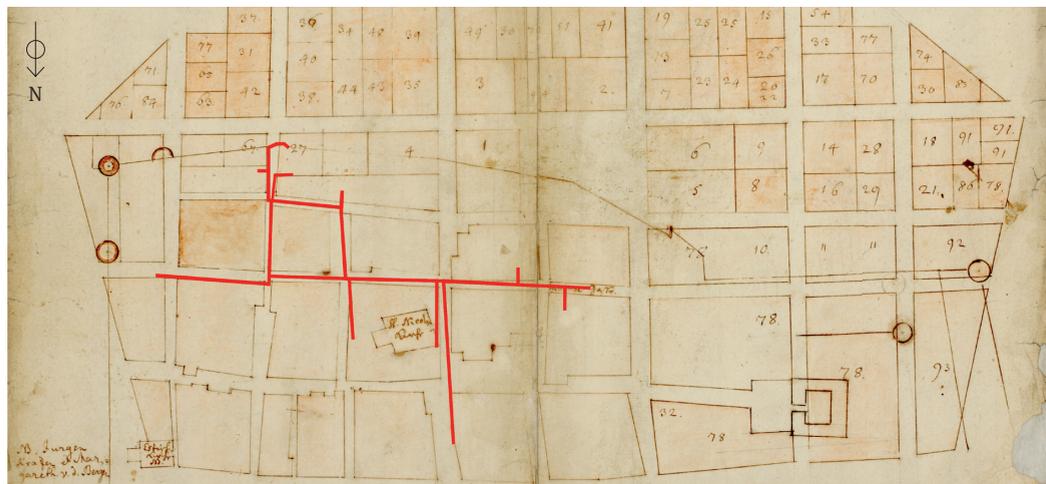
Fig. 1. Map of Pärnu from the year 1678 with the approximate location of trenches dug in 2015. The trenches are marked with red lines.

commissioned due to large-scale earthworks in the central part of Pärnu, where remote heating pipelines were renovated. This work took place in Pühavaimu, Uus, Malmö, Gildi, Nikolai and Aida streets, also Pikk street was crossed on the line of the imaginary extension of Nikolai street (Figs 1, 2).

A small section of the medieval town wall of Pärnu was unearthed in Pühavaimu street. Although it was opened in a very limited area, its location and direction correspond to the location and direction of the town wall, as known from the 17th century town maps (cf. Fig. 1). The other remains of buildings constructed on the Malmö, Nikolai and Pühavaimu streets gave evidence that these streets were once much narrower than at present.

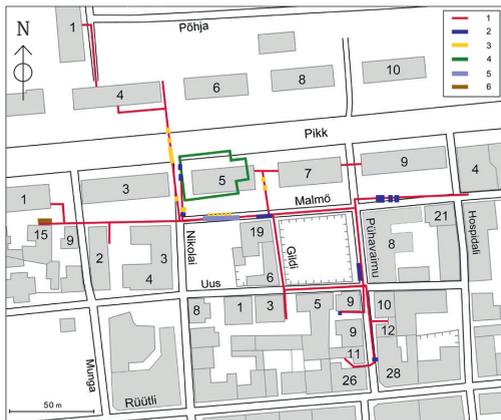
Fig. 2. The location of trenches dug in 2015 in the central part of Pärnu. 1 – trench, 2 – wall sections, 3 – area with human bones, 4 – location of St Nicholas Church, 5 – fragment of pavement, 6 – log.

In the course of excavation work several other building remains, fragments of cobblestone pavement and a log were unearthed (Fig. 2). These most probably originate from the Modern Period, some of them even from the 20th century. The building remains located in the Pühavaimu, Malmö and Nikolai streets give evidence that these streets of central Pärnu used to be much narrower and the old houses were partially located under the present street.

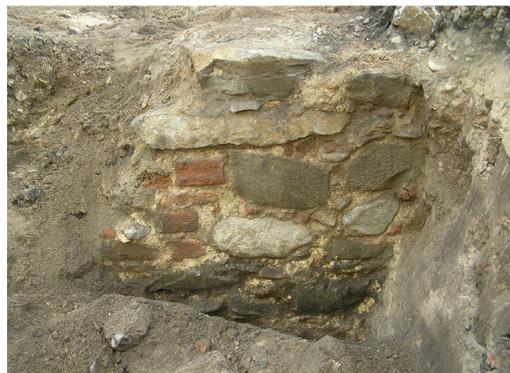
Fig. 3. St Nicholas Church. Southern section of the western wall. View from the west.

Two sections of that wall were cleaned out, the part between them was destroyed by earlier pipeworks. The church was built of large granite stones, limestone and red bricks, between and on the stones there was a large amount of lime mortar (Fig. 3). The northern section of the wall was demolished to a lower level; on the southern section it was possible to clean out the facade. The original thickness of the southern wall section was ca. 2 m, it was cleaned out in a length of 1.1 m and height of 1.3 m. In this place, only a 20 cm thick layer of brown soil separated the upper stone layer of the wall remains from the contemporary ground level. The northern section of the wall was ca. 2 m long and ca. 1.75 m wide.

13.–14. sajandil ehitatud ja 1950. aastate keskel õhitud Nikolai kirikust jäi kraavidesse kaks lõiku selle läänepoolsest seinast (jn 3). Kahest seinakatkest põhjapoolne oli lammutatud madalamale tasapinnale, lõunapoolsel katkel õnnestus välja puhastada ka fassaad. Kiriku massiivse läänepoolse otsasena välimine külg asus Nikolai tänava praeguse sõidutee idapoolses servas. Jälgi Nikolai kiriku juures asunud kalmistust saadi nii Pikalt tänavalt kui ka kiriku lääne-, lõuna- ja idaküljelt. Peamiselt oli tegu kas üksikult esinevate või segatud luudega. Kirikust ida pool asuvalt alalt leitud luude hulk oli väga väike, kuna enne kortermaja ehitamist oli kogu ala tühjaks kaevatud. Üks algses asukohas kuid lõhutud matus leiti Nikolai kiriku lääneseina lõunapoolse osa lähedalt. See luustik paiknes avatud alas vaid osaliselt, reieluude distaalsed osad ning sääreluud jäid kraavist välja. Teisest võimalikust algses kohas olevast matusest asus kraavis vaid kolju, mis jäi Nikolai kiriku oletatava edelanurga kohale praeguse Nikolai tänava keskosas.

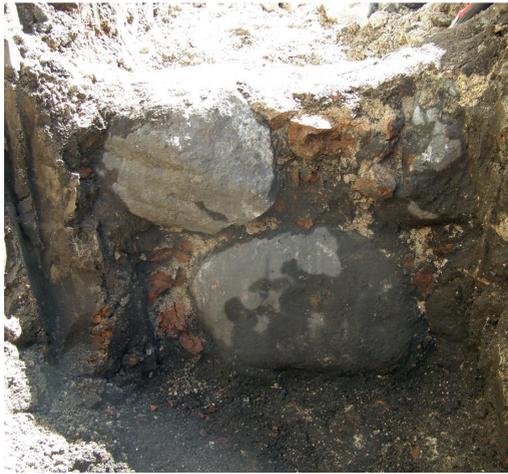
Fig. 4. Probable town wall in the Pühavaimu street.
View from the north.

street, and its upper stone layer was 60 cm below the current street level. That wall was oriented approximately in the east–west direction. Its western side was destroyed by earlier water- and sewer pipelines, its eastern end proceeded beneath the building of Rütli Street 28. The width of the section of the wall, situated in the trench was 1.1 m in the north–south direction, but it continued towards the south into unexcavated area. Only two layers of stones were dug out of that wall, the height of them was *ca.* 55 cm. Only one large granite stone was visible in the lower layer and two large granite stones in the upper layer of that wall fragment. Stones were bound by a thick layer of mortar that contained fragments of red tiles. Taking into consideration the location and direction of the wall, it is probably a fragment from the town wall of New Pärnu (Fig. 4).

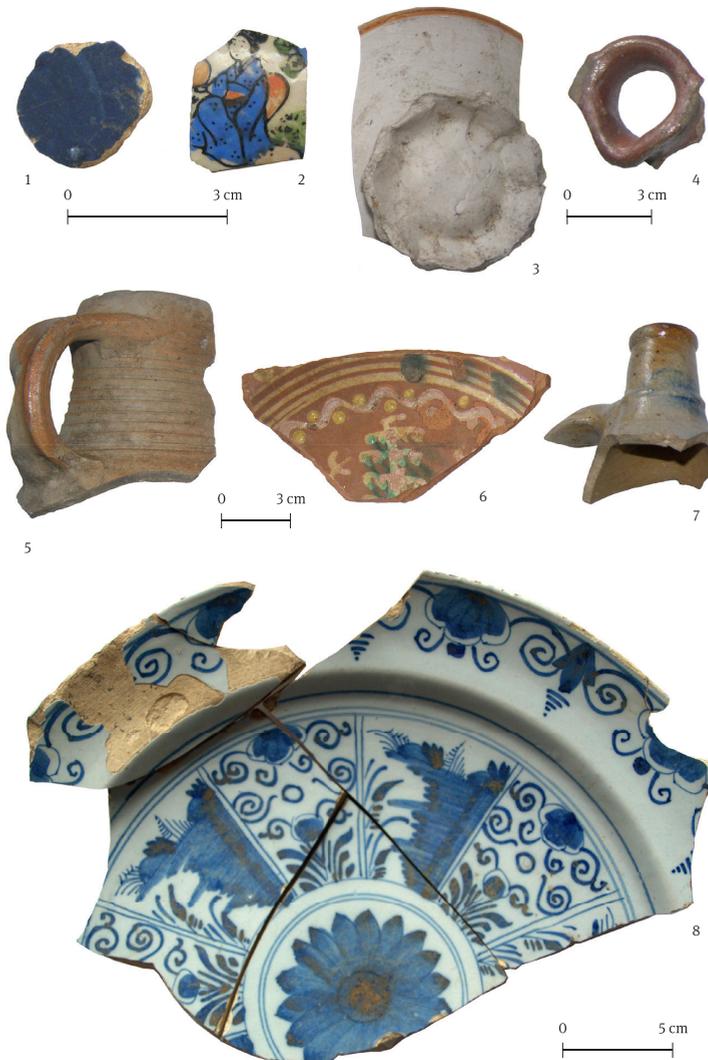
Fig. 5. Ceramics from Pärnu. 1 – gaming piece made from a faience vessel sherd, 2 – 19th-century faience sherd, 3, 5 – Siegburg and 4 – Lower Saxony stoneware fragments from the 14th – 15th centuries, 6 – red slipware sherd, 7 – stoneware mineral water bottle fragment and 8 – pieces of Delftware platter, all from the 18th century.

Altogether 55 find numbers were gathered during the archaeological monitoring. The majority of the finds were fragments of ceramic vessels from different periods. All finds came from mixed or backfilling layers and mostly it was not possible to follow the stratigraphy of the artefacts. The reason of the small number of finds is that most places have been investigated previously and the artefacts have been picked up already during earlier archaeological surveys. Some more typical and interesting examples from different periods are presented here. The earliest finds are fragments of 14th – 15th-century stoneware of Siegburg and Lower Saxony (Fig. 5: 3–5; Heege 2002, 254ff., figs 538ff.; Russow 2006, 47ff., fig. 12). The latest stoneware sherds come from the 18th – 19th centuries (Fig. 5: 7; Heege 2002, 326, fig. 706).

Fragments of 15th – 18th century glazed redware and whiteware of North Germany and Low Countries were also found, including some sherds of tripod pipkins and slipware (Fig. 5: 6; Heege 2002, 269–270, figs 567, 569; Russow 2006, 97–98). Similar ceramics have been found from Pärnu also during earlier archaeological fieldwork (Russow 2006, 164ff.;

Heinloo & Vissak 2012, 157–159, fig. 8). Some decorated fragments occur among sherds of 17th – 19th century faience and porcelain vessels, e.g. a small sherd with a Japanese girl figure (Fig. 5: 2), and pieces of a large Delftware platter with a chrysanthemum and landscape motifs, the platter originates from the middle or the second half of the 18th century (Fig. 5: 8; e.g. Matusz 1977; Pauts in print). A small faience sherd with dark blue glaze is cut round and was presumably used as a gaming piece (Fig. 5: 1; e.g. Heege 2002, 320, fig. 694; Gläser 2002, 123–124, fig. 17; Russow 2012, fig. 7: 2). In addition to the pottery fragments some other artefacts were also found: a couple of glass vessel sherds, some fragments of clay pipes, a small flint piece and a flat deformed piece of tin with a scratched motif (Fig. 6).

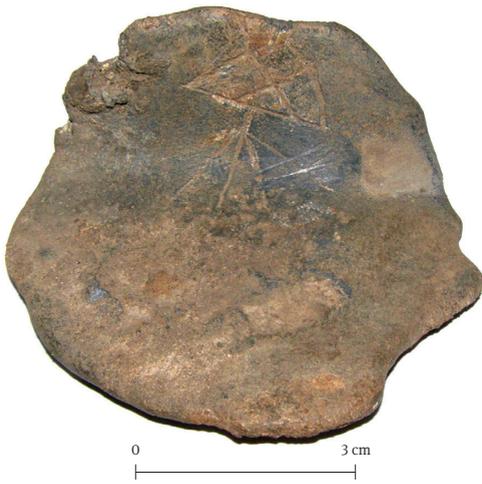
Fig. 6. A piece of tin with scratched motif, found from the Malmö street.
