Archaeological research in Vastseliina

Jekaterina Lissitsina, Kaur Alttoa, Martin Malve, Alo Ervin

In 2015 three minor archaeological investigations took place in Vastseliina, located in south-east Estonia. Two of the excavations were actuated by the intention of Vastseliina Piiskopilinnuse SA, a local nongovernmental organization aiming to make the Vastseliina Bishop's Castle a more attractive destination for both tourists and pilgrims. The overall goal of this project was to partially unearth and exhibit the castle's chapel and to build a house for pilgrims next to the Piiri tavern close to the castle ruins. Based on the job commissioned by Vastseliina Municipality, a preliminary research was conducted to estimate the condition of the chapel walls and the extent of the possible archaeological excavations and conservation. Since human remains have previously been found near the Piiri tavern (Valk 2009), several trial excavations were conducted on the future areas of the buildings and pipelines. The borders of the cemetery were specified during geophysical studies using ground-penetrating radar.

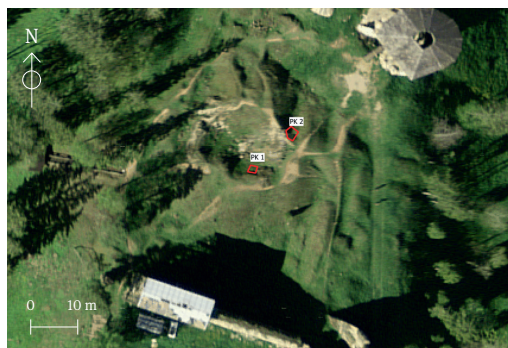
Fig. 1. Ruins of the Vastselliina bishop's castle chapel and area of the archaeological test pits.

A trial pit measuring 1.5×1.5 m was located inside the chapel's southeastern corner (Fig. 1), just next to the chapel walls. On the northern side, only construction debris was found. The debris that comprised of broken bricks and fragments of mortar partially filled the chapel. The floor measured to be 140.02 m above sea level was also unearthed. The ceiling vault of the cellar below the chapel was not reached, but taking the level of the concavity in the centre of the chapel (138.91 m a.s.l.) into account, it is possible that the vaulted ceiling of the cellar was destroyed at least in the centre of the chapel. The inner sides of the chapel walls have preserved intact up to the height of approx. 2.15 m, both fieldstones and whole bricks were used as building material (Figs 2, 3).

Another trial pit measuring 2.4 × 1.8–2.3 m was made to clarify the outer contour of the northern wall of the tower (Fig. 1). This goal was not achieved, as the northeastern corner of the tower had mostly been destroyed. This explains why on the Reinhold Guleke' reconstruction drawing, the tower's north-eastern corner is cut diagonally.

2015. aasta väljakaevamiste käigus rajati kabeli alale kaks proovikaevandit: üks sise- ja üks välisnurka (jn 1). Kabeli ehitamisel on kasutatud nii maakive kui ka telliseid (jn 2–3), ruumi siseseinad olid lubjatud. Kabeli sisemuses on säilinud mõnevõrra mörtpõrandat (jn 4) ning arvatavasti osa ühe kõrvalaltari alusest. Kabeli välisküljelt kaevati välja osa ees- ja pealinnust ühendanud väravaehitisest (jn 5). Torni välisseinad olid krohvitud ning ookruga värvitud (jn 6). Nii sise- kui ka välismüüride seisund on väga halb.

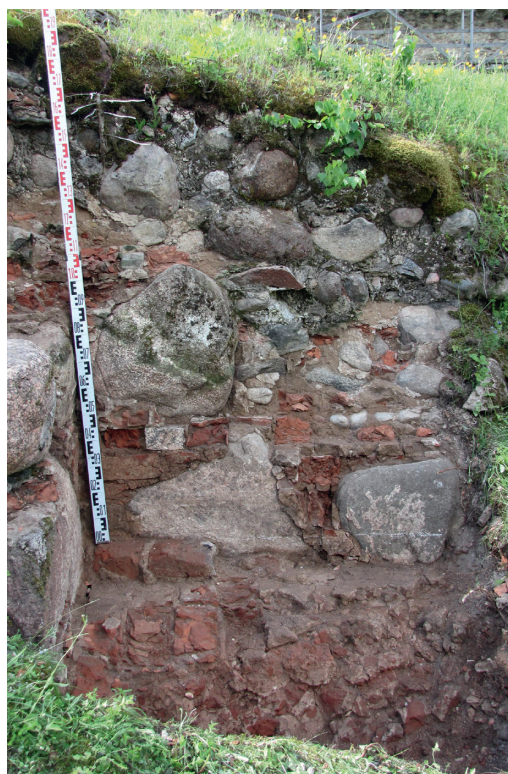
Fig. 2. Test pit 1. Inner face of the south wall of the chapel, view from the north.

The floor has become dilapidated and it is only observable in the southern part of the trial pit i.e. right in front of the chapel's inner walls (Figs 2, 3). The extant floor was 33–88 cm in width and narrowed towards west. Below the levelled floor of lime mortar was a homogenous layer of both whole and broken bricks and a copious amount of lime mortar. The bricks in the monolith formed no lay pattern.

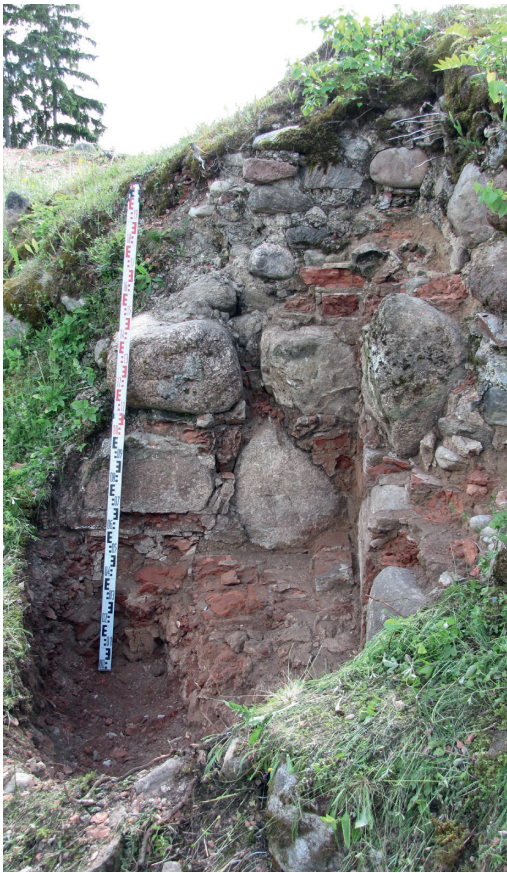
Fig. 3. Test pit 1. Inner face of the eastern wall of the chapel, view from the west.

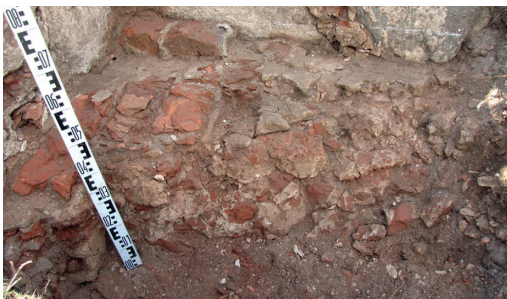
Fig. 4. Test pit 1. Remains of the chapel floor and its underfill, view from the north.

A construction fragment consisting of two rows of bricks laid flat was found on the floor of the chapel (Fig. 4). At first, it seemed to have been a floor pavement, but there are several arguments against this hypothesis. A floor of bricks laid flat was frequent during

the Medieval Period but an example of a floor consisting of two layers of bricks is not known in Estonia. There is no need for such construction and this only adds extra weight to the ceiling vault. It is possible that the second row was added later to fix the eroded floor, but since the surfaces of the lower bricks show no signs of abrasion, it is highly unlikely. The hypothesis of this being a floor is also opposed by the fact that the final whitewashed layer of the chapel walls was also found behind the bricks and this means that the bricks were placed there after the walls had been completed. In addition, the area where the brick wall is built is only a 67 cm wide strip next to the eastern chapel wall. West of the brick wall, only the even floor of lime mortar could be found. The possibility that some floor bricks have been removed from there can be ruled out since there are no signs of bricks having been laid there. This leads to the hypothesis that these bricks do not originate from the chapel floor, but are the remnants of the corpus of one of the side altars (*stipes*). In the end of the 16th century, there were three altars in the chapel (PAI 1970).³ Between the aforementioned low brick wall and the eastern wall of the chapel there is a 4–5 cm wide gap. In case of the floor hypothesis, this would not make any sense, but in connection to the side altar hypothesis it becomes understandable. The altar was built adjacent to the south wall, so it is natural that no attempt was made to connect the altar to the wall.

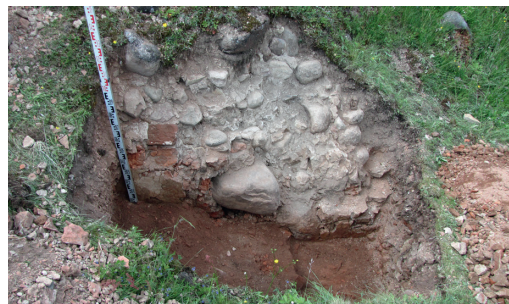
Fig. 5. Test pit 2. Outer face of the eastern wall of the chapel, view from the east.

The outer face of the chapel's eastern wall was also the western profile of the trench. In the northern, eastern, and southern profiles, only construction debris consisting of brick and mortar fragments was visible (Fig. 5); this debris covered the inside of the chapel, its walls, and most likely, also the outer surfaces of the walls. The wall was excavated in the length of 2.3 m, it measured at least 1.3 m in width and 1.8 m in height. It was laid of fieldstones and both halved and whole bricks. The infill building technique has been used to erect the wall. The fieldstones used on the outer side of the wall are up to 50 cm in diameter, the width of the bricks was 15 cm and the height 10 cm. Smaller fieldstones measuring 15 to 25 cm in diameter have been inside the wall. Stronger grey mortar has been used as binding material for the inner layer, and yellowish and crumbly lime plaster on the outer side.

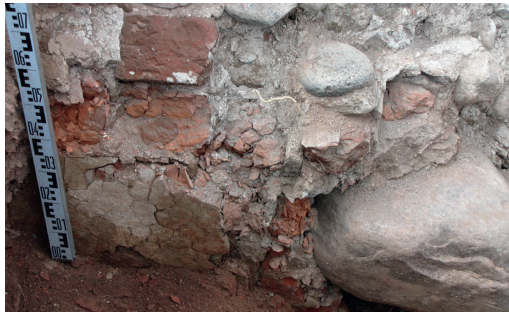
Fig. 6. Test pit 2. Remains of the southern fragment of plaster on the outer face of the eastern wall of the chapel and springing of the vaulted arch.

was intact only in the northern part of the trial pit. The height of the plastered surface was 38 cm in the southern part (Fig. 6) and 25 cm in the northern part. There were two distinguishable plaster layers on the northern surface. The lower one was white, and this was covered with a layer of plaster painted with ochre. On the southern part of the wall, the remains of a springing of the vaulted arch consisting of two brick rows (Fig. 5) were found intact and remains of the springing were also found in the northern part of the wall. Both springings were added later. There is no doubt that they are the remains of the vaulted arch of the gate that connected the main castle and the outer bailey.

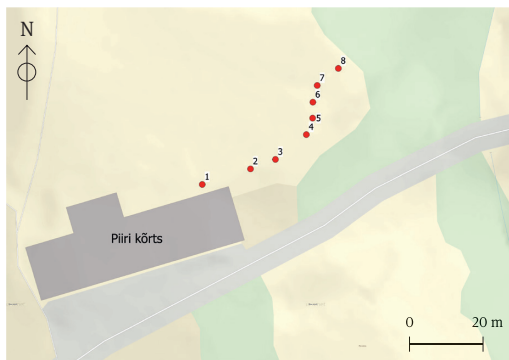
Fig. 7. Archaeological test pits made in 2015 on a cemetery in the eastern part of the yard behind the Piiri tavern.

In the summer of 2015, eight trial pits were dug in order to specify the borders of the burials in the eastern part of the cemetery (Fig. 7). Six trial pits out of eight gave us *in situ* burials and

19. sajandi esimesel poolel rajatud Piiri kõrtsi juures tehti eeluuringuid hoone ümbruses paikneva kalmistu alal (jn 7). Mitmest prooviaugust leiti *in situ* paiknevad matused ja segatud inimluid. Matused algasid umbes 0,5 m sügavuselt. Paigal olevaid skelette välja ei puhastatud, pinnases olevad segatud inimluid võeti kaasa. Osteoloogiline analüüs näitas, et luud pärinevad peaaugult täiskasvanute, harvem alaealiste luustikest.

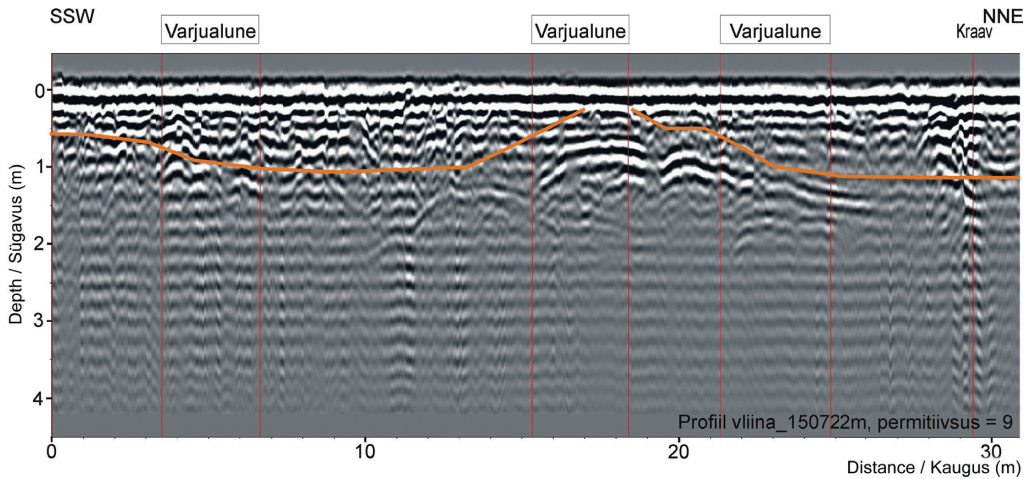
Fig. 9. Example of radar image along the profile vliina_150722m. The interpretative orange line indicates the lower surface of filling soil.

Ground-penetrating radar studies were used to specify the location of the eastern border of the cemetery. Differences in dielectric properties between the mixture of soil and trash, and natural soil, were a precondition for the radar studies. Zond 12e by Radar Systems Inc. was used at frequency 500 MHz moving the antenna at walking speed. The reflected signal was measured at every 1 cm during 100 ns. To convert time-scale to depth-scale, relative dielectric permittivity value 9 was used as based on the hyperbolic fitting method.

Hammastel leiti kergest hambakivi ning ühe täiskasvanu I nimmelüli keha alumisel pinnal oli lülivahekettasongast tekkinud lohk. Eeluuringud näitasid, et 19. sajandi lõpus või 20. sajandil on ala, millel paikneb kalmistu, ümber planeeritud ning platoo serva on kuhjatud prahiga segatud mulda. Kalmistu idapiiri täpsustati georadari-uuringutega (jn 8–9).

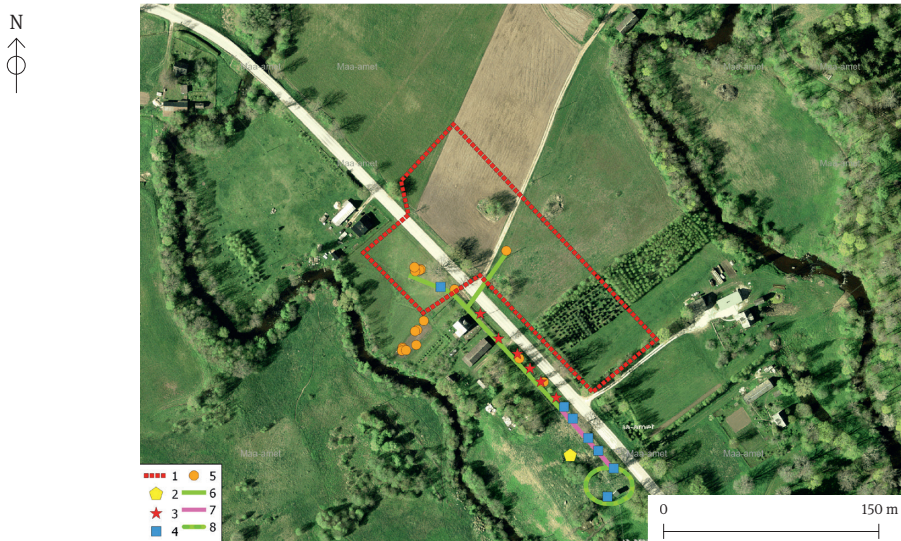
Fig. 10. Research area in the protection zone of the Vana-Vastseliina I settlement site and the nearby cemetery. 1 – protection area of the settlement site, 2 – cemetery, 3 – trial pit with finds, 4 – trial pit without finds, 5 – surface finds, 6 – area that would require archaeological excavations, 7 – earthwork area where archaeological monitoring would not be necessary, 8 – area where earthwork should be archaeologically monitored due to previous discovery of human skeletal remains.

In connection with the reconstruction of electricity cables, archaeological preliminary research was commissioned by OÜ Firstel Group on the Vana-Vastseliina settlement site⁵ and the protection area of the nearby cemetery⁶ to determine the presence of the occupation layer of the settlement site and/or graves on the area of the planned underground electricity cable. Several test pits were dug covering the entire area, surface finds from mole mounds and the nearby field were collected (Ervin *et al.* 2015) (Fig. 10).

Vana-Vastseliina I asulakoha ja selle läheduses paikneva kalmistu kaitsetsoonist ei leitud haudu, küll aga dokumenteeriti ulatuslikul alal asulakoha kultuurkihti (jn 10). Leidude järgi (jn 11) otsustades on seal nii rauaaja lõpu kui kesk- ja varauusaegne asustusjärk. Asula kultuurkiht lasub oluliselt ulatuslikumal alal kui see on praegu riikliku kaitse all.

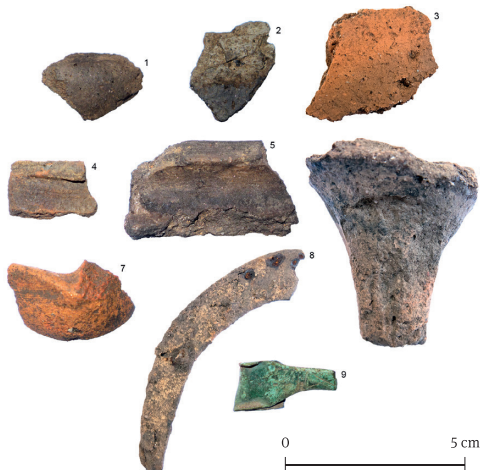
Fig. 11. Finds from the Vana-Vastseliina settlement site. 1–3 – sherds of hand-made pottery, 4–5 – sherds of wheel-thrown pottery, 6 – sherd of tripod vessel, 7 – stove tile fragment, 8 – heel plate, 9 – fragment of bronze brooch pin.

No graves were discovered on the site. The occupation layer of the settlement site was dark in colour and contained pieces of charcoal, burnt stones, animal bones, and brick crumbs. Sherds of ceramic vessels, some slag, fragments of glass, daub, a fragment of a brooch pin, and a heel plate dated to the Livonian War Period (1558–1583) were found (Fig. 11). The collection of ceramics consisted of both hand-made and wheel-thrown pottery including fragments of tripod vessels that indicates that the site was inhabited from the end of the Iron Age to the Early Modern Period. The cultural layer of the settlement site extends further than the current protection area.
