Archaeological studies on the site of the former Cistercian grange Kolga

Villu Kadakas and Erki Russow

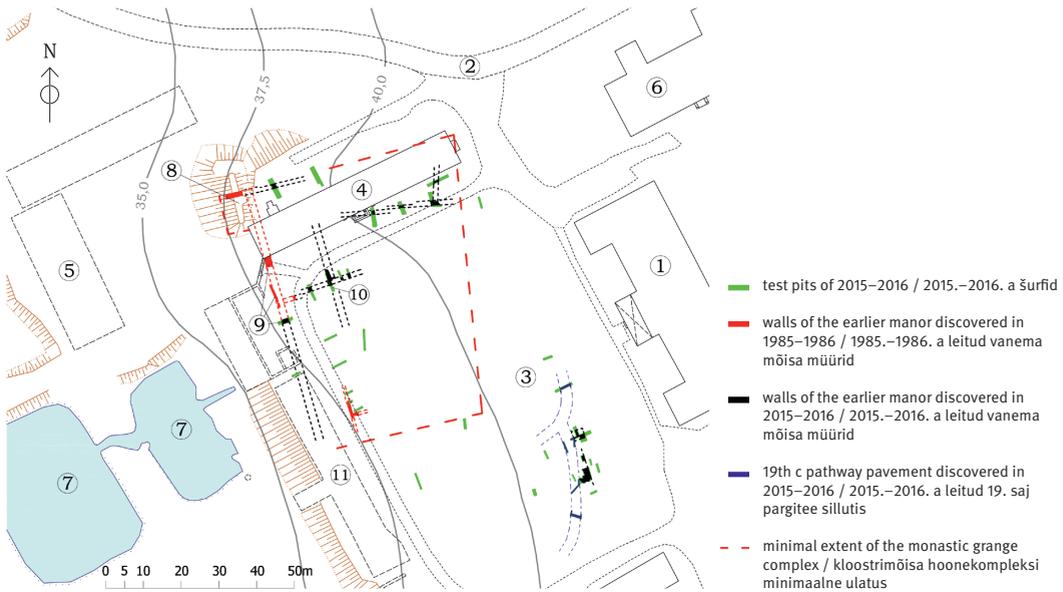
Fig. 1. Plan of Kolga manor centre. Plan of walls discovered during fieldwork. 1 – existing mansion, 2 – road, 3 – main square, 4 – former cattle barn, 5 – former distillery, 6 – Kolga museum, former steward’s house, 7 – ponds, 8 – two-room cellar, 9 – supposed western curtain wall, 10 – discovered cellar with a collapsed tiled stove, 11 – former coach washing pond.

The first archaeological fieldwork in Kolga manor was done in 1985 and 1986 by Kalle Lange who was called to document a trench (Fig. 1), which had been dug for installing heating pipes (Lange 1985; 1986).

In 2015, 14 pits were dug (Fig. 1) to locate the walls recorded by Lange and an extra wall near the northern edge of the main square, indicated by very clear GPR signals. While digging the first pit it became clear that the area is covered by a 1–2 m thick layer of demolition debris.⁴ Therefore an excavator was used to remove it.

A very thick wall (*ca.* 2.06 m), running in the north-south direction (Fig. 1: 9)⁵, had been recorded by Lange next to the south-western corner of a former cattle barn (Fig. 1: 4). Due to its extraordinary thickness Lange interpreted it as a defensive wall (Lange 1985, 5). An extension of this wall was discovered in 2015 *ca.* 15 m south of it (1.9 m thick). Considering its extraordinary thickness and location next to the slope, it could have been the western curtain wall of the complex. At the same time it could also have functioned as the western wall of the main building.

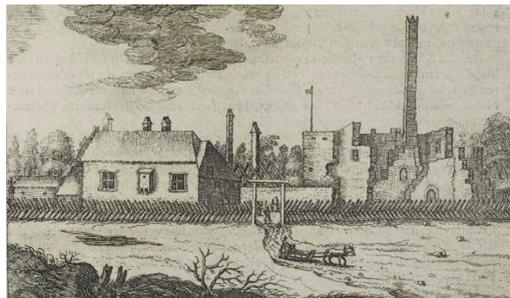
Fig. 2. Kolga manor in 1615. Copper engraving by Anthonis Goeteeris (Goeteeris 1619, 10–11).

An engraving of the ruins of Kolga manor exists from 1615 and has long served as the primary and only visual source regarding the buildings of the Cistercian grange (Fig. 2). It was made by Anthonis Goeteeris, a paymaster of a Dutch diplomatic mission on the way from Tallinn to Russia. Goeteeris kept a diary on the way and published it in 1619 with several copper engravings, which he had made on the way (Goeteeris 1619; Johansen 1927, 3–4).

In September 1615 Goeteeris depicted burnt ruins of a large stone building in Kolga manor. He also noted a markedly high chimney which had remained from another building (Goeteeris 1619, 10–11; Johansen 1927, 10, 15; Fig. 2). No medieval documents shed any light on the architecture of the building complex. One can get some idea of it based on an inventory, which was made in 1586 after the death of Pontus de la Gardie. It lists a fortified house, a room for a bakery, a room above the gate, cellars, and separate buildings for a brewery, a granary, a dwelling shed, a cattle shed, a cattle yard and stables (Karling 1938, 4).

Based on this engraving Paul Johansen concluded that the ruin of the large stone building comes from the period of the monastic grange, which was built as a conventual building (Johansen 1927, 10). Later researchers have rejected his suggestion of a conventual building, as there was no need for a regular monastic building complex in a grange (Tuulse 1942, 287–288; Kangilaski 1981, 62–63). All researchers have agreed that the building must have been fortified. On the basis of the engraving Armin Tuulse supposed that it was a towerlike high building (Tuulse 1942, 287–288). According to Tuulse it was in the later firearms period provided with a round corner tower; also that there were smaller stone buildings around the main one, represented by a building with a *dansker*, depicted on the foreground of the engraving (Tuulse 1942, 287–288). Villem Raam has supposed that the main building had three stories with two rooms each; he also identified a thick round cannon tower on the right side of the engraving (Raam 1988, 104).

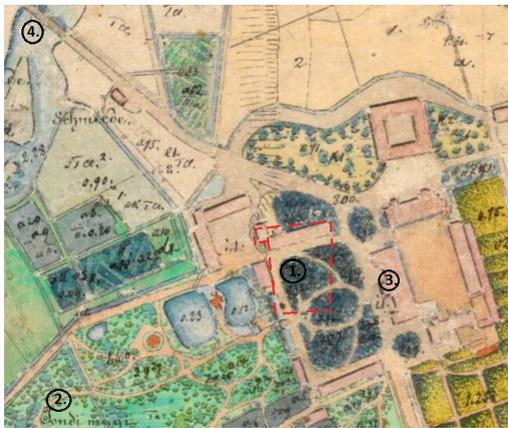
Fig. 3. Map of Kolga manor in 1880. Detail with the manor centre. 1 – area of grange walls, 2 – protected ruin on Tondimägi hill, 3 – early modern mansion, 4 – historic bridge on River Kolga.

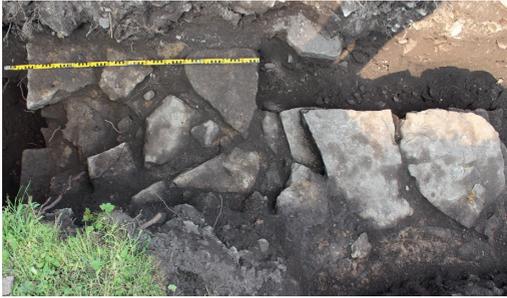
Fig. 4. Crossing walls in the north-western part of the main square.

From this thick wall a somewhat slimmer limestone wall running eastward (*ca.* 1.2 m) had been identified by Lange (1985, 5). Its extension towards east was discovered in 2015 in four test pits. In one of the pits, another wall extending towards north was discovered (Figs 1; 4). Traces of its demolished extension towards south were also recorded. Right south of this east-west wall a 2.5 m deep cellar room with a floor of dressed limestone slabs was discovered. Collapse debris of a black-glazed tile oven was discovered on this floor (see below). Probably an entire tiled stove had collapsed from the main storey into the cellar together with the intermediate floor(s). A small part of the oven debris was excavated.

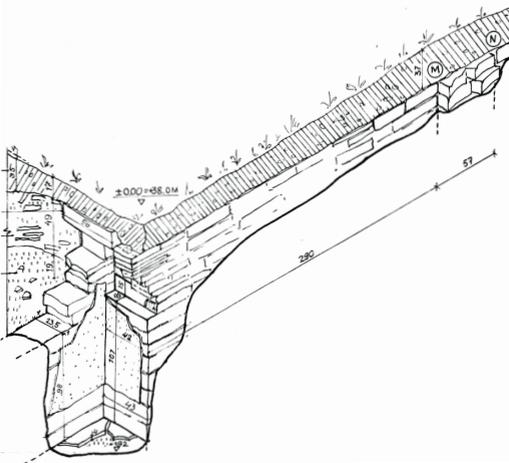
Fig. 5. A wall discovered in 1986 near the former coach washing pond, with remains of a partition wall, a niche and a limestone floor.

In 1986 Lange identified a *ca.* 3 m long fragment of another wall of undetermined thickness, running in the north-south direction and located *ca.* 30 m south-east from the above described walls (Figs 1; 5). On its southern end Lange identified remains of a narrow (*ca.* 0.6 m) intermediate wall, extending towards west. On its northern end he found a 43 cm deep wide niche. A floor of limestone slabs was recorded *ca.* 1.9 m deep from the ground level. Lange identified that a group of rooms had been located on the western side of this main wall, near the later

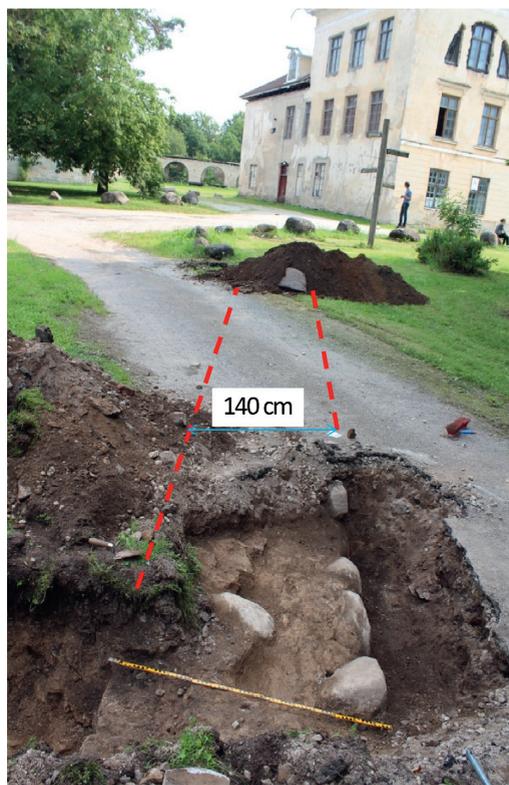
Fig. 6. Wall of the grange in the northern edge of the main square. North-western corner of the existing mansion in the background.

In 2015 near the northern edge of the square another wall, running in the east-west direction was discovered in three test pits according to the GPR signals (Figs 1; 6). On the southern side of this wall remains of a limestone pavement, and on the northern side remains of a floor of unworked limestone slabs was discovered. This indicates that probably an open area was situated right south of the wall, whereas an interior room (or row of rooms) was on the northern side. To be exact, the wall consisted of separate sections of walls, which ran in parallel, but were positioned slightly offset from each other, and had a different thickness (0.7–1.4 m). It could have been a row of façades of separate buildings, being built next to each other, probably not during one building phase. Another wall – possibly a side wall of such buildings, positioned at right angles to the main wall was discovered a year later.

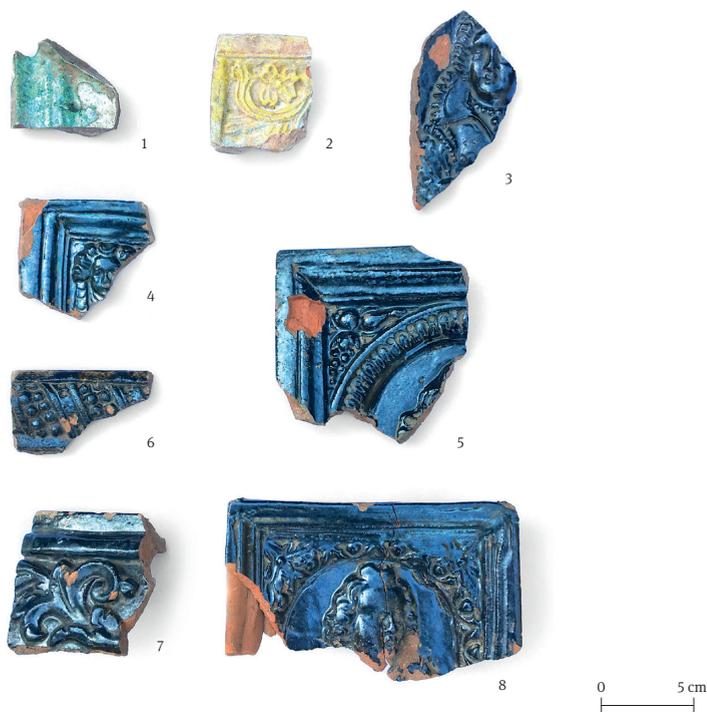
Fig. 7. A selection of stove tile fragments.

A survey of the stove tiles indicates that we are handling here remains of at least three tiled stoves. The earliest one of these (Stove 1) might belong the mid-16th century or an even slightly earlier period and is perhaps represented with two fragments (Fig. 7: 1–2), however, both are stray finds and too small to give a more detailed opinion.

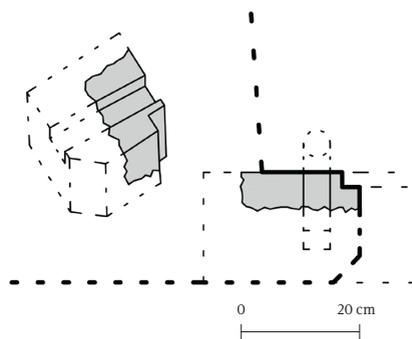
Fig. 8. Reconstruction of a dressed limestone portal or window detail based on a discovered fragment.

No household finds which could be linked to the monastic grange period were obtained. This is so probably because only park topsoil, demolition and collapse debris was excavated. A few small fragments of dressed limestone details – probably of door and window jambs of the grange – were found (Fig. 8).

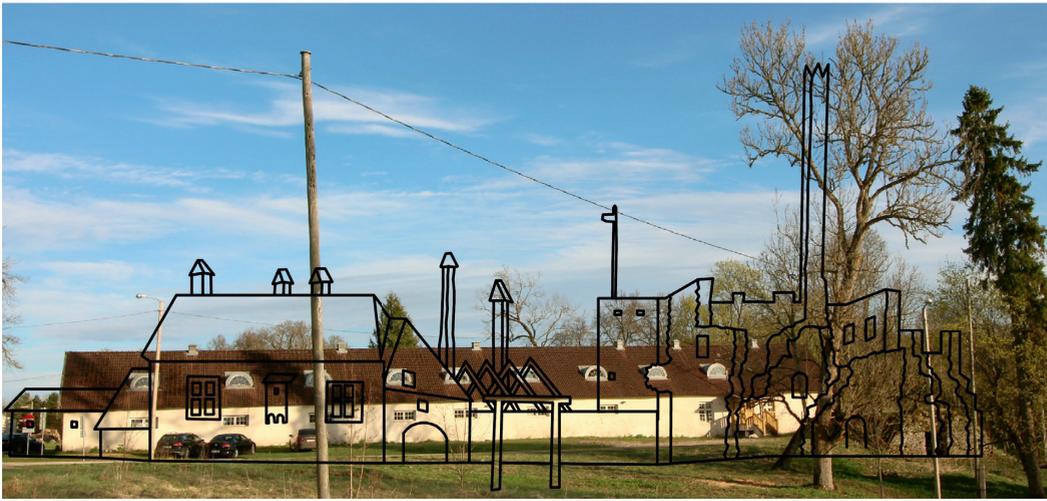
Fig. 9. Attempt to localize the ruin depicted in 1615 by Goeteeris in the landscape of 2017. View on the former cattle barn from north across the road.

the grange buildings. Unfortunately, even after recent fieldwork it is not possible to give a conclusive answer. Nevertheless, the direction of view from the north, from across the road seems most likely¹⁰ (Fig. 9). In such a case, the sledge moving from the gate along the path to the right would have headed towards the road bridge (Fig. 3: 3). In this spot the road is slanting towards the bridge even today. The main building, the fortified house would have been located in an area of the western part of the later cattle barn, and the house with the gate and dansker in an area of the eastern part of the cattle barn. The ruined cannon tower, depicted on the right side of the main ruin, would have been situated on the spot of the later two-room cellar building. The intermediate wall of the two cellar rooms, which comes from an earlier building phase (see above), could have been e.g. a side wall of the tower. It would explain why this intermediate wall is protruding westwards from the line of the thick wall, discovered running in the north-south direction and interpreted as the western curtain wall of the grange complex. However, this interpretation of the engraving waits confirmation or correction by further fieldwork results.
