Archaeological studies at the outwork of Rakvere castle, with emphasis on the Trojan hill

Tõnno Jonuks

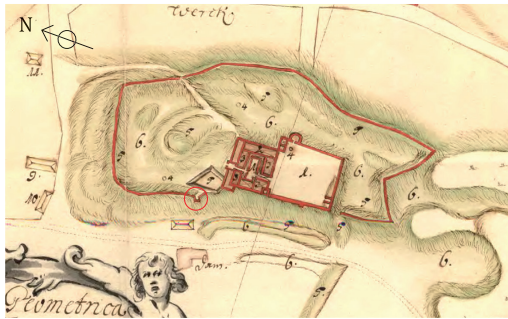
Fig. 1. *The outwork of Rakvere castle on the map by Samuel Waxelberg, 1683.*

Polish troops exploded part of the castle and the Swedish army eventually destroyed the rest. In 1619, Anthonis Goeteeris made a drawing of Rakvere castle during his journey to Moscow – most of the stone castle seems to be intact, except for the north-east corner, which probably was exploded by the Polish. It is most interesting that not a single feature of the outwork is depicted on the drawing. This probably means that by this time all fortifications outside the stone castle had been destroyed. In 1635, Rakvere was removed from the list of fortifications of the Swedish kingdom and since then, the hill together with the castle ruins belonged to the Rakvere manor. However, differently from the artists who painted Rakvere castle in the 17th and 18th century, Samuel Waxelberg noticed the outwork when plotting the castle in 1683 (Fig. 1). The outwork is marked as a single unbroken line and only at the NW-corner of the stone castle there is a feature that probably was the only preserved bastion-like formation by that time. Since then this map has been the major, if not the only source once the outwork of Rakvere castle is considered. Directly west from the bastion-like feature is a small square marked by a red circle. It is possible that it marks a small and separate fortification on

the slope (see below and Jonuks 2001), but it could also indicate another fortification that has not been located by archaeological fieldwork so far. Another interesting feature is a long earthwork on the western side of the stone castle (Fig. 2: 11). The earthwork is situated at the foothill and it is possible that this has been a rampart to fortify the castle from the side where outwork was not possible due to the natural reasons. The uninvestigated rampart is preserved until nowadays. In addition, until the 20th century a marsh extended all along the western side of Vallimägi and thus this side had been well protected by the natural conditions.

lik eelkaitsevöönd. Balthasar Russowi kroonika järgi kaevati selleks Vallimäe osaliselt üles ja nii kuhjati ilmselt põhjavall (jn 2: 4); linnust mujal ümbritsenud, peamiselt looduslikele kõrgendikele rajati puitkindlustused. Nii nägi Vallimägi välja ilmselt pigem linna kui kindlusena ning eelkaitsevööndi ja kivilinnuse vahele sai majutada suuri väehulki. Uuringutega selgus, et idavallil (jn 2: 10) domineerisid puidust kaitserajatised, samuti ka edela- (jn 2: 14) ning ilmselt ka kagukindlustusel (jn 2: 16). Läänevallil (jn 2: 12) on pigem jälgitavad kergeete kiviehitiste rusud. Rajatud eelkaitsevöönd pakkus linnusele tugevat kaitset ning Rootsi vägi ei suutnud Rakveret vallutada enne 1584. aastat, mil kroonikateate järgi põletati eelkaitsevöönd maha. Ilmselt sellest sündmusest maha jäänud massiivne põlengukiht oli selgelt jälgitav edelabastioni alumise kihina, kuid ulatuslikku põlengukihti on leitud pea kõikide uuringutega. Rakvere linnuse enda valdusesse saanud Rootsi väed alustasid kolmanda suure ehitusetapina eelkaitsevööndi moderniseerimist ning lisaks uutele, nüüd ilmselt kergetele kivikonstruktsioonidele, rajati kolmeosaline kindlustuste süsteem linnuse lõunaküljel ja üks bastion kivilinnuse loodenurka. Ilmselt hävis kogu eelkaitsevöönd Poola-Rootsi sõdades lõplikult. Ainus dokumentaalne allikas eelkaitsevööndi kohta valmis ligi sajand hiljem, kui Samuel Waxelberg joonistas 1683. aastal esimese täpse plaani Rakvere linnuse ja selle ümbruse kohta (jn 1).

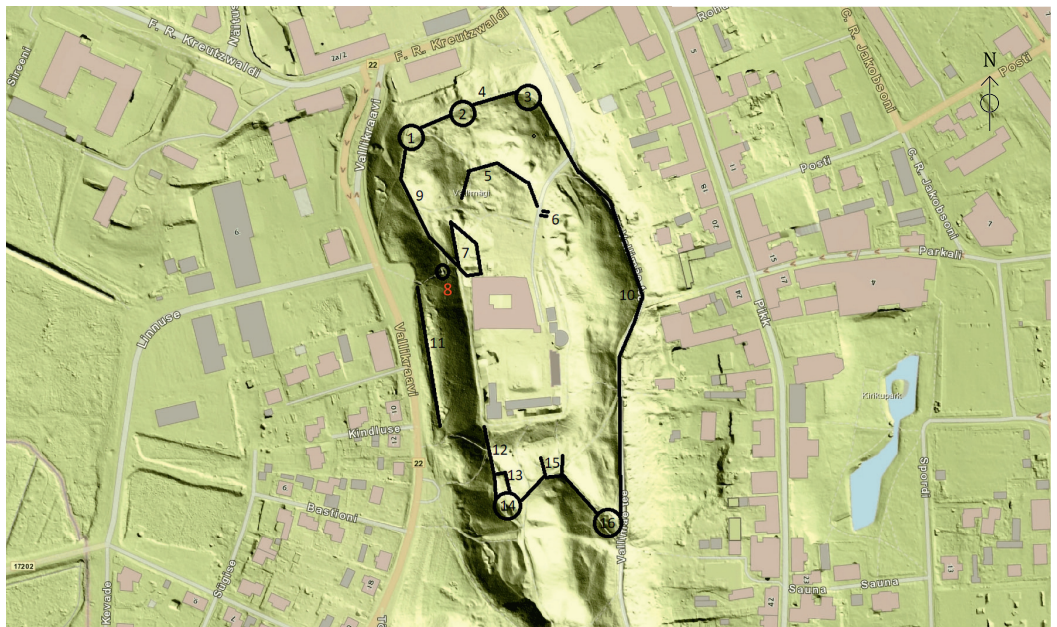
Fig. 2. Outline of the outwork of Rakvere castle. Numbers indicate the features in the text: 1 – NW fortification, 2 – N fortification, 3 – NE fortification, 4 – N wall, 5 – inner outwork, 6 – limestone walls, 7 – NW bastion, 8 – fortification on the western slope, 9 – W wall, 10 – E wall, 11 – W rampart, 12 – W wall, 13 – rectangular structure of the SW fortification, 14 – SW fortification, 15 – S fortification, 16 – SE fortification.

Since the 1970s the majority of studies in Rakvere were focused on the stone castle and only single test excavations were conducted on the north (Fig. 2: 4) and east walls (Fig. 2: 10) of the outwork (Aus 1984). Burnt wooden remains found in the course of these studies together with northwest Russian-style pottery confirmed that wooden constructions have once stood on the walls (Aus 1984; Tvauri 2002). Toivo Aus associated these remains with fortifications built in the 16th century and described by Balthasar Russow. The 16th century ceramic and other finds, found everywhere on the ground across the northern part of outwork, confirmed the dating together with Russow's record that Russian troops were settling inside the outwork during the Livonian War (Aus 1984, 17). Burnt trunks are recorded also along the

east wall (Fig. 2: 10), confirming that wooden constructions once stood there (Jonuks 2004). It is interesting to note that wooden remains are found on the east wall, while the west wall (Fig. 2: 9, 12) has had stone constructions where clay is used to bind brick and natural stone (Jonuks 2006; 2019). However, as all the remains of the constructions are situated almost on the ground these are heavily damaged and only the lower horizon of the ruins is preserved. Demolishing is partly due to the natural conditions, but even more due to the construction of the tracks along the walls. Vallimägi was opened for citizens for walks and festivals during many centuries but particularly in the 1930s when a system of public paths was created. According to the municipality reports from that time paths were paved, hills levelled and valleys filled for this purpose (Pagel & Kirss 2008, 97). For instance, observations have confirmed (Jonuks 2006) that the original north wall has been on different levels with three clearly higher locations. It seems that three fortifications, or bases for towers, have been on the north wall – in the northwest corner (Fig. 2: 1), in the northeast corner (Fig. 2: 3) and one in the middle of the wall (Fig. 2: 2) – which are connected with a lower wall (Fig. 2: 4). Levelling the original walls in the 20th century is the reason why the whole north wall now is eventually of an even height.

(Fig. 2: 10), where Toivo Aus found a clay-paved quadrangular stone foundation built on top of an earlier construction (Aus 1984, 19). Although none of the finds suggested the function of the construction, it was interpreted as a foundation of a blockhouse or a tower (*ibid.*). Another construction that was located at the west wall (Fig. 2: 8) sat on the outer slope, it had a stone foundation or stone walls with a possible wooden superstructure (Jonuks 2001). The location of this feature is the same as a small square marked on Waxelberg's plan. A gun barrel from this construction was dated to the period of the Livonian War by Ain Mäesalu (TÜ). The third identified construction (Fig. 2: 6) consists of two narrow stone walls, made of unworked limestone, on the way to the main entrance of the castle. It was not possible to suggest any particular purpose of this partially preserved construction, but it is possible that the construction is part of the late medieval outwork (Fig. 2: 5), forming a two metres wide wall with stone layers on both sides and filled with natural gravel and sand (Jonuks 2015).

Most of the previous studies are focused on the northern part of the outwork although the only clearly visible structures are located on the southern side of the castle. The southeast fortification (Fig. 2: 16) has not been studied, except a brief watching in 2006 (Jonuks 2006) when an electricity cable was installed passing the northern side of the hill. A thick layer of black soil containing 16th century potsherds, was detected at the lower part of the slope and in the valley beneath the hill while the soil was significantly thinner on the higher slopes. It was suggested that the eroded layer originates from the top of the fortification and has been eroded after its destruction (Jonuks 2006). Part of the layer could have also formed *in situ* as it is most likely that the valley between the castle and the east wall was used to billet the troops.

In 2019, the southwestern fortification, locally known also as the 'Trojan hill', was changed to a belvedere (Jonuks 2019). The artificial hill has two clearly different levels, with a higher southern peak (Fig. 2: 14) and a lower northern part (Fig. 2: 13), the latter had a regular rectangular depression. In the course of the construction work, topsoil was removed from most of the construction and on the eastern slope, exposing the ruins of double-layered fortifications (Fig. 3). The lower layer of the peak consisted of ca. 10–20 cm thick heavily burnt soil, it included sherds of 16th century NW-Russian-style pottery, a few animal bones, melted pieces of copper alloy and slices of pitch. This heavily burnt layer continued also on the eastern slope and submerged under the wall connecting the SW and S fortifications (Fig. 2: 15). The layer did not contain any *in situ* remains. Only a few burnt circles in the sand beneath the burnt layer indicated branches or small-scale trunks stuck into the ground. It was interpreted as remains of fences but unfortunately no system was possible to follow. It seems that after the

Topsoil was also cleaned from the lower level on the northern part of the fortification (Fig. 2: 13). The rectangular depression located there did not have any layer of datable finds leaving the date and purpose of the depression open. Most part of the western wall is originally the 16th century fortification, constructed of debris consisting of a mixture of clay, charred wood and limestone. However, the depression partially cut the 16th century fortifications and reached deeper, indicating that it was built later. The northern and western walls of the depression consist of local moraine and no floor or occupation layer was noticed. As a result, it seems most likely that the depression could be an uncompleted fortification from the WWII when Vallimägi was used for anti-aircraft guns by the German army. It is possible that a larger observation site was planned and the ground was prepared for that, but the construction was never finished.

(Aus 1984, 19; Fig. 2: 10) and SW fortification (Jonuks 2019; Fig. 2: 14). It is also apparent that joint walls on the southern side to connect the SW (Fig. 2: 14) and SE fortification (Fig. 2: 16) were built only after the massive fire and thus most likely postdate the 1584 siege. Between the SW and SE fortifications lies a much smaller construction (Fig. 2: 15) that originally had only three walls, leaving the castle side opened. It is possible that also this fort was constructed by Swedish military engineers, as such three-part fortification forms now a system that resembles the early bastions. It is also most likely that a bastion in NW corner of the stone castle (Fig. 2: 7), the only one marked as a bastion by Samuel Waxelberg in 1683, was built by the Swedish army. However, this bastion has been so badly damaged during the last few decades that almost nothing remains and thus the construction is not available any more for studies.

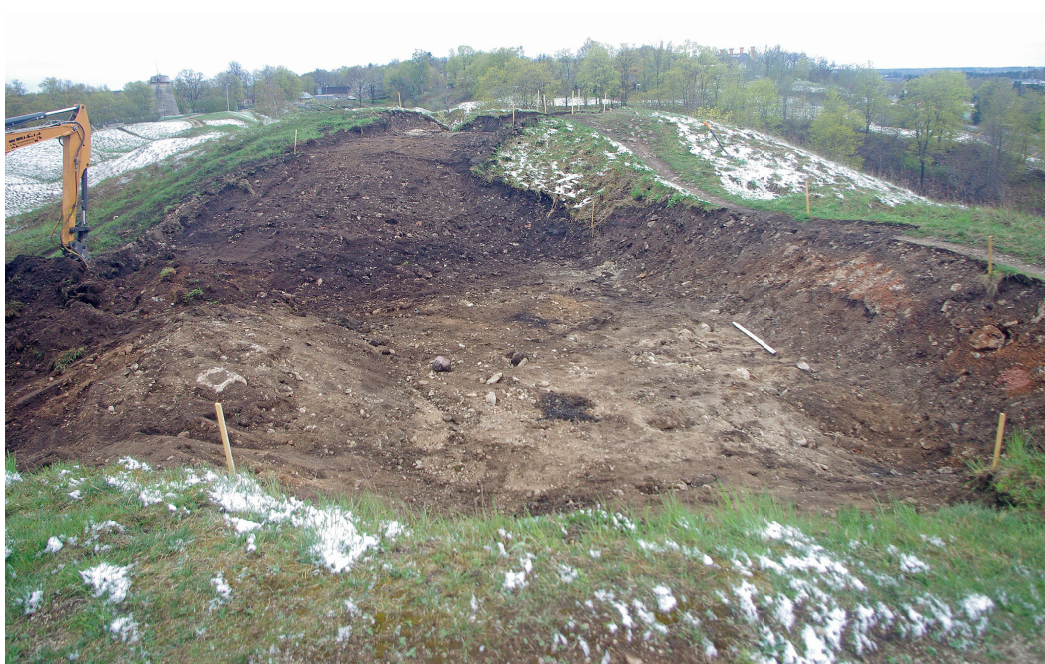
Fig. 3. Stripping the topsoil on the SW bastion. Photo from the north. The rectangular depression on the foreground and higher bastion in the rear. The dark and burnt soil layer covers the slope of the bastion. A burnt clayish layer, mixed with burnt logs and stones from the western wall at the right side of the photo.

heavy fire the ruins were dispersed, apparently to prepare the site for the next phase of fortifications.

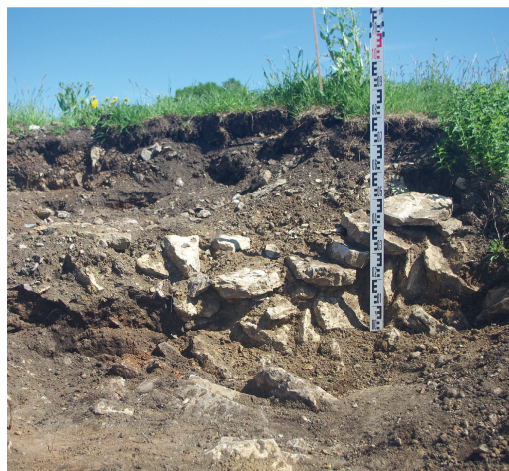
Fig. 4. Cross-section of the collapsed stone construction on top of the SW fortification.

Above this heavily burnt layer was another, distinctively different debris – it consisted mostly of small pieces of limestone, mixed with clay and lime mortar. The layer was apparently a debris layer of light stone constructions – in most part, it was not possible to distinguish any constructions, but occasionally on the southern side small remains of a limestone wall with clay binder were noticed (Fig. 4). By using metal detector seven tin/lead-based bullets with the diameter of around 2 cm were found and one with the diameter of 1.1 cm. In addition, also a large cannon bullet with the diameter of 7.3 cm was found from a clump of still soft and plastic lime paste.

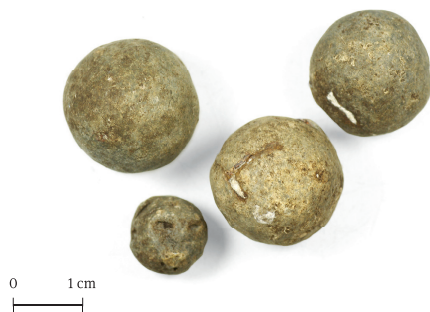
Fig. 5. Tin/lead-based bullets from the SW fortification.
Jn 5. *Edelakindlustusest kogutud tina/plii-sulamist püssikuulid.*
 (RM A 181: 17–20.)
 Photo/Foto: Tõnno Jonuks

The SW fortification (Fig. 2: 14) was somehow richer in finds – mostly light firearm bullets and a cannon ball were collected from the upper debris layer and from the burnt remains on the slope. This was also the first time when a metal detector was used at the outwork area and the firearm bullets (Fig. 5) were collected as a result. Firearm bullets occurred in both layers of the fortification, confirming a short chronological distance between the formations of the layers. A rich collection of cannon balls has also been found over the years from the same side of the outwork and from its eroded slopes. Unfortunately, most of the cannon balls are lost by now or are stored in houses in the neighbourhood of the castle as souvenirs. Surprisingly potsherds were very rare in the SW fortification, especially when compared with the number of

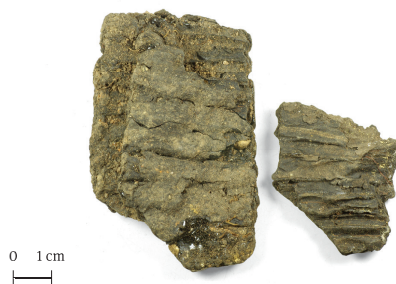
Fig. 6. Slices of pitch with ribbed surfaces from the SW fortification.
Jn 6. *Ribilise pinnaga tõrvatükid edelakindlustuselt.*
 (RM A 181: 3.)
 Photo/Foto: Tõnno Jonuks

The most interesting group of finds are flat, 5–9 mm thick pieces of pitch with rib-like formations on both sides (Fig. 6). These pieces were originally interpreted as a layer to make wickers waterproof. As both surfaces are covered with ribs, the pitch was probably added in between two layers of woven branches. As an alternative interpretation, the slices of pitch can also represent a shell of igniting ball, covering and protecting the explosive compound. Pitch-fragments were measured with p-XRF at the University of Tartu, Institute of History and Archaeology by Ragnar Saage. However, no elements that could be connected with the explosive compound were detected. The measured amount of K and S was so small that it probably represented natural values. Thus, the interpretation of the pitch slices remains open and will be addressed in future studies.

The Swedish army tried conquering the castle in 1574 but failed, despite using igniting bullets. It is tempting to associate the flat pieces of pitch with shells of igniting bullets fired to the outwork during this siege, although this association still needs proof. Rakvere castle was successfully conquered finally in 1584 when the castle was burnt down. Most likely it meant that only the outwork was burnt, as also confirmed by the archaeological excavations at several places on the northern, eastern and southern side of the outwork. Deciding by the amount of burnt remains the wooden fortification had to be massive. From the burnt layer of the SW bastion a number of pieces of melt copper alloy pieces were collected, again referring to a massive fire that had destroyed the place.
