Dendrochronological dating of an 18th century shipwreck from the Tallinn harbour

Alar Läänelaid

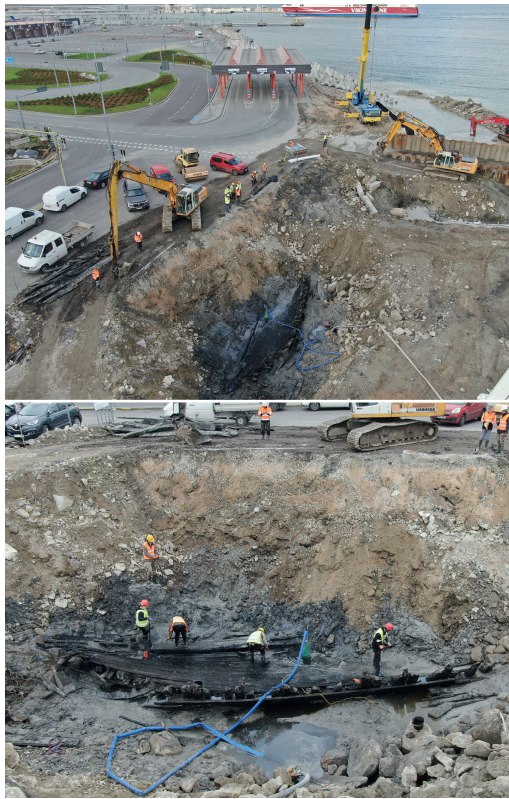
Fig. 1. Location of the shipwreck found in the filled sea-shore near the D-terminal of Tallinn harbour, at Petrooleumi St. 12 (above). A pump helps to lower the water level in the pit (below). Loose timbers were removed to the background of the excavation.

The shipwreck was found in the seabed northwest-southeast oriented. Only the bottom part of the ship was preserved. The complicated conditions on the construction site allowed to unearth only a small part of the wreck (Fig. 1). The wreck's port was measured to be 3.5 metres, so the whole width of the ship was probably at least 7 metres. The wreck in the excavation area was documented in a length of 13.6 metres. The wooden details of the wreck were coated with tar.

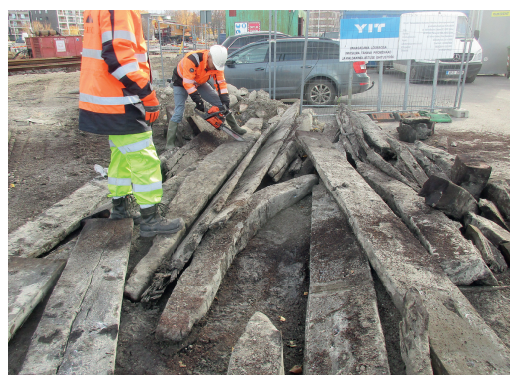
Fig. 2. Sampling loose timbers of the shipwreck with chain saw.

To keep the impact on the wreck remains minimal, we sampled loose wreck timbers that were collected from the excavation (Fig. 2). With a chain saw, more than 20 cross sections were cut from the planks and frames (Fig. 3). The locations of the cross sections of the timbers were chosen with a view to getting long ring sequences and where possible

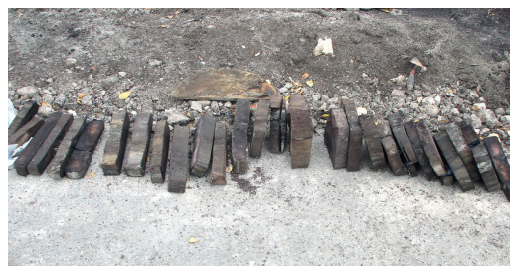
Fig. 3. Cross sections of the shipwreck timbers (oak) after sampling.

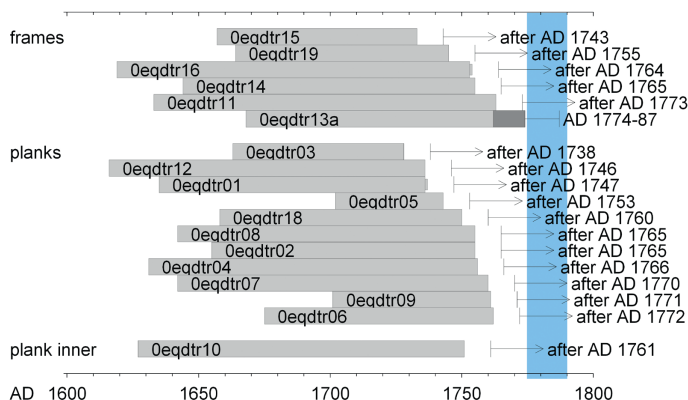
Fig. 4. Temporal span with probable cutting time of the dated timbers of the D-terminal wreck, Tallinn. The diagram illustrates the dendrochronological dating of the timbers from the ship.

Dating of the material is illustrated in Fig. 4. The grey bars show the time period that the tree-ring series from each sample is positioned. The arrows in the diagram represent the estimated felling time for each tree, where only heartwood was preserved. We cannot know how much heartwood was trimmed off these timbers when they were shaped. Thus the dating of these are termini post quem. Sapwood was preserved on one of the samples, however. The dark grey block on sample no 13 in the illustration represents the preserved sapwood.

for frame 13, we might suggest that all were felled at the same time, around AD 1775–1790 (highlighted with blue in Fig. 4).

10–30 rings). The measured number of sapwood rings, 12, in this shipwreck timber No 13A exceeds the minimal sapwood number for German oaks, 8 rings (95% confidence). The upper limit of the sapwood ring number is 30 or 38 (95% confidence). It means that the ship timber could not have been cut later than AD 1792 or AD 1800. These are the extreme latest years of timber cutting for the ship. More probably, there was less sapwood in the timber under study and the oak trees were cut between ca. AD 1775 and 1790 (marked with blue in Fig. 4).

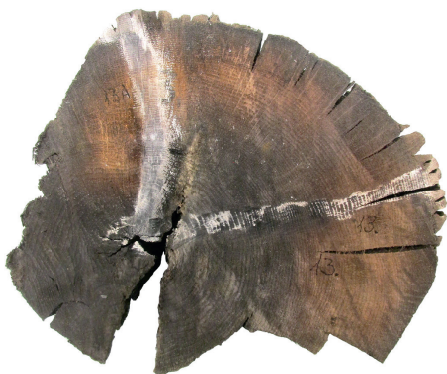
Fig. 5. *Sample no 13 from a frame of the ship. Sapwood rings were measured in two perpendicular radii of the disk.*

We did not observe waney edge or bark remains on the wreck timbers. However, sample no 13, from a frame, contained 12 sapwood rings (Fig. 5). The outermost sapwood ring was formed in AD 1774. The outer surface of the sample is coarse and we cannot be sure that it is the surface under the bark, i.e. waney edge. Fortunately, the average numbers of sapwood rings of oak trees growing in Europe are known (Haneca *et al.* 2009; Sohar *et al.* 2012; Sohar 2013). Thus we can estimate that the tree that was used to make frame 13 was felled within the period AD 1774–1787. As the other timbers from the ship seem to have come from a homogeneous source, and as the estimated dating for the other samples all fall before the dating
