Archaeological investigations in the middle room of the ‘Clergy House’ of the Teutonic Order Castle in Viljandi

Heiki Valk and Mait Raudsepp

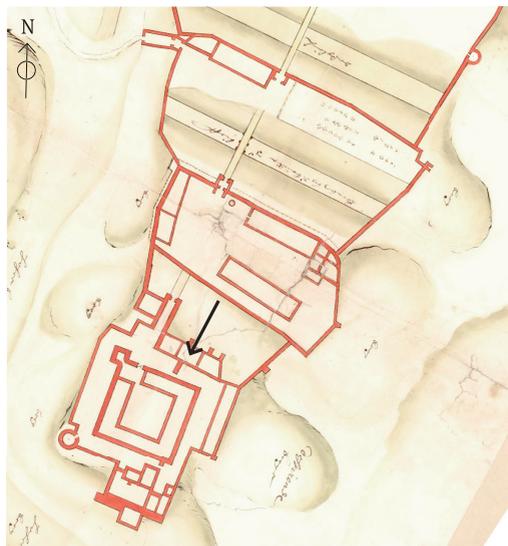
In 2023 archaeological monitoring was carried out in Viljandi, in the ruins of the castle of the Teutonic Order. The work took place in the middle room of the ‘Clergy house’ just north of the High Castle (Fig. 1) which was emptied of debris, its aim was to open and conserve the upper parts of the walls and to make the structure of the building more visible and attractive for visitors. The western room of the same building was emptied from debris in 2022 (Valk 2023).

Fig. 1. Plan of Viljandi Castle from 1656.

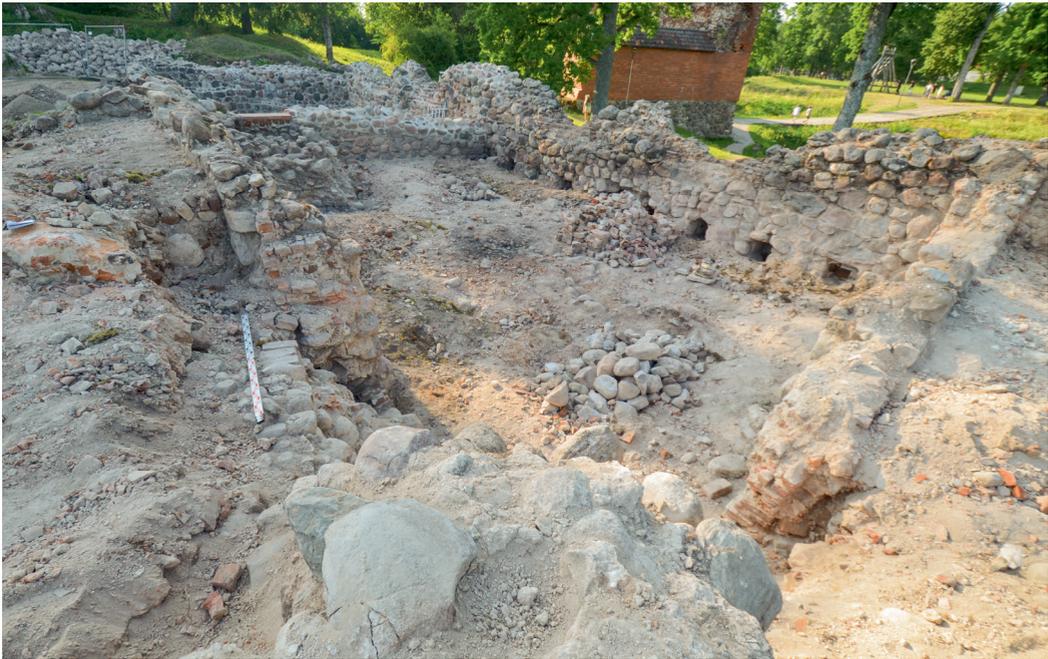
Likewise in the western room, seven openings for cellar ceiling beams (31–40 cm wide and 43 cm high) came to light in the northern wall of the middle room. Evidently, their top surface indicated the lower level of the floor planks or other beams under them. Most of the openings were framed with granite, but the easternmost was lined with bricks. As in the western room, the vault top of a cellar window framed with bricks appeared in the central part of the middle room’s north wall.

Fig. 2. The middle room of the 'Clergy house' of the Teutonic Order castle of Viljandi after the investigations. View from the south-east.

dat kandnud talade pesa (jn 2), samuti tellistega vooderdatud aknaava ülaserv seinä keskel. Ruumi 0,85–0,9 m paksune väga halvasti säilinud idasein oli tehtud ülinõrga mördiga ning varises pärast seda toestanud rusu eemaldamist osaliselt kokku. Seinä lõunaosas kagunurga lähedal avastati 1,35 m laiune tellistega raamistatud ukse- või läbipääsuava ida-

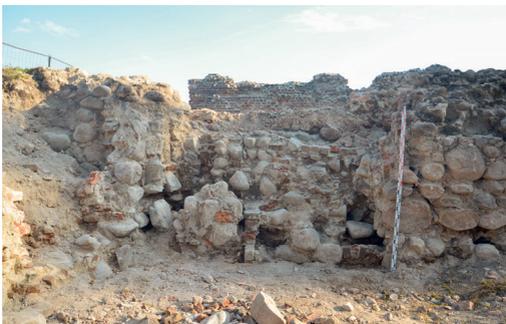
Fig. 3. The southern wall of the room with remains of a flue system, and opening in the eastern wall (on the left), view from the north.

The southern wall, also made of granite, was well preserved. In its eastern end also an opening, originating probably from a window with a staircase-like stepped bottom (Fig. 3) was discovered at the distance of ca. 1.65 to 3.3 m from the south-eastern corner. The opening had originally been narrower, since bricks which had lined it in the east had not preserved. From the upper window sill, i.e. the level where the window had opened

to the courtyard, eight bricks had remained *in situ*. South of the southern wall remains of a cobblestone pavement were unearthed almost at the same level with the window sill.

Lõunaseina lääneotsas, kagunurgast 1,65–3 m kaugusel tuli müüris nähtavale avaus (jn 3). Kuigi selle tellisvooderdu oli peaaegu hävinud, on ilmselt tegemist olnud eeslinnuse õuele avanenud astmikpõhjalisel aknaga, mille õuele avaneva ava alaserv asus ligikaudu hoovi munakivisillutise kõrgusel. Lõunamüüri idaotsa sees tuli nähtavale lõõrikoht (jn 4), mis oli horisontaalsena jälgitav ligi 1,5 m ulatuses ja tõusis seejärel püstjalt ülespoole. Lõunaseina müüritises polnud põhjaseina talapesadele vasteid.

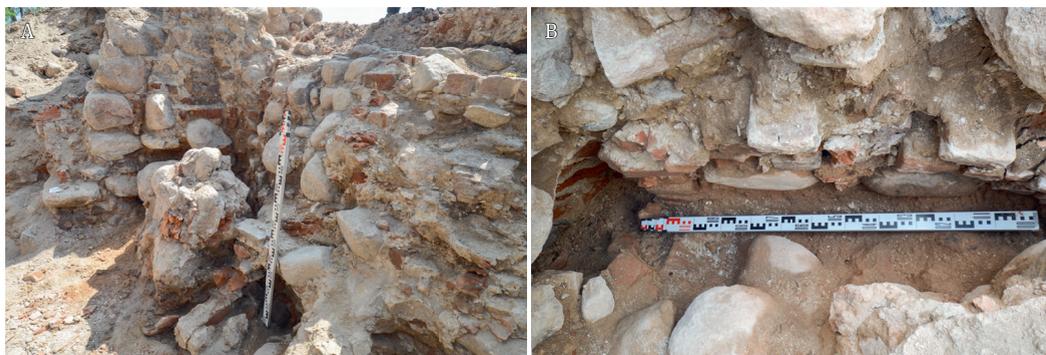
Within the eastern end of the southern wall a flue lined with sooty bricks was found (Fig. 4). The preserved lower horizontal flat-bottomed part of the flue could be observed in the distance from ca. 0.6 to 2.1 m west from the south-eastern corner of the room. The flue was 26–27 cm, i.e. one brick wide and it was situated at the distance of 50–60 cm from the cellar wall. The flue within the southern wall of the building ran almost parallel to it, but at a slight angle – the wall thickness on its northern side increased towards the east. When the horizontal part ended, the flue rose almost vertically upwards within the wall, being directed towards the meeting place of the southern and eastern walls. Judging by the measuring tape that was stretched into it, the flue had preserved for 1.5 metres. The remains of both flues relate to stoves which were heated from the cellar of the room, not emptied of debris.

Fig. 4. The flue in the southern wall. A – view from the north-west, B – view on its horizontal part from above.
Jn 4. Lõõr ruumi lõunaseinas kagunurga lähedal. A – vaade loodest, B – vaade horisontaalsele lõigule ülalt.
 Photo / Foto: Heiki Valk

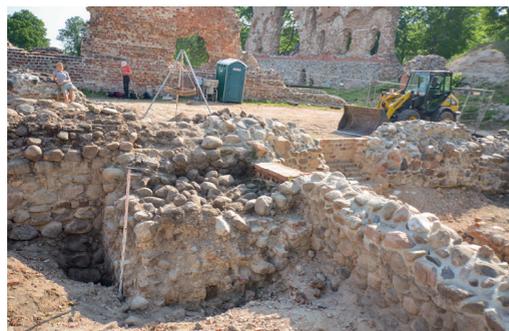
As suggested by the location of the hypocaust mouth discovered in 2022, the stove appeared under the layer of soil and debris in the south-western corner of the middle room (Fig. 5). The heating stones had the diameter of 20–30 (in some cases up to 35/40) cm (Fig. 6). The top layer of stones and soil between them were removed before conservation to make a waterproof ceiling for the stove.

Fig. 5. The hypocaust stove in the south-western corner of the room.
Jn 5. Hüüpkaustruumi edelanurgas.
 Photo / Foto: Heiki Valk

turned out to be severely damaged in the past, probably, for re-using the easily available material, and above the level of 84.00 m a.s.l. only a few bricks had preserved. The measures of the hypocaust were ca. 2.95 m in the north–south and 3.2 m in the east–west direction. The southern wall of the room became 30–50 cm thicker beside the hypocaust, – possibly to diminish warmth losses into the ground. In the northern wall of the hypocaust there was an opening for a beam (25 × 26 cm) lined with bricks, but its height and location did not correspond to those in the northern wall.

After the excavations the trench in front of the hypocaust mouth was re-filled with debris and the top of the hypocaust was conserved. To replace the perished brick lining, new walls were built for the hypocaust during the conservation.

Ruumi edelanurgas puhastati välja $2,9 \times 3,5$ m mõõtmetega hüpokaustahi (jn 5), mille keris koosnes suurtest, 20–30 cm läbimõõduga raudkividest (jn 6). Läbi uuriti ülemiste kerisekivide vahel olev pinnas – leide sisaldav tume Liivimaa sõja aegne kultuurkiht. Ahju põhja- ja idaseina tellisvooder oli 84,00 m tasemest kõrgemal peaaegu täielikult hävinud. Põhjaseina tellisvoodri säilinud lõigus avastati 25×26 cm mõõtmetega palgipesa, millele põhjaseinas puudus vaste. Selgus, et ahi on ehitatud samaaegselt hoone lõunaseinaga, mis oli ahju kõrval 30–50 cm paksem kui mujal.

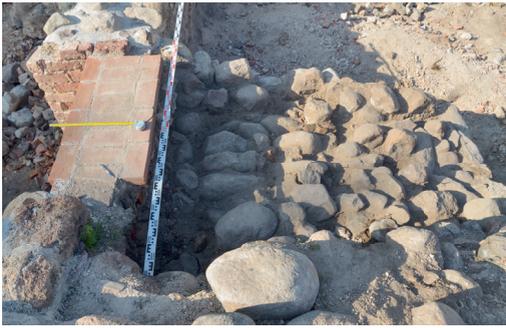
Fig. 6. *The heating stones of the hypocaust.*

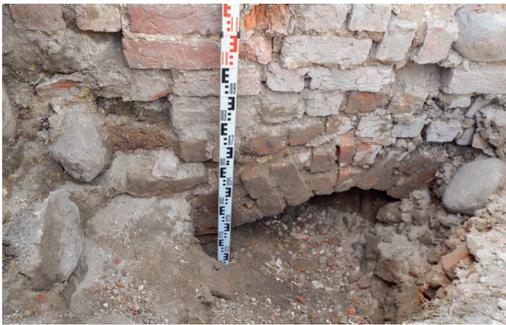
Fig. 7. *The lintel of the entrance to the hypocaust heating chamber.*

A test pit made at the meeting point of the stove and the southern wall of the room showed that the hypocaust was built contemporaneously with the wall. When looking for the lower, preserved part of the brick lining of the hypocaust's eastern wall (below the level of 84.00 m), an opening framed with bricks unexpectedly appeared in it (Fig. 7). After further digging it became evident that the hypocaust had two chambers overlying each other and that the opening was the mouth of the lower chamber.

Ahju ja hoone lõunamüüri liitekoha otsimiseks tehtud šurfi laiendamisel tuli ootamatult nähtavale tellistega vooderdatud ava serv (jn 7). Selgus, et hüpokaustahju 2022. aastal avastatud ja lääneruumi avaneva suuga küttekambri all asus veel teine kamber,

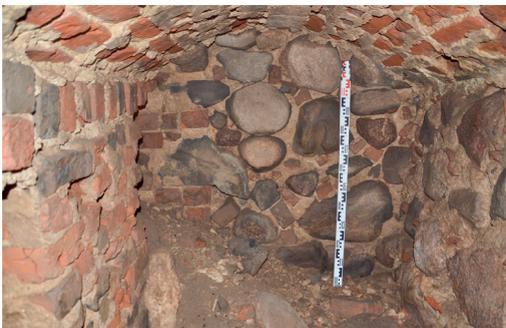
Fig. 8. *The heating chamber of the hypocaust.*

The lower chamber, probably also meant for heating, was perfectly preserved (Fig. 8) and it was possible to enter it. The chamber was 3.05 m deep and 1.2 metres wide and had a cylinder vault made of bricks. The height of the side walls was 1.1–1.15 m, the maximal height of the chamber in its middle was 1.3 metres. On the left side of the chamber there were two openings for flues, both filled with debris. The walls, vault and floor of the chamber had no traces of soot or smoke on them and the chamber had never been used for making fire. Evidently, in the course of construction work the original plans were changed and it was decided that the hypocaust will be heated not from the middle,

but from the western room of the building. When comparing the heights, it appeared that the vault top of the lower chamber was located ca. 60–70 cm below the floor of the upper one, the mouth of which was discovered in 2023. The height of the stove from the floor of the lower heating chamber up to the top of the highest heating stones was ca. 3.2 metres.

mille suu avanes ida poole. Kamber oli ülihästi säilinud (jn 8). Selle pikkus oli 3,05 m, laius 1,2 m, seinte kõrgus 1–1,15 m ja silindervõlvi keskkoha kõrgus põranda suhtes 1,3 m. Lõunaseina ülaosas algas kaks nelinurkset, telliserusuga täitunud lõõri. Kambris polnud kordagi tuld tehtud. Nähtavasti toimus pärast selle valmimist ehitusplaanides muudatus ja otsustati, et hüpokausti hakatakse kütma mitte keskmisest, vaid läänepoolsest ruumist. Uuringute lõppedes kaeti ahjusuu taas rusudega, põhja- ja idaseina tellisvooder laoti uuesti üles ning kerise peale tehti konserveerimistööde käigus vettpidav kate.

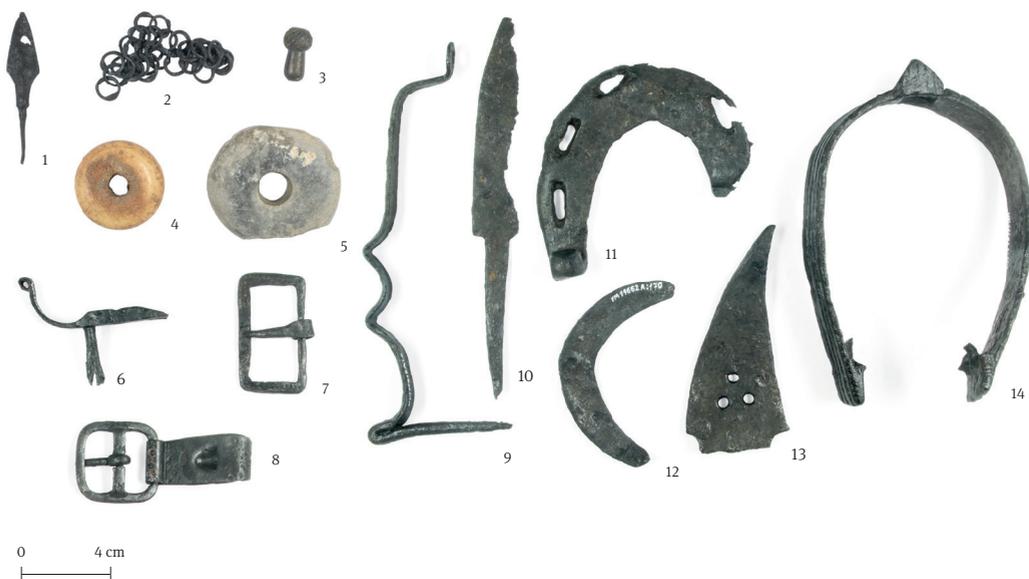
Fig. 9. Finds from the debris in the 'Clergy house' of the Teutonic Order castle in Viljandi. 1 – arrowhead, 2 – chain mail fragment, 3 – lace end (?), 4 – knob, 5 – spindle whorl, 6, 9 – firearm details, 7, 8 – buckles, 10 – knife, 11 – horse shoe, 12 – calk, 13 – halberd fragment, 14 – stirrup. 1, 2, 6–14 – iron, 3 – copper alloy, 4 – bone, 5 – stone.

Archaeological monitoring and detector investigations of the debris revealed several finds.¹ From the debris a Russian arrowhead (Fig. 9: 1), a chain mail fragment (Fig. 9: 2), a bone knob (Fig. 9: 4), a spindle whorl (Fig. 9: 5), some metal details of firearms (Fig. 9: 6, 9) including a trigger guard, two iron buckles (Fig. 9: 7, 8), a knife (Fig. 9: 10), a horse shoe (Fig. 9: 11), a calk (Fig. 9: 12), a halberd fragment (Fig. 9: 13), a stirrup (Fig. 9: 14), an osmund fragment, a blacksmithing slag cake, four pieces of lead window came, three bone fragments with traces of processing, some unidentified fragments of metal artefacts, a few sherds of wheel-thrown pottery and window glass, and some nails were found.

When sieving the cultural layer formed on top of the hypocaust in the second half of the 16th or in the early 17th century a probable lace ending (Fig. 9: 3), a lead bullet (: 30), a thumbtack (: 151), a cattle tibia with traces of processing (: 40), and about a hundred fragments of wheel-thrown pottery were found.
