ARHEOLOOGILISED  
VÄLITÖÖD  
EESTIS

ARCHAEOLOGICAL  
FIELDWORK  
IN ESTONIA

# ARCHAEOLOGICAL MONITORING IN THE PROTECTION ZONE OF OLD PÄRNU

**Ülle TAMLA, Priit LÄTTI, Irita KALLIS and Ingrid ÕUNAPUU**

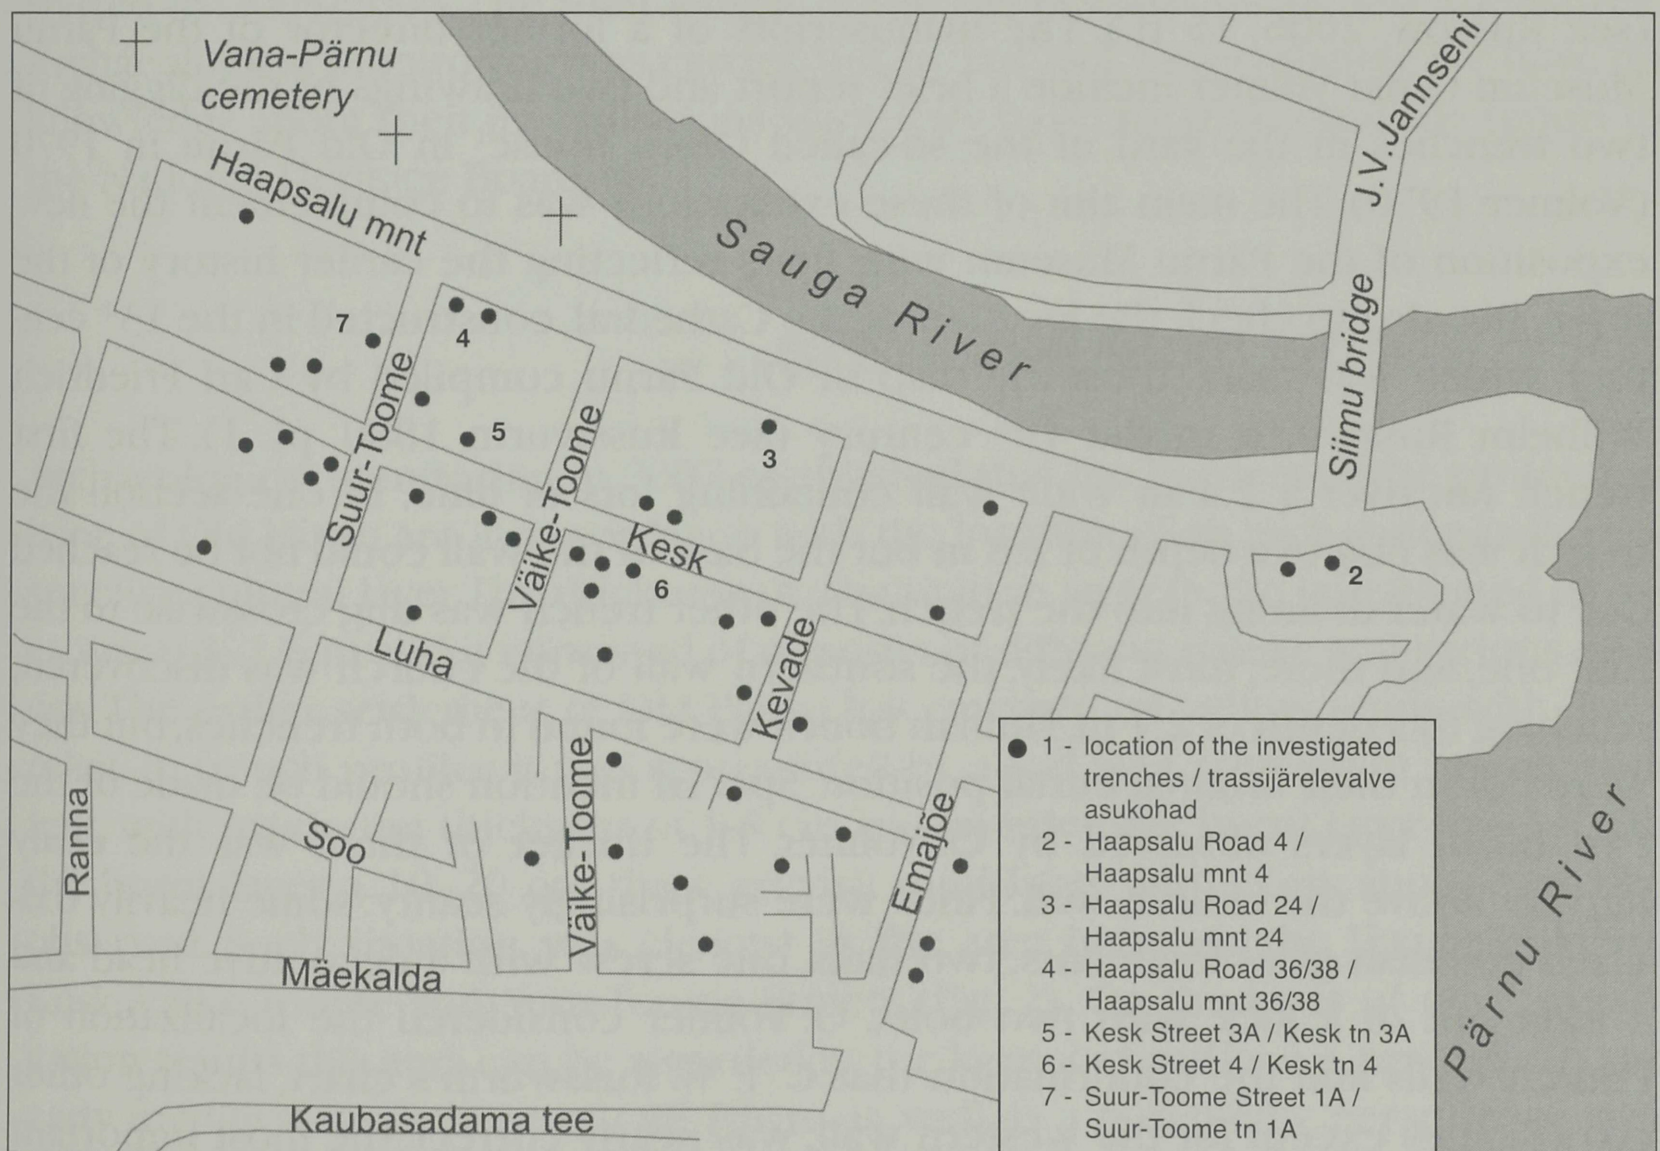
Fig. 1. Archaeological monitoring in the protection zone of Old Pärnu in 2007.

Archaeological fieldwork in Old Pärnu lasted for four months. We documented trenches, 0.8–1.2 m wide and 1–1.5 m deep, with a total length of *ca.* 700 m, excavated on 44 sites (Fig. 1: 1). Regardless of the means of digging the trenches – by hand or by machines – the research method was chosen the same. Owing to the sandy and crumbling soil of Old Pärnu research work had to be carried out fast, simultaneously with digging the trenches, concentrating on documenting cultural layers, construction remains and pits coming to light in the trench walls, and collecting archaeological and archaeo-zoological finds. At the same time inhabitants of Old Pärnu were questioned to obtain information about possible stray finds indicating earlier settlement (Tamla *et al.* 2008).

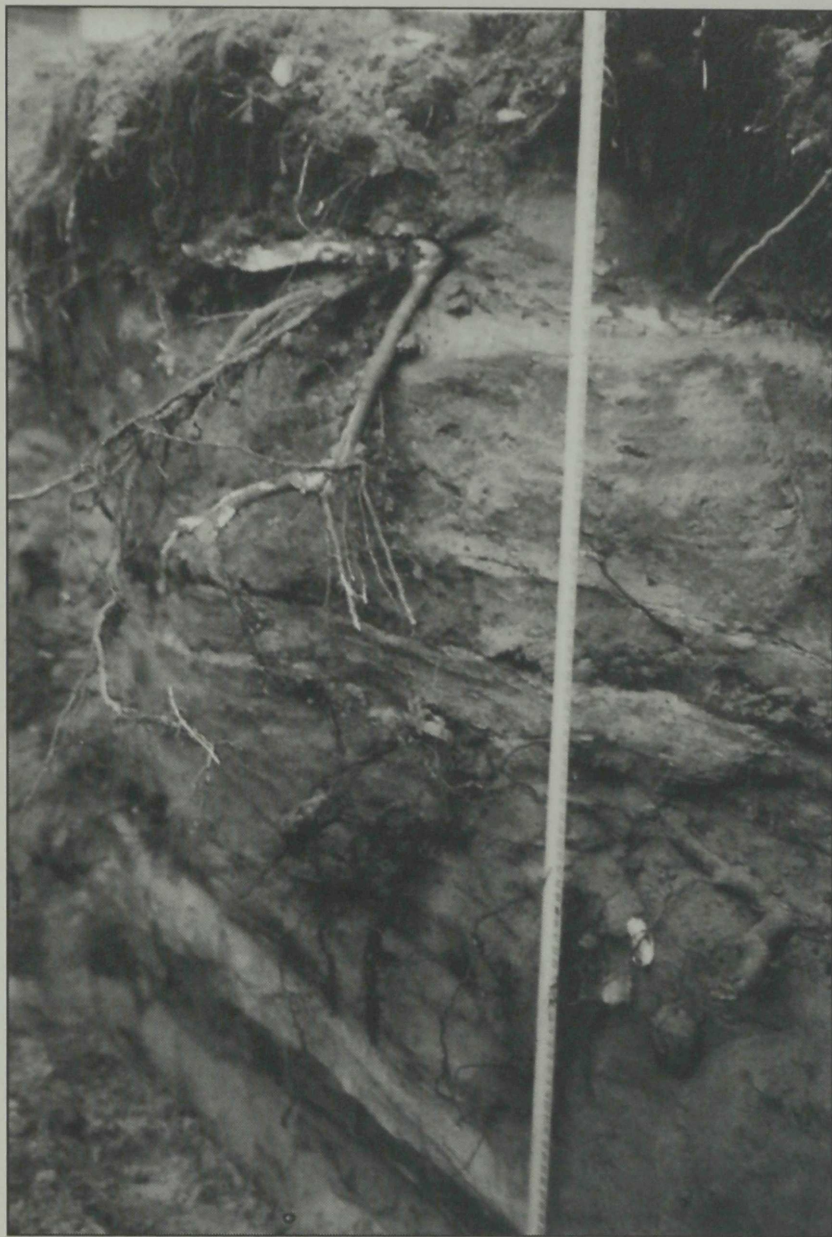
Fig. 2. Haapsalu Road 24. Western profile of the trench, with two layers of charcoal and the debris layer upon the lower burnt layer.

Two burnt layers could be observed in almost every trench investigated in 2007. They were clearest in the area that coincides with the kernel of the earlier settlement of Old Pärnu. On the sites of the Haapsalu Road and Kesk Street, as well as on Suur-Toome Street, the upper burnt layer was at a depth of 0.4-0.6 m and the lower one at 0.6-1.6 m from the present-day ground level (Fig. 2). Usually a 20-40 cm thick layer of greyish sand containing charcoal particles and brick fragments covered both burnt layers. The concentration of brick fragments was highest on the sites at the Haapsalu Road, Suur-Toome and Kesk Streets closest to the site where the Cathedral was built by bishop

Pea kõigis 2007. aastal uuritud kraavides äratas tähelepanu kaks põlengukihti. Kõige selgemal kujul ilmusid need nähtavale piirkonnas, mis kattub Vana-Pärnu varasema asustuse tuumikalaga (jn 2). Haapsalu mnt, Kesk tn ja Suur-Toome tn trassides jäi ülemine põlenguviir nüüdisaegsest maapinnatasemest 0,4–0,6 m ja alumine 0,6–1,6 m sügavusele. Üldjuhul oli mõlema põlengukihi peal 20–40 cm paksune hallikas liivakiht, mis sisaldas väikesi söekübemeid ja tellisetükke. Suurem tellisetükkide kontsentratsioon jäi Haapsalu mnt, Suur-Toome ja Kesk tn nendele kruntidele, mis paiknevad kõige lähemal kohale, kuhu Saare-Lääne piiskop Heinrich I lasi ehitada toomkiriku. Kirik valmis kümne aastaga (1241–1251) ja see pühendati evangelist Johannesele. Vana-Pärnu oli piiskopi residents veidi üle kümne aasta. Leedu vürsti Traniate Läänemaale tehtud rüüsteretk hävitas 1263. aasta alguses nii katedraali kui ka linna. Samas seoses väärib eraldi nimetamist Haapsalu mnt 16 ja 24 ning Kesk tn 3A kinnistul dokumenteeritud alumisele põlengukihile ladestunud rusukiht, mis sisaldas lisaks tellisepurule ka lubimördiga kaetud suuremaid tellisetükke (jn 5). Helepunaste telliste savimassi koostises esines pae- ja lubjatükke ning kivide põletus oli ebaühtlane. Mõne tellise pealispinnal esinev kergelt läikiv kollakat värvi õhuke kiht (lubivärv?) ootab keemilise analüüsi tulemust.

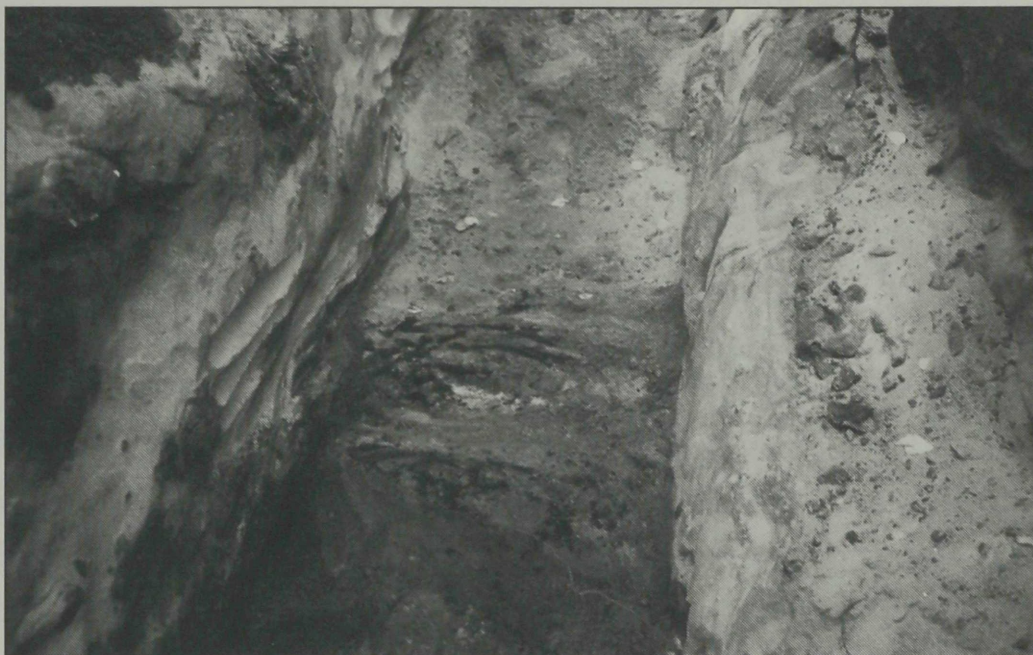
At the bottom of the 1.6 m deep ditch dug on the site at Haapsalu Road 4 in close vicinity of the mouth of the Sauga River (Fig. 1: 2) a burnt layer, 3 cm thick, came to light together with charred pine boards (2.5–2.8 cm thick and 27–30 cm wide) located near each other on the same level (Fig. 3). Upon

Fig. 3. Haapsalu Road 4. Burnt layer together with charred boards on the bottom of the trench.

one of the boards two fragments of hand-moulded pottery, one of them a rim fragment, were found. <sup>14</sup>C-analysis of a charcoal sample<sup>2</sup> performed in the laboratory of the Institute of Geology of Tallinn Technical University gave the result 620±62 BP (cal. with 95.4% confidence level 1270 AD).

Sauga jõe suudme lähedusse jäävale Haapsalu mnt 4 kinnistule kaevatud kuni 1,6 m sügavuse kraavi põhjas puhastati välja u 3 cm paks põlengukiht ja söestunud männilauad (jn 1: 2; 3). Samast leiti kaks käsikeraamilise anuma kildu, neist üks servatükk. Tallinna Tehnikaülikooli Geoloogia Instituudi <sup>14</sup>C-laboratooriumis analüüsitud söeproov andis arvatava laudpõranda vanuseks 620±62 BP (kalibreerituna 95,4% tõenäosusega 1270 pKr).

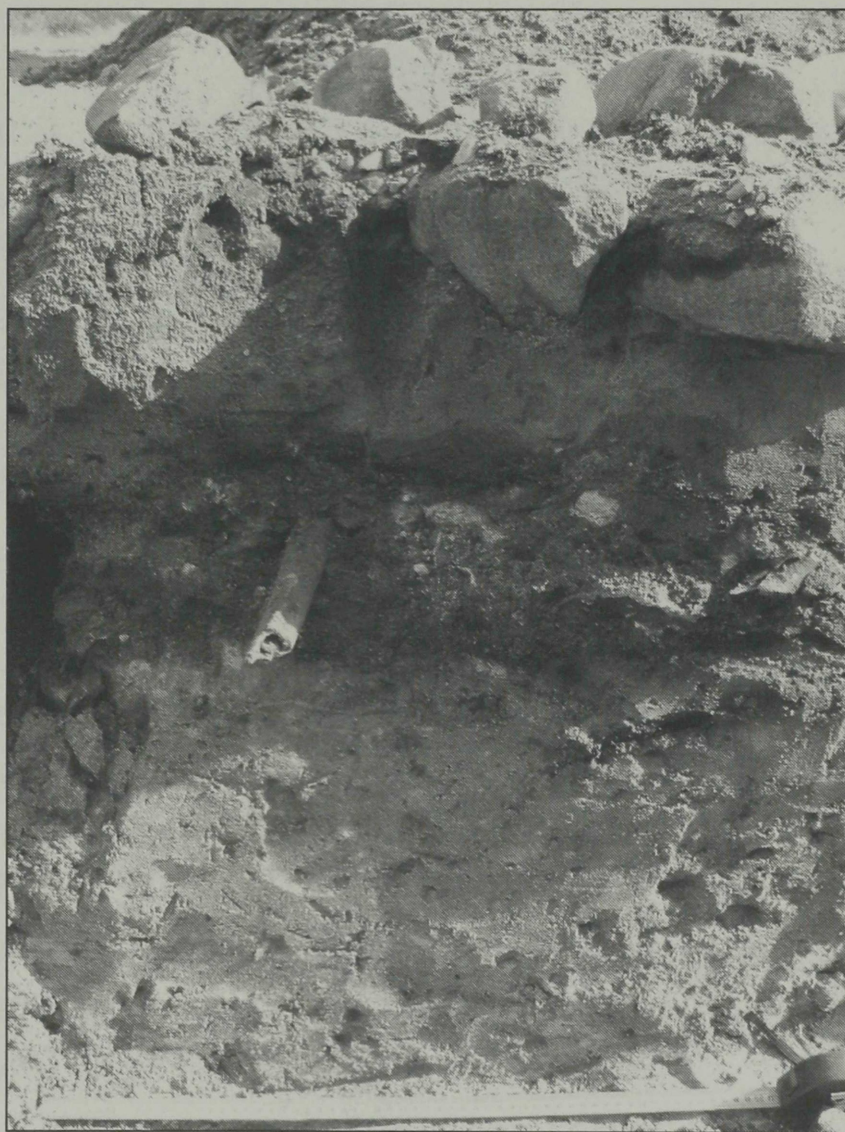
In the trenches investigated in 2007 we did not come across the walls of the Cathedral destroyed in the 13<sup>th</sup> century, but on the site at Haapsalu Road 36/38 (Fig. 1: 4), where O. Volmer dug trial pits in 1970 (Volmer 1970), a layer about 20 cm thick, containing brick fragments, lime mortar, charcoal and small pieces of human bones could be observed beneath the cobbled pavement of the yard, at a

depth of about 20 cm from the present-day surface (Fig. 4). The occupants of the house remembered that in the 1960s-1970s when sewerage was laid in the yard, a lot of human bones and at least one complete skeleton came to light in front of the stairs of the building at Haapsalu Road 36 facing the yard. They also remembered that, when digging flower-beds in the garden of the same house, large mortar-bound stones came to light, and similar stones were also found near the well dug in the south-west corner of the yard (Tamla *et al.* 2008, 6).

Fig. 4. Haapsalu Road 36/38. Layer containing brick fragments, lime mortar, charcoal and small pieces of human bones beneath the cobbled pavement of the yard.

2007. aastal uuritud kraavides ei satunud 13. saj hävinud toomkiriku müüridele, kuid Haapsalu mnt 36/38 krundil täheldati tellisetükkide, lubimördi, söe ja fragmentaarsete inimluudega segunenud u paarikümne sentimeetri paksust ladet, mis ilmus nähtavale hoovi katva munakivisillutise alt (jn 4).

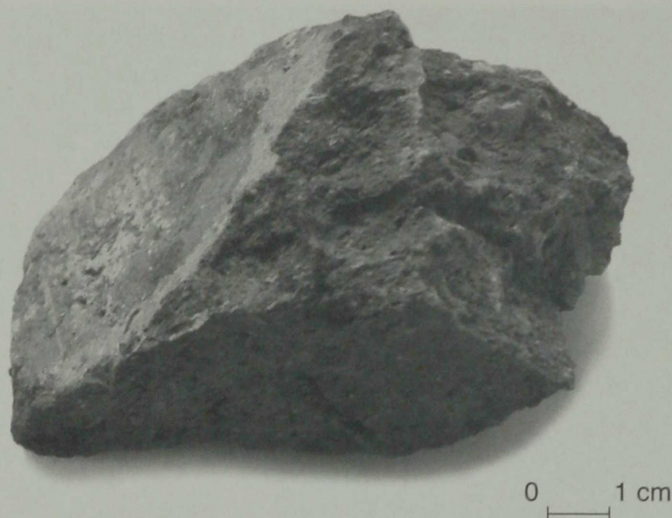
Fig. 5. Haapsalu Road 24. A fragment of light red low-quality brick with lime mortar.

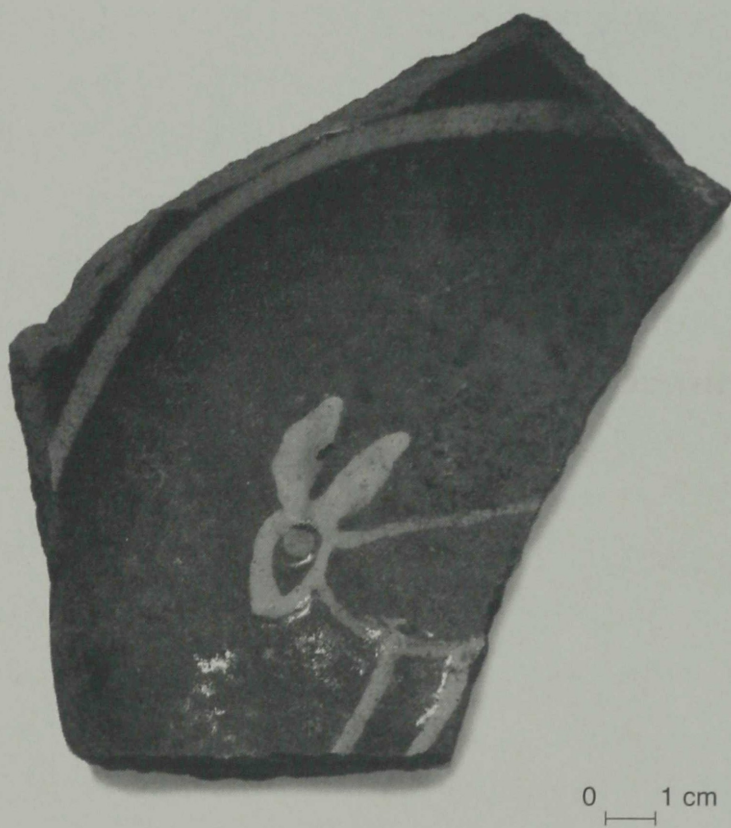
Fig. 6. Kesk Street 3. Fragment of a painted dish.

cooking vessels, *grapens*, as well as bowls and dishes, some of them painted (Fig. 6). Material of the 17<sup>th</sup> century prevails while production of the 14<sup>th</sup> and 15<sup>th</sup> century is absent altogether.

E. Russowi hinnangul on Vana-Pärnu keraamikaleidude hulgas ülekaalus kohalike meistrite hiline toodang. Liigiliselt esineb nii toidu valmistamiseks mõeldud kolmjalgnõude e graapenite kui ka vaagnate ja kausside fragmente, sh maalingutega anumate kilde (jn 6). Ajaliselt domineerib 17. saj materjal. Puudub 14. ja 15. saj toodang.
