ARCHAEOLOGICAL FIELDWORK IN ESTONIA

## ARCHAEOLOGICAL INVESTIGATIONS AT LAI STREET IN TARTU

## Rünno VISSAK and Eero HEINLOO

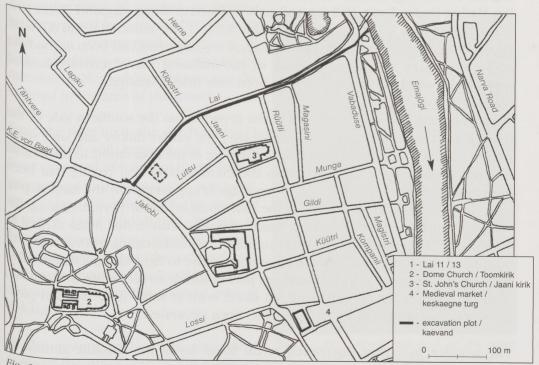
Joon. 1. The site of archaeological investigations in Lai Street.
Arheoloogiliste uuringute ala Laial tänaval.

Arheoloogiline järelevalve ja uuringud Tartus Laial tänaval olid tingitud uute vee- ja kanalisatsioonitrasside paigaldamisest. Töid tehti kogu tänava pikkuses alates Emajõe kaldapealsest pargialast Laia tänava ja Vabaduse puiestee ristumiskoha läheduses kuni Laia ja Jakobi tänavate ristumiskohani, ühtekokku üle 500 m pikkusel ja 2,5–3 m laiusel trassil (joon. 1).

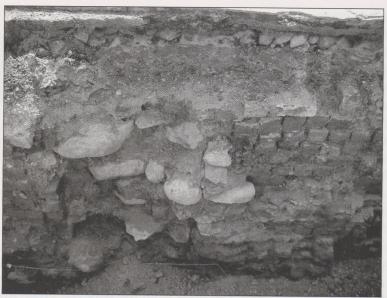
Fig. 4. The walled-up aperture in the southern wall of the outer gate. Joon. 4. Kinnimüüritud ava eesvärava lõunapoolses müüris.

below the present-day street level, at the altitude 35.65-35.80 m. A part of the curved eastern end of the outer gate could be observed in the excavation. On the southern side it was damaged by an earlier trench (Fig. 3). The thickness of the wall of the curved part was approximately 4-4.5 m. The walls on the southern side of the gateway also came into sight. Between these and the curved wall a 3.3 m wide lower part of the gateway located in the southern side of the outer gate was discovered. South of the gateway a wall made of bricks and granite stone was located. In its excavated northern side, towards the outer gate, three walledup apertures (Fig. 4) came to light. Parallel to this southern wall another wall ran approximately in E-W direction. Its upper part was made of bricks and the lower part, quite irregularly, of granite stones. The southern side of this wall was heavily damaged by the installation of an earlier sewerage and therefore it was impossible to establish whether a narrow, ca. 0.75 cm wide gallery had been once located between these two walls, or a supporting extension had been erected against the northern side of the earlier southern wall. The described walls were unearthed in a length of 13 m and rested upon a base of large granite stones.

Leitud ehituskehanditest on huvipakkuvamad Vene värava eesvärava müürid Laia tänava jõepoolses osas (joon. 3; 4) ja üsna massiivsete müüride jäänused Jakobi ja Laia tänava ristumiskohal, mis ilmselt kuuluvad keskajal siinses piirkonnas eksisteerinud Katariina kloostri hoonetekompleksi. Nimetatud müüride vahelisel alal tulid kaevetöödega päevavalgele matused, mis pärinevad perioodist, mil hoone oli juba varemetes.

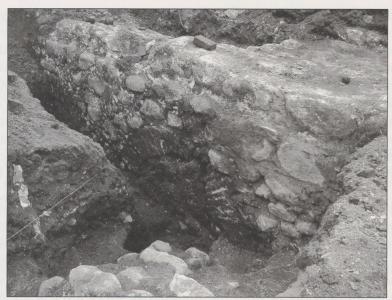
Fig. 5. Lai Street 11/13 wall with arches from the 17th century. View from N.

Joon. 5. Lai t. 11/13 kaartega müür 17. sajandist.

The preliminary investigations carried out on the site of Lai Street 11/13 brought to light at the altitude of 41.00 a NE-corner of a post-medieval building, erected most likely in the 17th century mainly of granite stones. The thickness of the E wall was 1.12 m but the N wall was 3 m thick. The cellarless building had been erected on the place of an earlier medieval brick building. A 1 m long fragment of a destroyed wall of this earlier building came to light at the altitude of 39.94 m between the later walls in the NE-corner. In the eastern foundation of the later building two brick-laid successive round arches (Fig. 5) were discovered. The merit of such construction, alongside with reducing the weight of the wall, might have been also the better drain of rain water in the ground.

Lai tänav 11/13 krundil läbi viidud eeluuringutel paljandus tõenäoliselt 17. sajandil rajatud hoonemüüri kirdenurk. Peamiselt maakividest ehitatud hoone idapoolses alusmüüris tulid nähtavale kaks tellistest laotud läbivat ümarkaart (joon. 5). Keldrita hoone oli rajatud varasema tellishoone kohale, millest õnnestus välja puhastada ühe meetri pikkune lõhutud müürifragment hilisemate müüride vahel.
