Results of archaeological fieldwork in 2005

**ARCHAEOLOGICAL
FIELDWORK
IN ESTONIA**

ARCHAEOLOGICAL INVESTIGATIONS AT THE TOWN WALL OF VILJANDI AND THE CONSTRUCTION SITE TARTU STREET 8A

Arvi HAAK and Priit LÄTTI

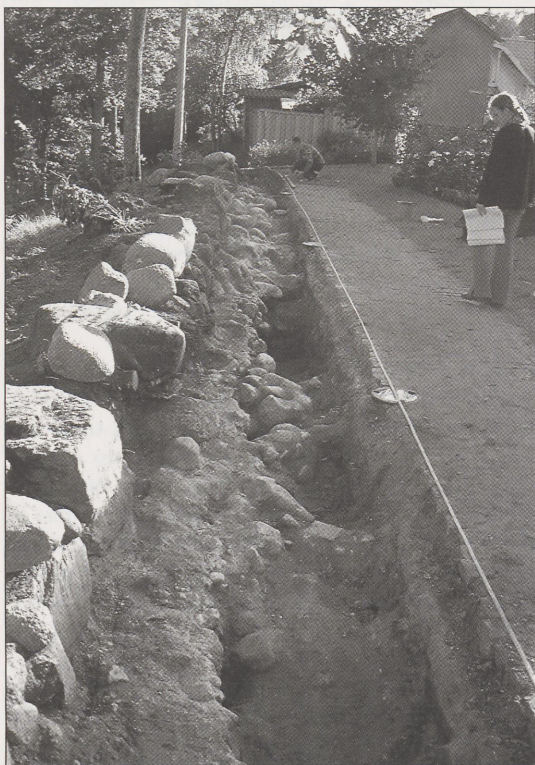
Fig. 2. The remaining part of the town wall at the yard of Linnu Street 2, and the foundation of the later outbuilding on top of it.
Joon. 2. Linnu t. 2 hoovis väljapubastatud linna- müürilõik ning sellele toetuv kõrvalhoone vundament.

The outer side of the original town wall revealed a **narrower granite stone wall**, the only part that could be observed on the ground. At the extent of the later wall, only the inner side of the town wall was cleared out, while elsewhere the old town wall could be excavated in full width. The character of the later wall and its connection to the town wall were also documented (Fig. 2).

The later wall consists of large granite stones, 20–50 cm in diameter and is about 70–80 cm wide. The stones are joined with lime mortar, and the most recent addition to the wall consists of larger stones loosely placed on top of the wall. The wall rises about 30–40 cm above the ground and has been preserved in a relatively uniform condition in full length. The only gap in the wall is an about 50 cm long section of missing stones, caused by a tree growing on the eastern side of the wall, its roots anchored through the wall. Possibly, the growing tree has crumbled this section of the wall.

The excavations revealed that the **original town wall** directly under the layer of tuft had been seriously damaged, especially in the northern part of the excavated area, most likely during the later construction works. There are huge gaps in several places where the wall stones have been removed and only an extremely solid part of the wall of 1.4 m in width, consisting of smaller stones and joined with ample mortar, still stands. An extremely sturdy layer of light colour mortar is located directly beneath the layer of tuft. As one of the test pits indicated, at some places the wall has been damaged up to its base, while at other places the preserved masonry begins deeper, below the layer of mortar. The cleared wall stones are relatively small, approximately 20–30 cm in diameter. In some places, larger stones that may have served as the lining stones of the wall can be seen in the north-western wall of the pit or directly next to it.

Viljandi raeoja (Linnu t. 2) taga puhastati konserveerimiseks välja linnamüüri säilinud osa 26×2 m suuruse kaevandiga. Välitöödel selgus, et maapinnal jälgitav müüriosa on hilisema, arvatavasti 19. sajandil rajatud abihoone vundament, mis toetub linnamüürile. Vundament oli 70–80 cm paksune ning koosnes 20–50 cm läbimõõduga lubimördiga seotud maakividest. Linnamüüri oli abihoone rajamisel tugevasti kahjustatud, sest nähtavasti kasutati vundamenti ladumiseks linnamüüri kive. Linnamüüri säilinud osa oli abihoone kohal vaid 1,4 m laiune. Tihkes lubimördis olid eristatavad kivipesad, prooviaugu kaevamisel ilmnnes, et kohati olid müürikivid eemaldatud kuni taldmikuni.

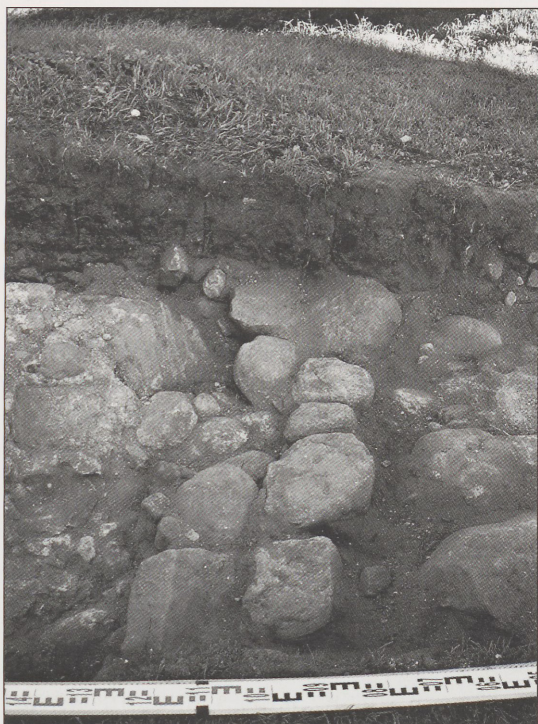
Fig. 3. A probable gutter on top of the town wall.
 Joon. 3. Oletatav pinnasevee äravoolu renn lin-
 namüüiril.

of stones with a smooth top, approximately 20–40 cm in diameter, which are slanted towards each other in some places, thus the structure reminds a gutter (Fig. 3). The assumption of a gutter leading off surface water could be further strengthened by the lack of any traces of mortar on the stones forming it. This explains why the stones have probably not been a part of a former wall.

Linnamüüri säilinud ülapinnast kõrgemal asus kahest kõrvuti asetsevast kivireast rajatis, mille kivid polnud omavahel mördiga seotud, kuid nende ülapinnad olid keskkoha poole kaldu. Võib oletada, et tegemist on pinnasevee vallikraavi juhtimiseks ehitatud renniga, sest kivide ülapinnal puudusid mördijäljed. Kaevamistel kogutud leidudest (VM 11088) moodustab suure osa keraamika, mille võib dateerida 16.–20. sajandisse.

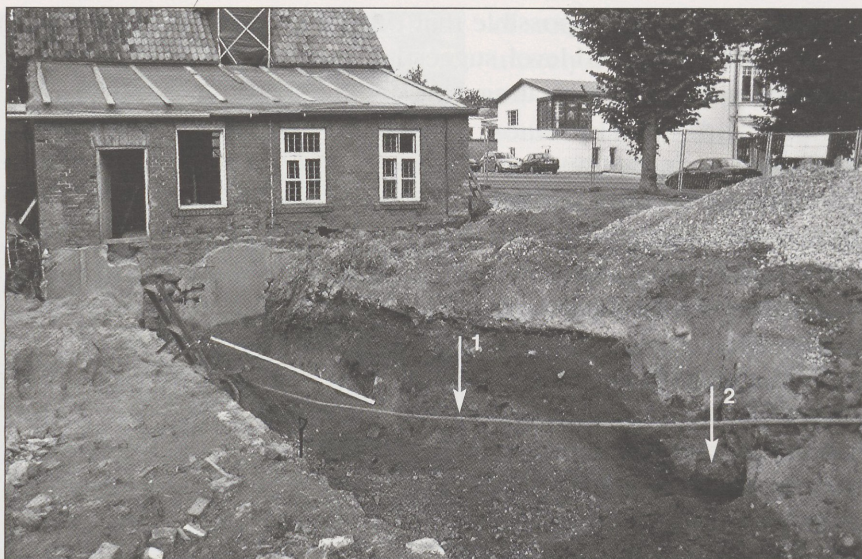
Fig. 4. Profile of the excavation plot at Tartu Street 8A. The arrow (1) indicates an intrusion into virgin soil, containing finds from late 18th and early 19th century. Another arrow (2) indicates the northern edge of the moat.

Joon. 4. Tartu t. 8A hoonesüvendi profiil. Noolega 1 on tähistatud 18. saj. lõpu või 19. saj. alguse leide sisaldav sissekaeve puutumata pinnasesse, noolega 2 on märgitud vallikraavi põhjaserv.

the moat (Fig. 4). The cultural layer that had been deposited onto the natural soil contained only minimal finds: a fragment of a stove-tile (Fig. 6: 2), and of imported pottery from the 18th–19th century. From the intrusions into the virgin soil (Fig. 4, arrow 1), a few fragments of thin bricks (less than 7 cm thick), typical to the Post-Medieval period, were collected.

Järelevalvetöödega selgus, et uuritava alal pole keskaegne kultuurkiht säilinud (või tekkinud). Looduslikul aluspinnal paiknev väheintensiivne kultuurkiht sisaldas 18.–19. sajandi leide (roheline glasuuriga kahlite katked, klaas- ja fajanssnõude killud, õhukeste, alla 7 cm paksuste telliste tükid). Vaid vallikraavi servalt (joon. 4) leiti ajavahemikku 13. sajandi lõpust 15. sajandini dateeritav savinõu servakild.

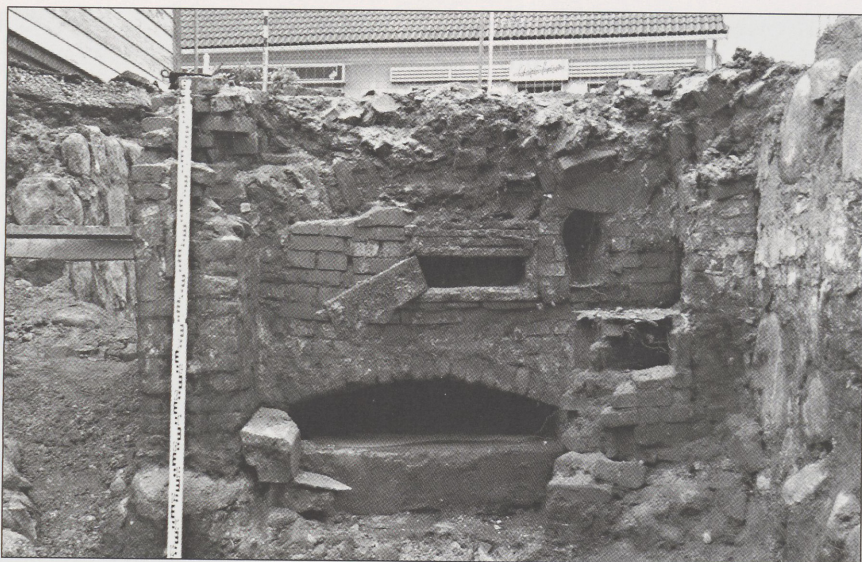
Archaeological investigations showed that the walls of the cellars had survived relatively well, with wooden doorframes still standing. In the cellar of the stone building, the remains of a bakery oven had been preserved and were described in detail. The dimensions of the stove (Fig. 5) were 2.55 × 4.1 m, the height of the remaining part was up to 2.1 m. The stove was put up of 27 × 13 × 6.5 cm bricks bonded with clay; stones of one row faced the outer surface of the wall with the end, in rows below and above – with their side. The western, and partially the southern side of the oven had been whitewashed. The mouth of the oven was directed toward the south and the northern part of the oven seemed to be a later addition, as 2.1 m north from the southern side, a projecting post was constructed, and a traversing joint could be seen just north of it. The construction of the walls of the oven was strengthened with two iron rods at both sides, joined with horizontal rods across the oven below the upper vault. The floor in front of the oven, and its lower edge were reinforced with concrete.

Fig. 5. Front side of a baker's oven unearthed at Tartu Street 8A.
 Joon. 5. Tartu t. 8A avastatud pagariabju esikülg.

The front side of the oven was determined with two protruding posts of bricks, the eastern one connected with a flue. The heating chamber in the lower part of the oven was vaulted, its width being 120 cm and maximum height 30 cm, its length exceeded 3 metres. It could also have been used for baking. Above the vault, there was another chamber with the width of 60 cm; its exact construction remained unclear, as the stones of the upper vault had crushed in and destroyed its inner construction. The lower vault, which also formed the bottom of the upper chamber, was covered with an up to 50 cm thick layer of clay. The chimney was most likely located east of the central axis of the house, in the room east of the bakery, where a cooking stove was located. It seems likely that it also hosted a laundry.

19. sajandi lõpul rajatud ning 20. sajandil Hans Bärsonile kuulunud Tartu tänava ääres asunud hoone keldrist leiti hästi säilinud ja oletatavasti kahes järgus ehitatud pagariahi (joon. 5). Kirjalike allikate põhjal otsustades on hoones pagari- ja kondiitriäri tegutsenud 1920. aastateni, seejärel aga arvatavasti suletud. Pole välistatud, et äri suleti tiheda konkurentsi tõttu: Viljandis tegutses 1920–30. aastatel 4–5 pagarit. Sarnase kujuga pagariahje on ehitatud keskajast alates ning neid on kujutatud ka mitmel kaasaegsel joonisel.

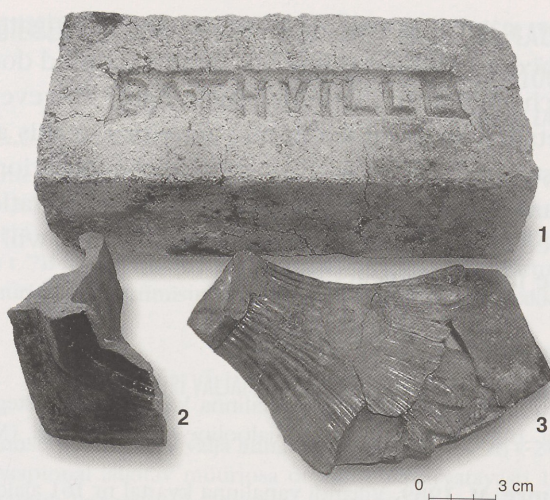
Fig. 6. Finds from the investigations at Tartu Street 8A. 1 - firebrick produced in Bathville, 2 - 18th-century stove tile, 3 - fragment of faience soup bowl.

Joon. 6. Leide Tartu tn 8A uuringutelt. 1 - Bathville's toodetud šamott-tellis, 2 - 18. saj. ahjukabli katke, 3 - fajansist supitirina katke. (VM 11116: 39, 1, 15.)

Of the finds collected, firebricks carried most information of their production. In addition to local products from the 1920s or 1930s (brand *E. Šamott*), the products of Sweden (*Skromberga*) and Scotland (*Bathville*) (Fig. 6: 1) were present. At the latter place, fireclay manufacture was established in 1882 (Hynd-Brown 1906). In addition to these, pottery typical to the 20th century, a steelwork frame for the oven or a chimney, and pokers of extraordinary length (over 3 m) had been preserved.
