ARHEOLOOGILISED  
VÄLITÖÖD  
EESTISARCHAEOLOGICAL  
FIELDWORK  
IN ESTONIA

# ARCHAEOLOGICAL INVESTIGATIONS OF MEDIEVAL AND POST-MEDIEVAL VILJANDI

**Arvi HAAK and Heiki VALK**

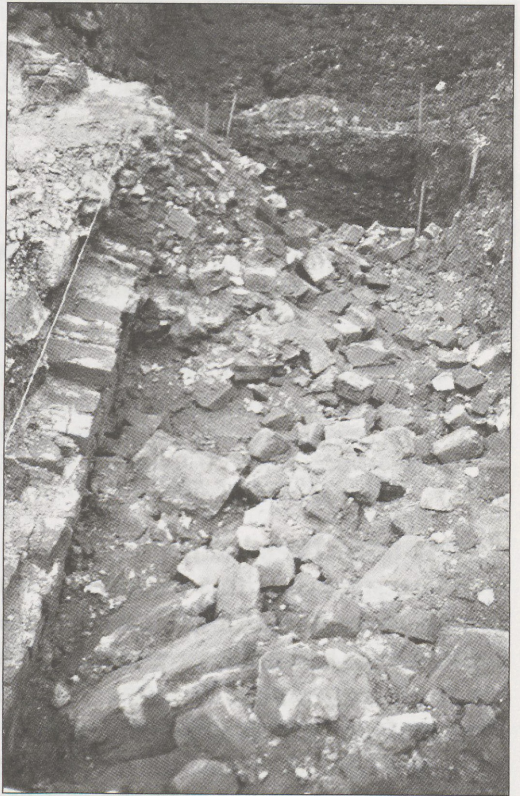
Fig. 2. The remains of a cylinder vault in the cellar of the choir of the castle chapel.

It soon became evident that the cellar below the choir had been vaulted: up to eight rows of bricks from a cylinder vault had been preserved in their original position at the southern wall of the choir (Fig. 2). Most likely, the debris that filled the cellar originated from the walls of the choir, as well as from the vaulted ceiling. In addition to bricks, from the debris some construction details of limestone, a capital (Fig. 3), seven profile bricks and fragments of mortar with painting (VM 10846: 27–28) were found. In order to avoid further collapse of the vault remains, the debris next to the best-preserved part of the vault was left intact. The depth and character of the layers below were investigated only in both ends of the

Joon. 2. Silindervõlvi jäänused linnusekabeli kooriosa keldris.

Varasematest kaevamistest puutumata kooriosas satuti silindervõlvi jäänustele (joon. 2). Võlvi ning kooriosa tellismüüride sisselangemisel oli tekkinud üle 1 m paksune rusukiht, millest leiti lubjakivist ehitusdetalle, kapiteel (joon. 3) ja maalingutega krohvitükke. Kooriosa keldriruumi mörtpõrandale oli ladestunud 16. sajandi teise poole kultuurkiht, mis sisaldas looma- ja kalaluid ning mõne savinõukilli. Kihist leiti põlenud metallesemeid, sh. 30 kaitserõivastuse fragmenti, kaks võtit ja lukku (joon. 4), samuti aknahing. Põranda all algas segatud saviliiva kiht, kultuurkihi varasemad ladestused puudusid. Kooriruumi ligi 2 meetri paksusest idaseinast leiti aknaava.
