# Archaeological monitoring on the northern and northeastern sides of the University of Tartu main building

Silvia-Kristiin Kask, Irina Khrustaleva and Aivar Kriiska

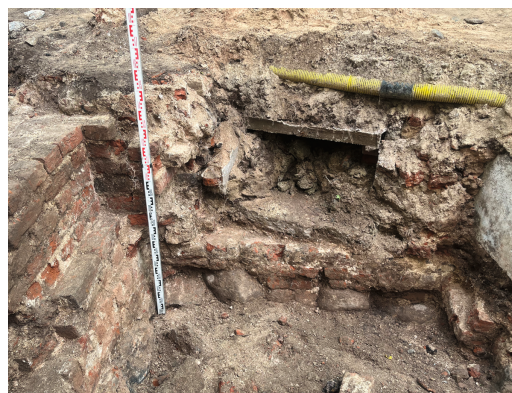
Fig. 2. Building 1, view from the south.

Within the trench areas, the rooms of three buildings were partially exposed. From Building 1, a brick-built room was uncovered, of which the western and northern interior walls and the corner of the eastern wall were mostly visible (Fig. 2). The southern part ended neatly where the university's wing building foundation trench started. The western wall, the best preserved of the three, had been constructed on a foundation of crystalline boulders and was likewise supported by stones on the exterior wall. The bricks, measuring  $30 \times 15$  cm with a thickness of 8.5 cm, rested directly on the foundation stones. In the lower four courses, the wall was four bricks thick, i.e. ca. 60 cm, stepping down thereafter to a thickness of three courses. Between the bricks, a 2–3.5 cm layer of friable whitish mortar was visible. The northern and eastern walls showed comparatively poorer preservation but were structurally identical to the better-preserved western wall. The northern wall measured 1.94 m from corner to corner, while the length of the other walls could not be determined. About one metre southeast of the building was a curved structure made of bricks similar to those used in the walls of Building 1. However, some of the bricks were covered with a layer of black soot. The soil surrounding the building yielded mainly pottery sherds, among which glazed redware dominated, though fragments of wheel-thrown coarseware pottery with incised wavy ornamentation (Fig. 3: 5) and a fragment of a white clay tobacco pipe were also recovered.

Uuringualalt kaevati välja 14 müürikatket ja kolme ulatuslikumalt säilinud hoone seinad. Hoonest 1 (jn 1B) oli säilinud kolm tellistest laotud seina, neist läänepoolne suuremas mahus (jn 2). See oli alumiises osas nelja tellise laiune ning kahanest astmeliselt kolme tellise laiuseks. Müüri all oli näha maakivist vundament ning kive oli laotud ka läänepoolse välisseina vastu. Hoonevare 1 lähedusse jäi tellistest laotud kaarjas konstruktsioon. Hooneosa väljapuhastamisel leiti selle vahetust lähedusest arvukalt savinõukilde, valdavalt pärinevad need glasuuritud punastest savinõudest, kuid leidus ka üks lainelisejoonornamendiga ketrakeraamika kild (jn 3: 5) ja kaoliinsavist piibuvarre katke. Hoonega 2 seostati kolme kivivundamenti osa, mille sarnane ehituslaad ning paiknemine ühel joonel ja kõrgusel lubab arvata, et tegemist on ühe ehitisega. Kahe müüriosa juures avati nii ruumi põhja- kui ka läänepoolne vundament. Täitepinnas oli selle hoone siseküljel leiurikkam kui ülejäänud uuringualal. Hoone 3 oli samuti ehitatud tellistest. Avatud alale ulatus selle põhja-, lõuna- ja läänessein, viimane oli säilinud kõige terviklikumalt. Läänesein

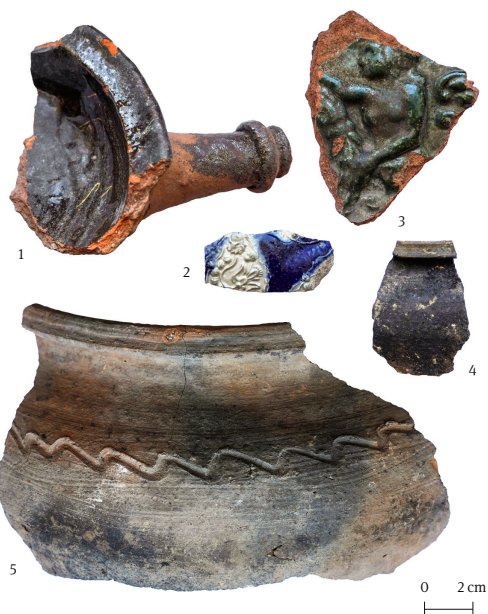
Fig. 3. Pottery and stove tile fragments collected during archaeological monitoring on the northern side of the University of Tartu main building. 1 – a broken tripod vessel, 2 – a fragment of Westerwald stoneware, 3 – a fragment of green-glazed stove tile depicting a woman with a garland, 4–5 – fragments of wheel-thrown pottery.

A total of 118 artefacts were collected during the work. The most numerous group of finds is pottery sherds, with a total of 61 collected. Of these, the majority – more than 40 – are redware. Most of the vessels are covered with brown or green glaze, some sherds have engobe paintings. In at least eleven cases, the fragments belonged to tripod vessels, including separate legs (8) and handles (1) and two better-preserved small, low broken tripod vessels (Fig. 3: 1). Based on analogies (e.g. Tvauri & Metsallik 2006; Kriiska *et al.* 2011), most of the redware fragments can be dated to the Early Modern Period. Ten sherds are from wheel-thrown coarseware, including five rim sherds, four body sherds, and one bottom fragment. One of the rim sherds belongs to type 5 of Northwest Russian ceramic tradition according to Tvauri (2000, 107–108), characterized by a short, everted rim (Fig. 3: 4). This type of pottery was probably introduced into Estonia during the Livonian War in the second half of the 16th century, by Russian soldiers and civilians who settled in Estonian towns, strongholds, and villages, including Tartu (Tvauri 2004, 400). Three pottery pieces may be attributed to Tvauri's group 6 and dated to the 18th century.<sup>1</sup> One rim fragment of this type bears an incised wavy ornament (Fig. 3: 5). Only three sherds of stoneware were found, for which the production area of two can be identified (based on Russow 2006). One sherd is Siegburg stoneware (TM A-309: 79) and is among the few objects in our assemblage that may date from the Middle Ages, while another piece is Early Modern Period stoneware from Westerwald (Fig. 3: 2).

The finds include 11 stove tiles fragments covered with green (4), black (3), brown (1), or white (1) glaze. One fragment of a green-glazed stove tile depicts a woman with a garland (Fig. 3: 3). Based on analogies (e.g. Tvauri & Metsallik 2006; Kriiska *et al.* 2011; Ose 2013), most of the tile fragments can be dated to the 17th–18th centuries.

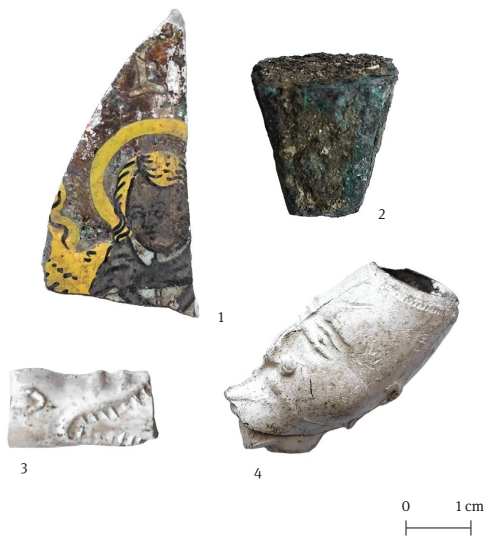
**Fig. 4.** Finds collected during archaeological monitoring on the northern side of the University of Tartu main building. 1 – a fragment of painted glass depicting a saint, 2 – a leg of a metal vessel, 3 – a fragment of a white clay pipe stem, 4 – a white clay pipe bowl.

Among other finds, a fragment of painted glass depicting a saint (Fig. 4: 1), a piece of a lead window frame (TM A-309: 90), and a leg of a metal vessel, found in the trench at Munga street (Fig. 4: 2) are also remarkable. Finally, a specific ceramic tile can be highlighted. It bears the impressed manufacturer's name, Бергенгеймъ, and the place of production, Харьков<sup>3</sup> (Fig. 5). This floor tile was produced sometime in the late 19th or early 20th century in Kharkiv, in present-day Ukraine. The factory, which operated from 1877/1878 until 1917, was founded by Baron Edward Ferdinand Bergenheim (1844–1893), a Finnish-born military officer, railway engineer, industrialist, and politician. The factory's products were widely distributed across the Russian Empire (Nezvitskaya 2012).

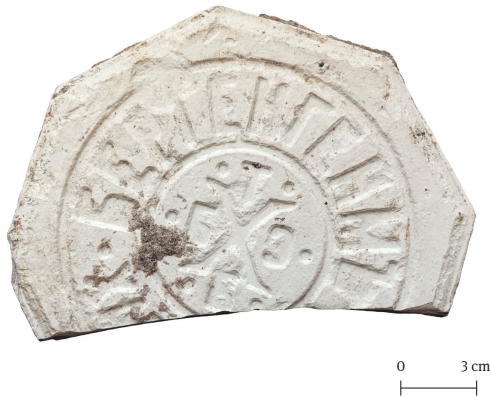
**Fig. 5.** A fragment of a floor tile found during archaeological monitoring on the north side of the University of Tartu main building.

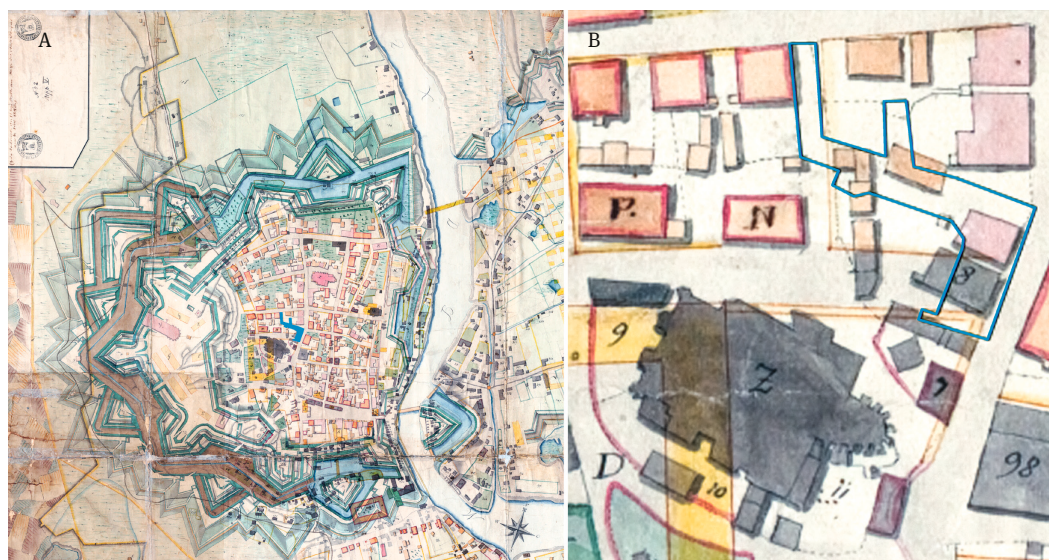
**Fig. 6.** A – a map, probably from 1845, compiled based on earlier city plans (RA, EAA.2623.1.2049, p. 49), on which the main research area (marked in blue) has been georeferenced, B – a detail from Figure 6A.

is the city plan made in the 1640s<sup>4</sup> (RA, EAA.5393.1.17, p. 1), which shows the names of the plot owners, and may refer to possibly built-up properties. The buildings are shown only on some of the maps, reflecting the situation of the 1760s. Georeferencing of the historical and present-day plans indicates that the three building remains excavated correspond – though not entirely, yet with sufficient accuracy – to the three buildings shown on the 1767 map, while the remains of other walls cannot be associated with any historical plans (Fig. 6).<sup>5</sup>
