Istmikunärvi iatrogenenne vigastus

Tarvo Sillat^{1,2}, Veith L. Moser³, Christopher Pivec¹, Gerd Bodner¹

Iatrogenic injury of the sciatic nerve

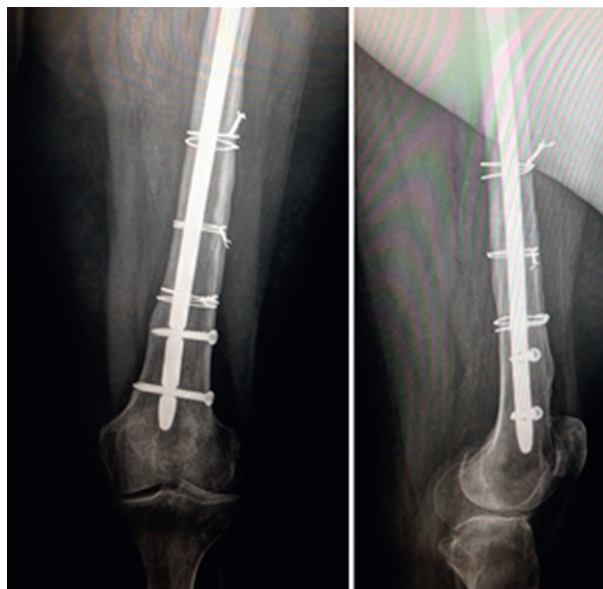
Joonis 1.

Anteroposterioorsel ja lateraalsel röntgeniülesvõttel on näha luustunud reieluumurd koos sissejäänud fiksaatsioonimaterjaliga.

Figure 1. AP and lateral x-ray images show the retained hardware used to fix the spiral fracture of the femur.

Röntgenipiltidel oli näha reieluu diafüüsi luustunud murd koos intaktse fiksaatsioonimaterjaliga (vt joonis 1). Ultraheliuuringul tuli reie keskosas nähtavale paksenenud istmikunärv, mille diameeter piki närvi distaalsemale liikudes lühikese distantsi jooksul järsult vähenes ja seejärel jälle laienes (vt joonis 2). Ahenemispirkonnas oli närv pitsunud reieluu ja sellest pindmisele jääva kajarikka struktuuri vahele. Arvestades ka anamneesi

The X-ray images of the femur showed a well-healed femoral fracture and intact fixation hardware (Fig. 1). Ultrasound imaging showed a swollen sciatic nerve in the mid-thigh region. Moving distally, the diameter of the nerve diminished abruptly over a short distance and then enlarged again (Fig. 2). In this area the nerve was clearly compressed between an underlying bone and a small echogenic structure on top of it. Based on the patient history and comparison of x-ray images, a compression of the nerve by the fixation material was strongly suspected. The patient underwent surgical nerve inspection and the nerve, which was indeed trapped under one of the cerclage wires, was released (Fig. 3). After the operation the patient still had paresis, however, the complaints of paraesthesia have since diminished significantly.
