*Anneli Randla*

## MEDIEVAL PAINTED DECORATION IN ST MICHAEL'S CHURCH IN MIHKLI, ESTONIA

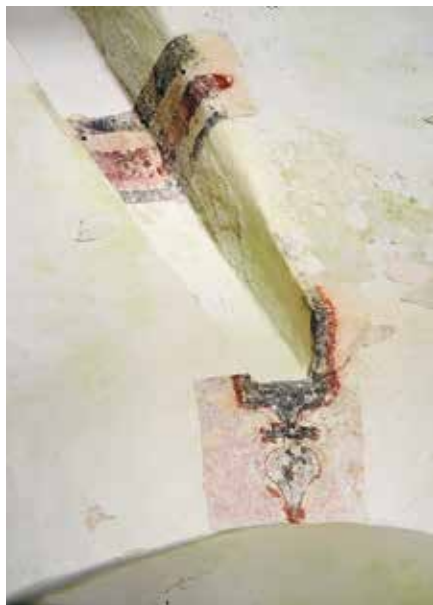
Fig. 1. A painted pendant completing the rib in the chancel. Photo by Peeter Säre.

This decorative scheme had the aim of enhancing the architectural features of the church; no figurative paintings were found. The structural elements of the vaults – bosses, ribs and corbels – are painted; the decoration spreads around the bosses and onto the walls. The background is creamy white, and all of the ribs are painted grey with white-red-white ‘joints’ at somewhat uneven distances (65 to 90 cm). The red band of these ‘joints’ is continued casually onto the vault web. The diagonal ribs in the nave spring from small triangular corbels painted grey and surrounded by a wide red line. The transverse and ridge ribs in the eight-partite chancel vault end in grey painted pendants, also with a red contour (fig. 1).

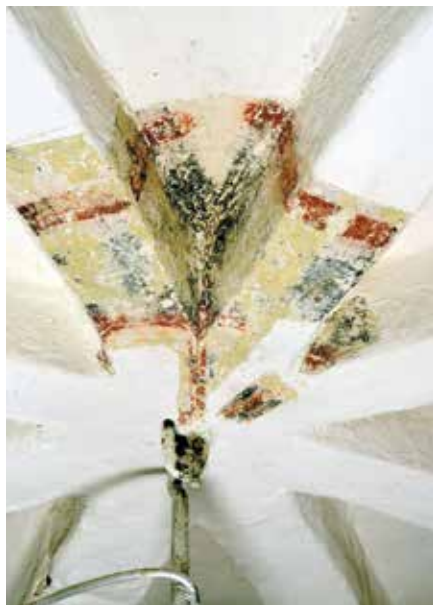
Fig. 2. Decorations in the centre of the chancel vault. Photo by Peeter Säre.

The centres of the vaults are decorated differently in the chancel and nave. The former has several circles of ‘joints’ painted in the centre, the innermost having the form of a small eight-petalled flower (fig. 2). The eastern nave vault has a circled cross on the boss, five curved ‘joints’ on the ribs, close together, and heart-shaped motifs between the ribs, forming a large (diameter approx. one meter) irregular flower-like composition (fig. 3). The ‘petals’ have red outlines, random brush strokes and dots on them, and tassels between the ‘petals’.

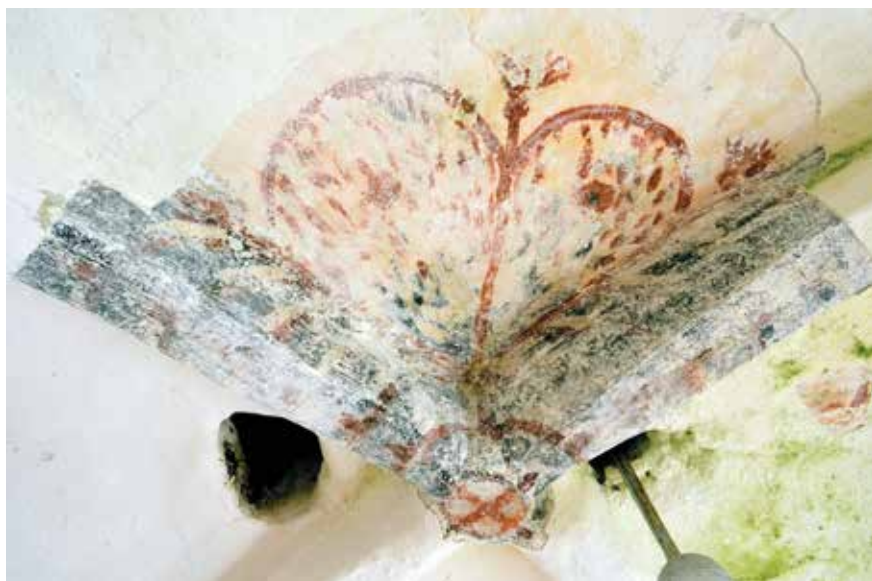
Fig. 3. Decorations in the centre of the eastern vault of the nave. Photo by Peeter Säre
