*Varje Õunapuu, Hilkka Hiip,
Anneli Randla, Karol Bayer*

EVALUATION OF MEDIEVAL ESTONIAN MURALS WITH A FOCUS ON PAINTING TECHNIQUE: NOVEL FINDINGS ON PAINT LAYER COMPOSITION

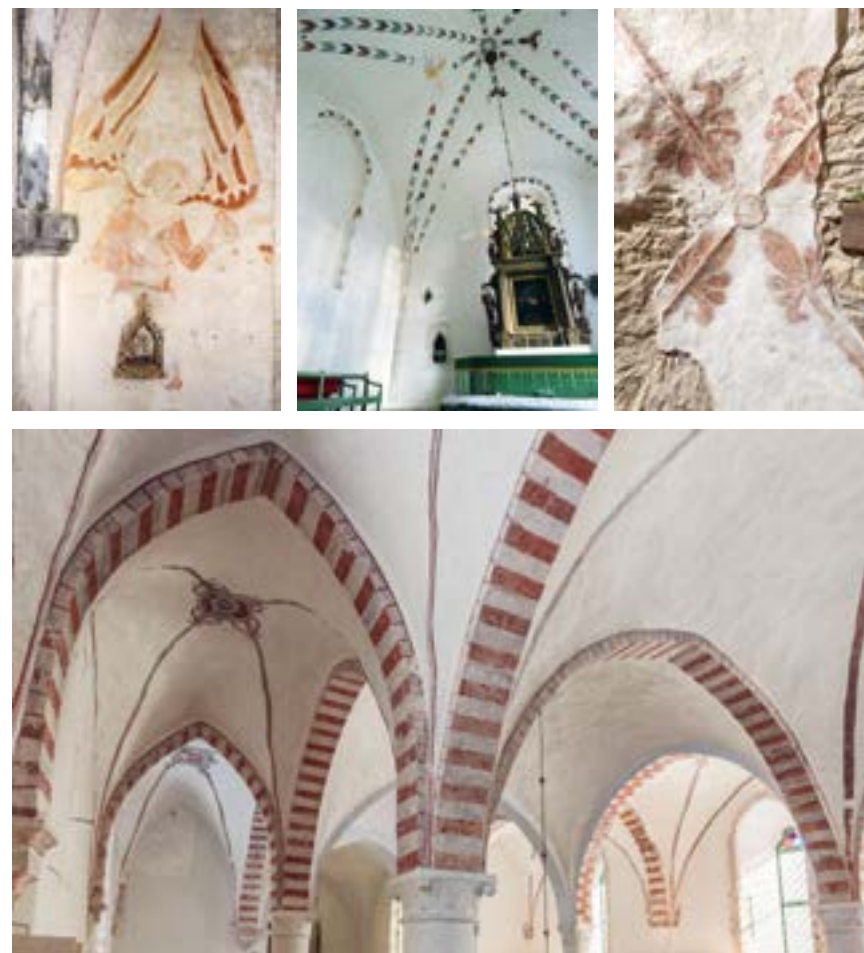
FIGS. 1–4. FRAGMENT OF FIGURATIVE PAINTINGS IN THE CHANCEL OF RIDALA CHURCH; ARCHITECTURAL PAINTINGS IN THE CHANCEL OF MARTNA CHURCH; VAULT PAINTINGS IN THE NAVE OF PÕIDE CHURCH; ARCHITECTURAL PAINTINGS IN KOERU CHURCH. PHOTOS: PEETER SÄRE

Estonian medieval wall-paintings can be divided into two main categories: architectural decoration and figurative paintings (see Figs. 1–4). Architectural paintings usually highlight architectural elements like windows, vault bosses, vaulting arches and ribs, or depict illusory windows. Traces of such decoration have been found in nearly all medieval churches where historical finishing layers have been preserved. Figurative paintings depict apostles, angels, laypersons or different creatures and symbols, and are located on the walls and vaults of the chancels and naves. These paintings are less common and are known from the churches in Valjala, Muhu,

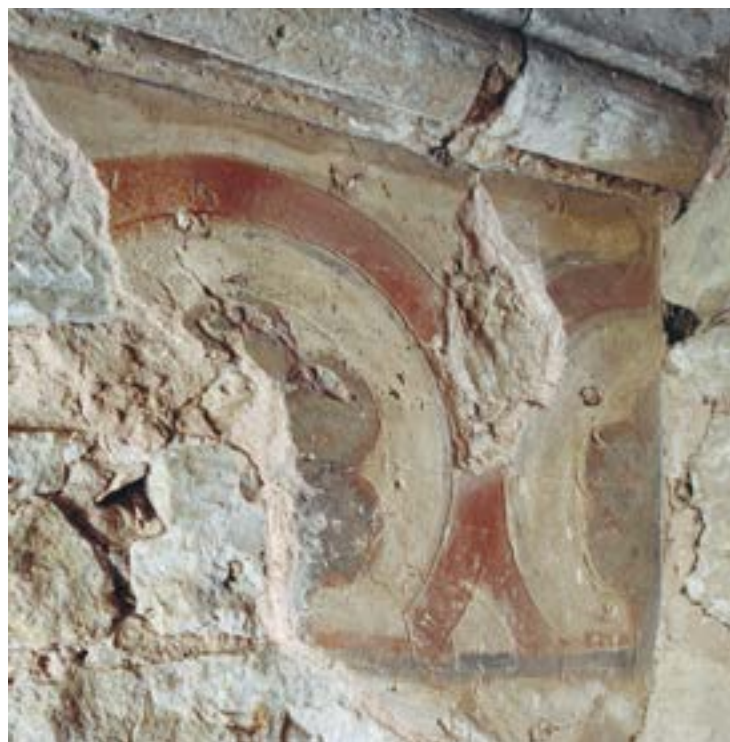
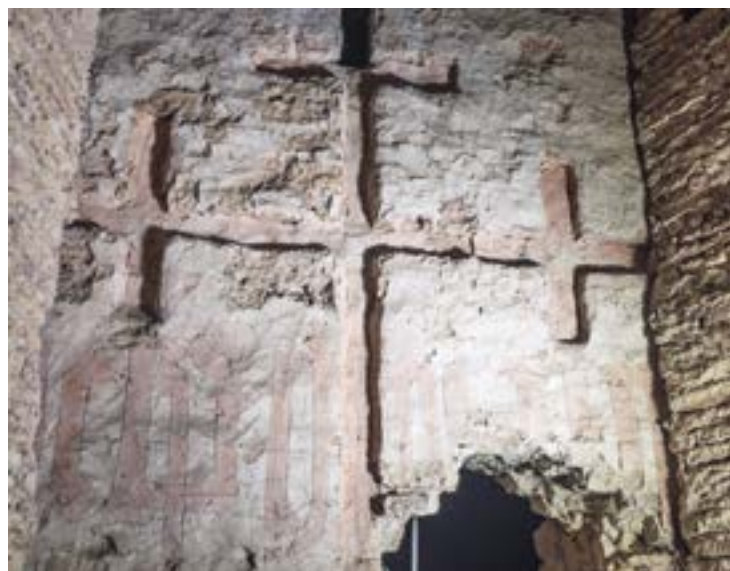
FIGS. 5–6. FORMER EXTERIOR DECORATIONS ON THE N-FAÇADE OF KAARMA CHURCH (CURRENTLY HIDDEN BEHIND LATER CONSTRUCTION); FORMER EXTERIOR INSCRIPTIONS AND CROSS ON THE W-FAÇADE OF LÜGANUSE CHURCH (CURRENTLY VISIBLE IN THE TOWER). PHOTOS: PEETER SÄRE

The same questions remain when studying façade paintings. Due to exterior climate conditions, only a few examples or traces of façade decoration have been preserved (see Figs. 5–6). One of the objectives has been to understand if and how exterior paintings differ from the interior ones.

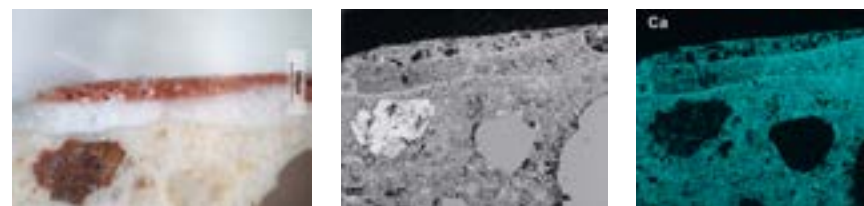
FIGS. 12–14. OPTICAL MICROSCOPE AND SEM-EDS ANALYSIS OF VALJALA ARCHITECTURAL PAINTINGS. FROM THE LEFT: POLARIZING LIGHT MICROSCOPE IMAGE (PLM), BACKSCATTERED ELECTRON (BSE) IMAGE AND CALCIUM DISTRIBUTION ON ELEMENTAL MAPPING.
