Jaan Tamm

RESIDENCES OF ABBESSES IN ESTONIAN
MONASTIC ARCHITECTURE, BASED ON THE
EXAMPLES OF ST MICHAEL'S CISTERCIAN
CONVENT IN TALLINN AND THE
BRIGITTINE CONVENT IN PIRITA

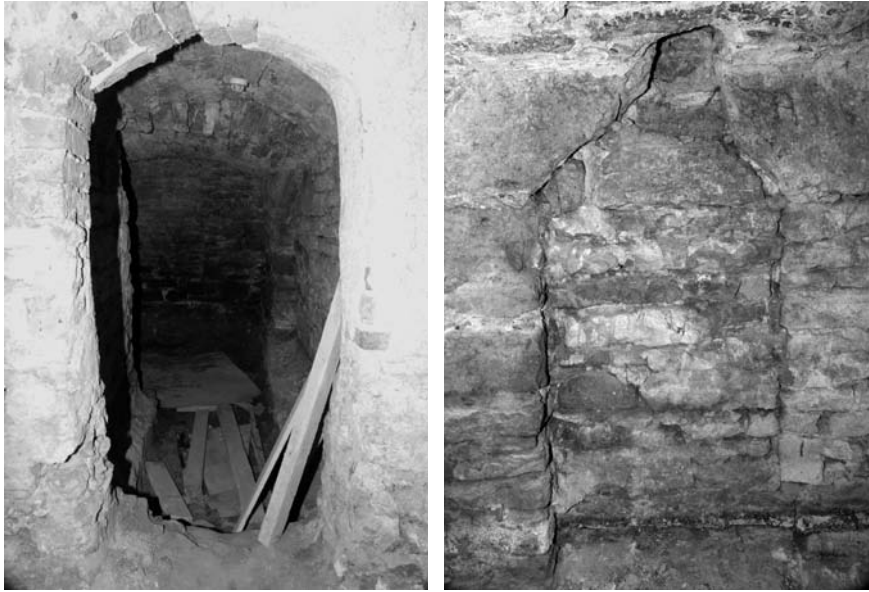
Fig. 2. New door of the hypocaust body. Photo by Heidi Tooming.

Fig. 3. The old, walled-up opening of the hypocaust. Photo by Heidi Tooming.

The residential and office rooms on the main storey of the building were heated by hypocausts,¹⁹ typical of medieval Tallinn. Both were situated at the eastern wall of the basement rooms; the air rose to the floor above through special vents from the heated loose stones on the firebox. Unlike the numerous hypocaust furnaces (a total of 13) in the Pirita convent (see below), the internal constructions of the hot

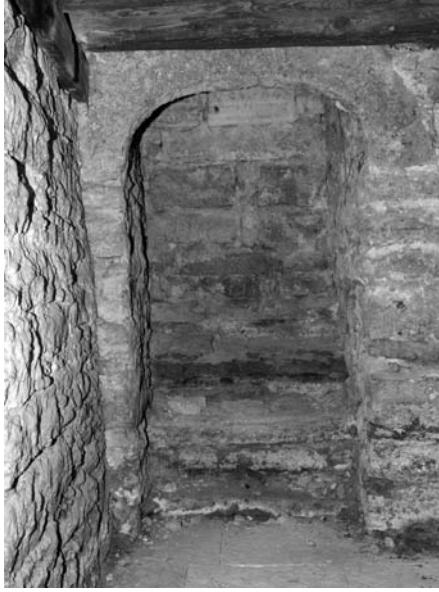
Fig. 4. Old, walled-up basement staircase. Photo by Heidi Tooming.

In addition to changes in the hypocaust, the wide staircase (Fig. 4) leading from the basement to a ground floor room was shut with ashlars, found during demolition work. During the convent period, the staircase served as access to the provisions needed and controlled by the abbess, especially the firewood, which was crucial in our climate. After the gymnasium took over the premises, the main floor

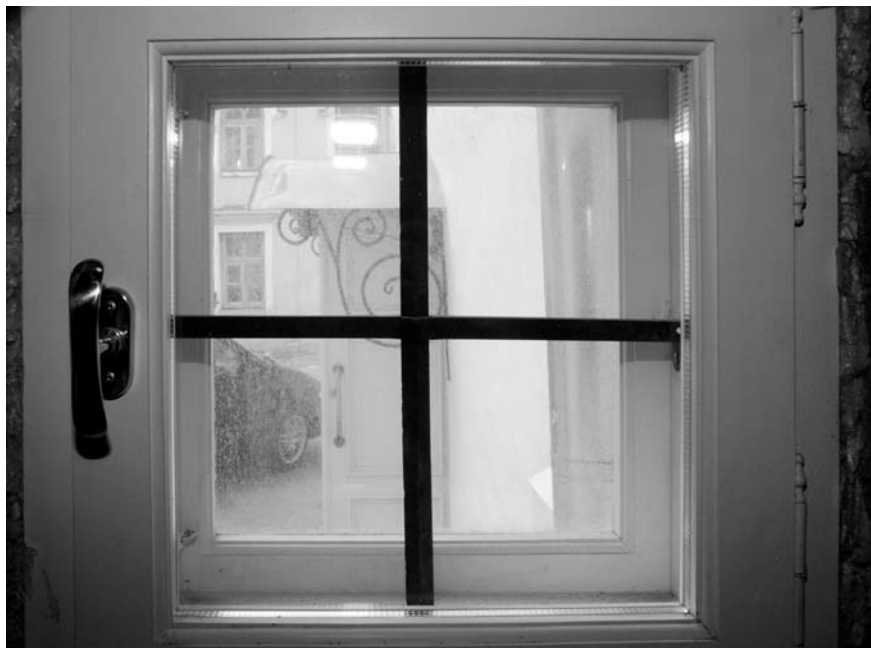
Fig. 5. Window opening of a wall staircase in the northern wall of the abbess's residence. Photo by Heidi Tooming.

was still connected with the northern basement space by a narrow staircase in the northern wall, with a small opening for light (Fig. 5). The staircase ended on the ground floor, with a pointed-arch portal cut from four stones and closed by a wooden door (Fig. 6).

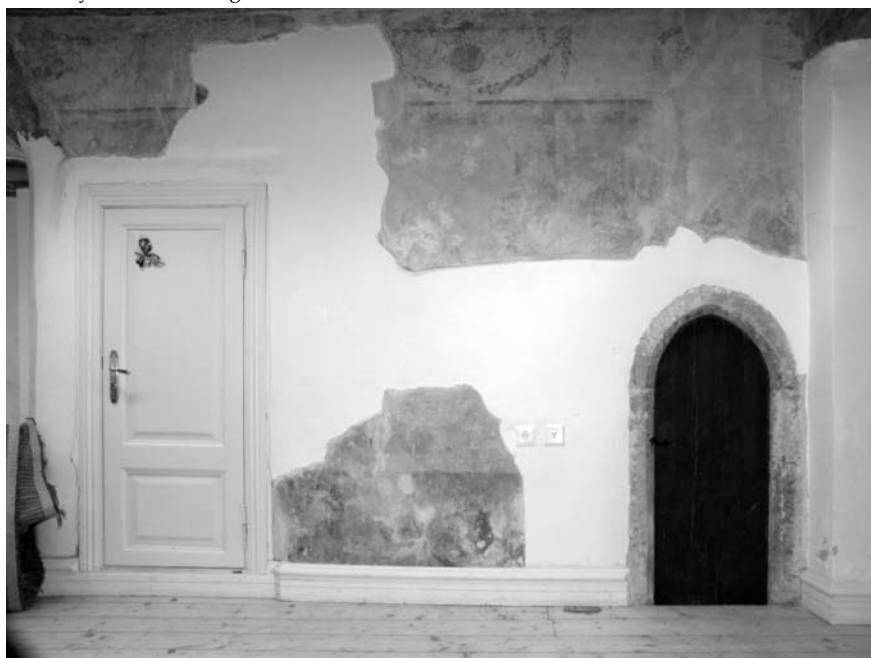
Fig. 6. Doorways of staircases in the northern wall of the main storey. Photo by Heidi Tooming.

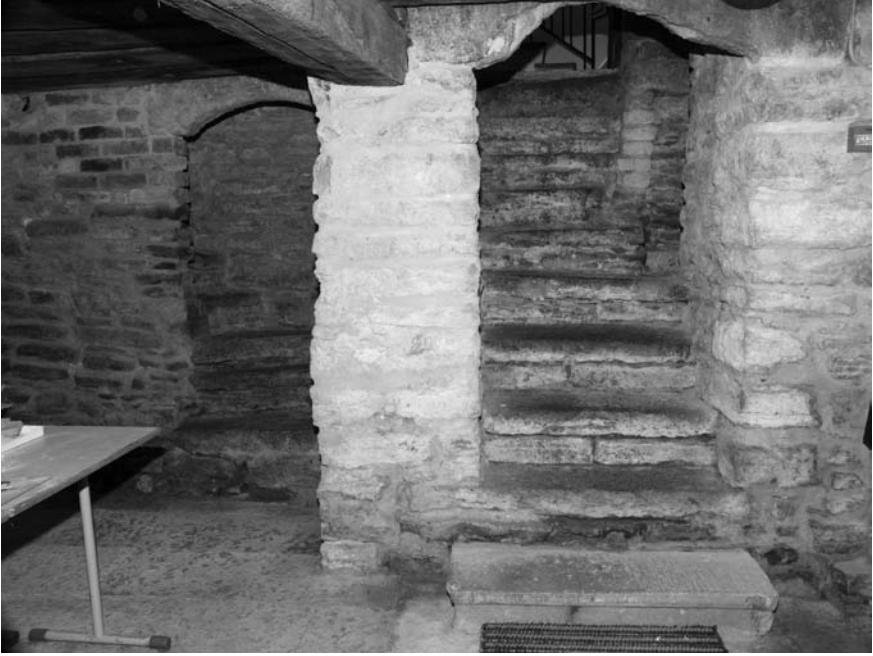
Fig. 7. Stairways in the northern wall of the southern basement. Photo by Heidi Tooming.

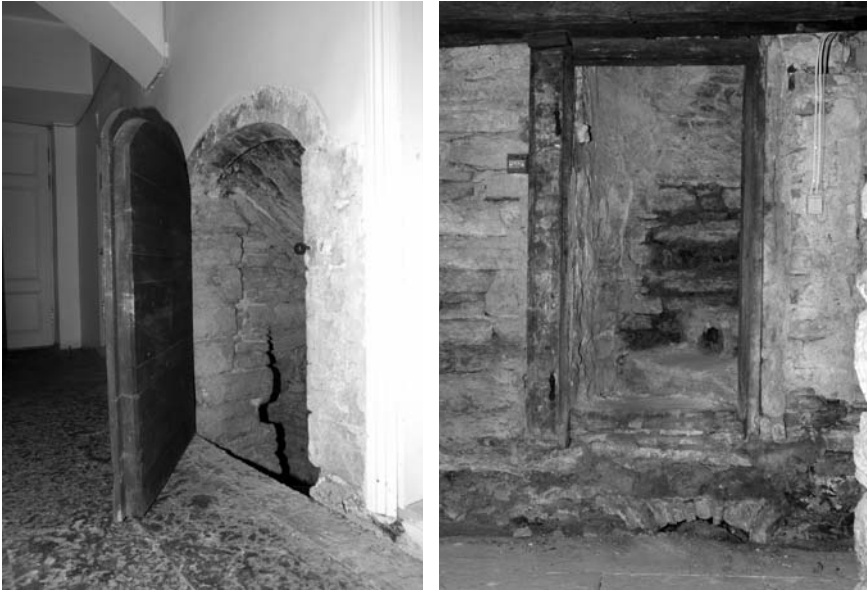
Fig. 8. Upper part and door of the new staircase. Photo by Heidi Tooming.

Fig. 9. Water channel with lintel and staircase. Photo by Heidi Tooming.

unused hypocaust was filled with soil and the small hallway later became the staircase leading to the ground floor interspace. Due to the insufficient thickness of the basement wall, the new stairs had to be rather steep; thus the single-stone lintel was partially cut and the staircase opening on the ground floor was fitted with a new portal that could be closed from the outside (Fig. 8).

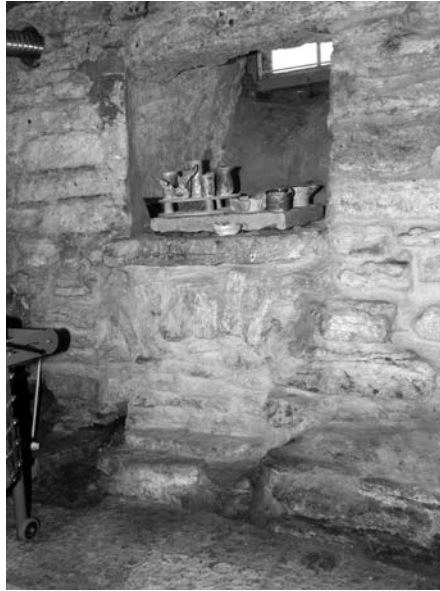
Fig. 10. Inlet of the water channel and a window in the western wall. Photo by Heidi Tooming.

of the convent infrastructure (including sewage and soil water channels) had already been completed. The water channel, which was probably built earlier, was therefore left underneath the new building and covered with a lintel only where it ran through the northern wall (Fig. 9). As the window wall (Fig. 10) of the southern basement also has a lintel vault, this must be the point where the channel proceeded under the abbess's house. It is not possible to say at present whether it belonged to the sewage water channel located in the convent's household yard near the Sauna Tower, which got its name from the nuns' sauna and was often a source of conflict with the town²⁰. The same canal track was also partially used, although in the opposite direction, later when the sewer pipes were installed; this is clearly shown in the technical drawing dating from the 20th century. According to this drawing, the sewage of the water closet in the extension behind the eastern wall of the former residence of the ab-

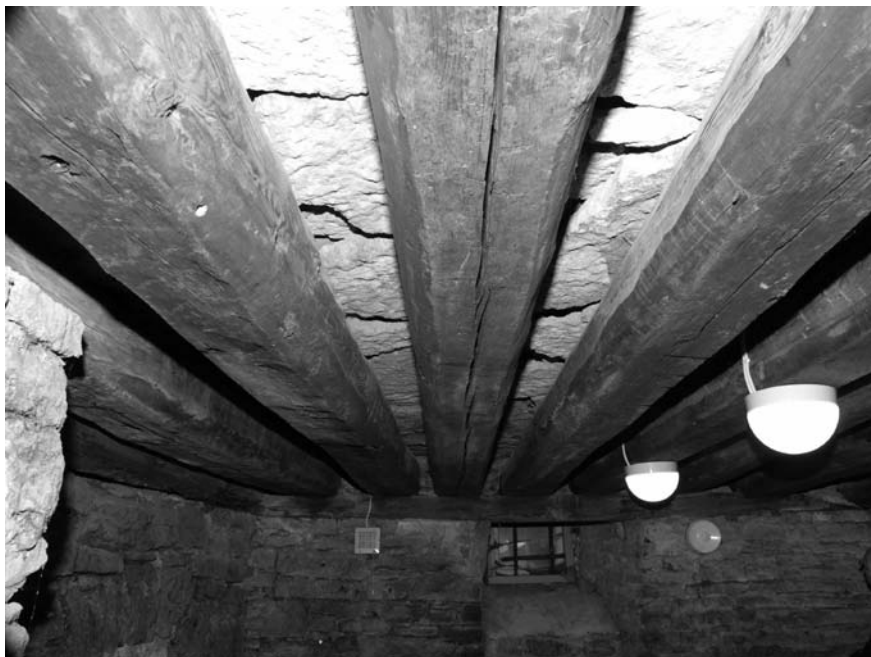
Fig. 11. Ceiling beams in the northern basement. Photo by Heidi Tooming.

Another common feature of the basements were the ceiling beams, which covered the massive vaulted hypocausts with slabs that reached the ground floor level; the beams also covered all the rooms in the east-west direction. The beams mostly consisted of angular, closely placed 8.5-m-long logs resting on the wall rafter, with the ends running east and west; according to the medieval custom, the logs were covered with irregularly shaped limestone slabs (Figs. 11 and 12). As seen in the ceiling construction in the southern basement, the beams were, if necessary, supported by an additional diagonal beam (Fig.13).

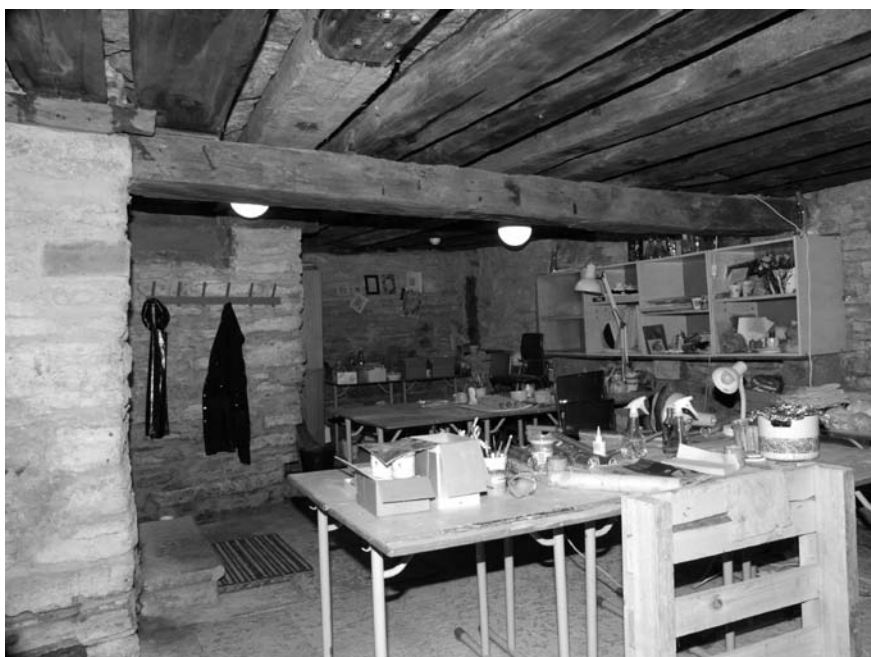
Fig. 12. Ceiling beams in the southern basement. Photo by Heidi Tooming.

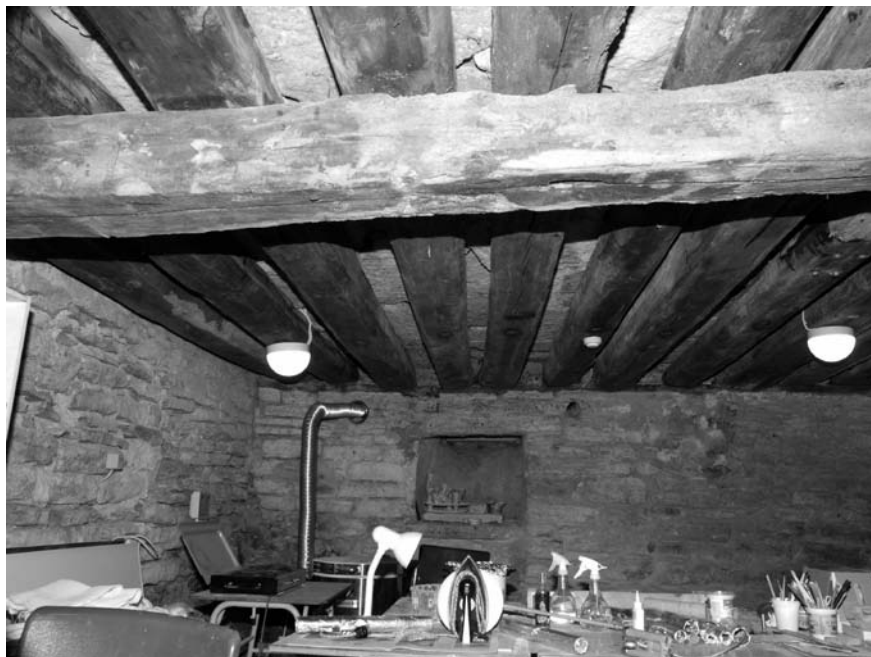
Fig. 13. Extra beam supporting the beams in the southern basement.
Photo by Heidi Tooming.

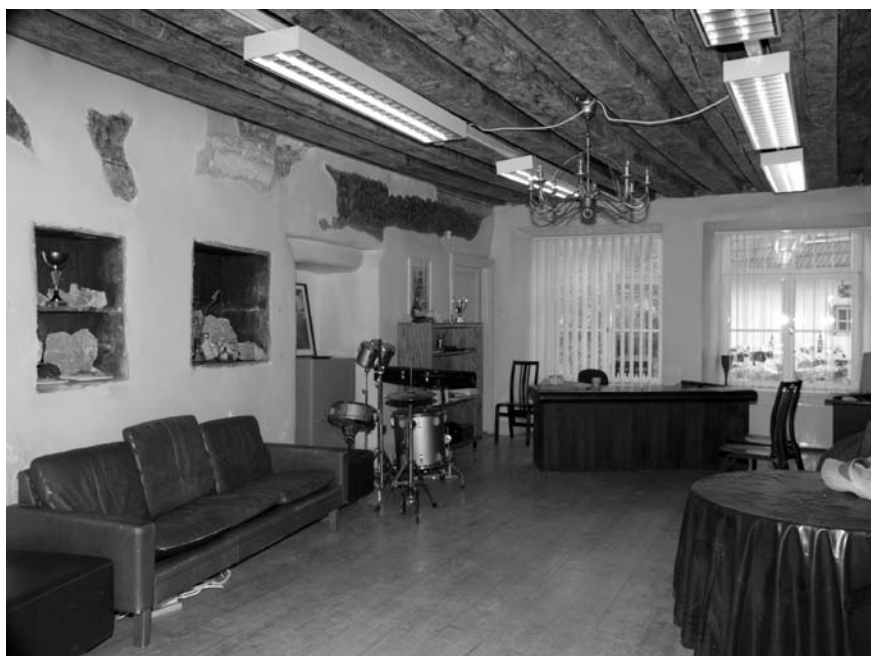
Fig. 14. Northern room of the main storey. Photo by Heidi Tooming.

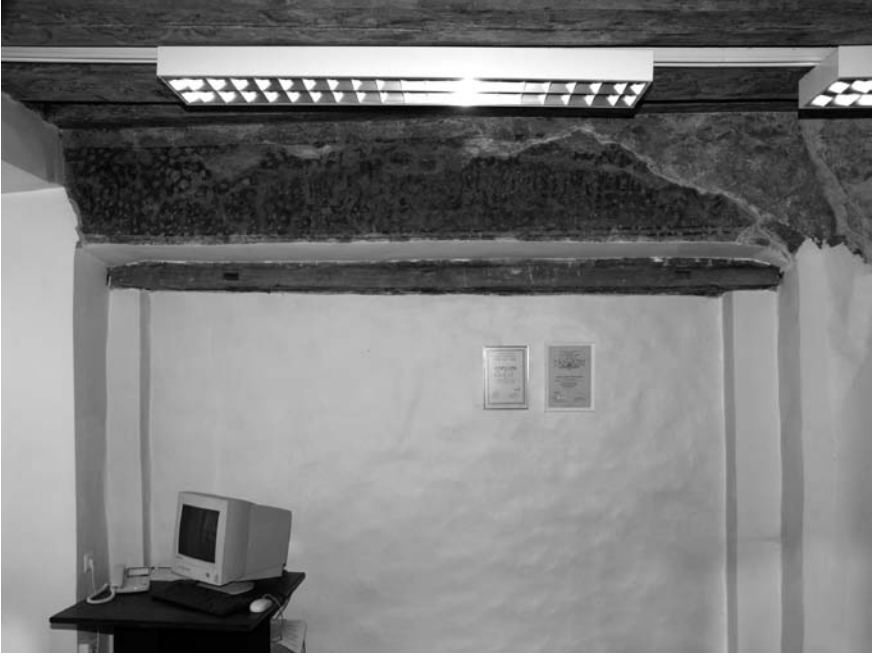
Fig. 15. Niche in the northern wall of the main storey. Photo by Heidi Tooming.

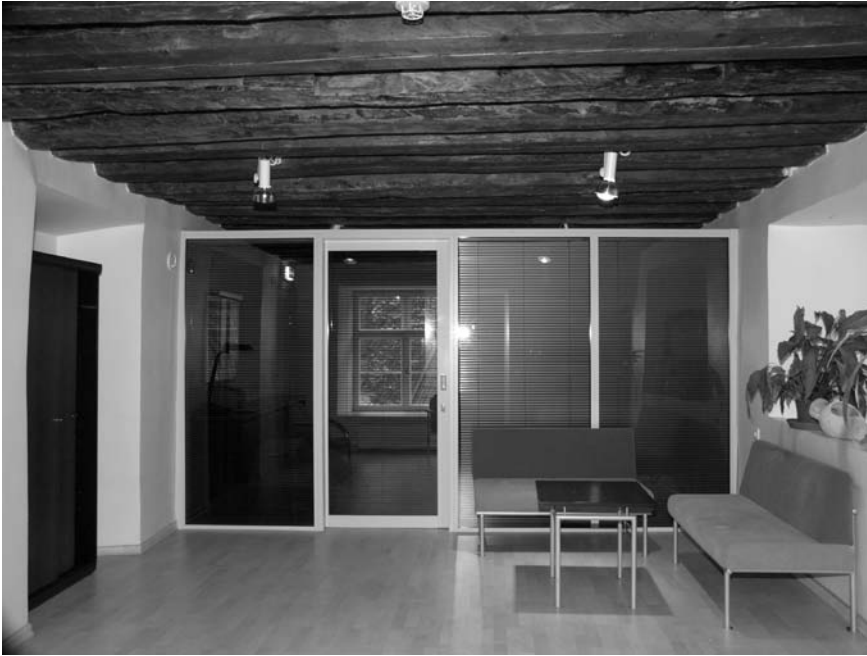
Fig. 16. Ceiling beams of the first floor in the abbess's residence. Photo by Heidi Tooming.

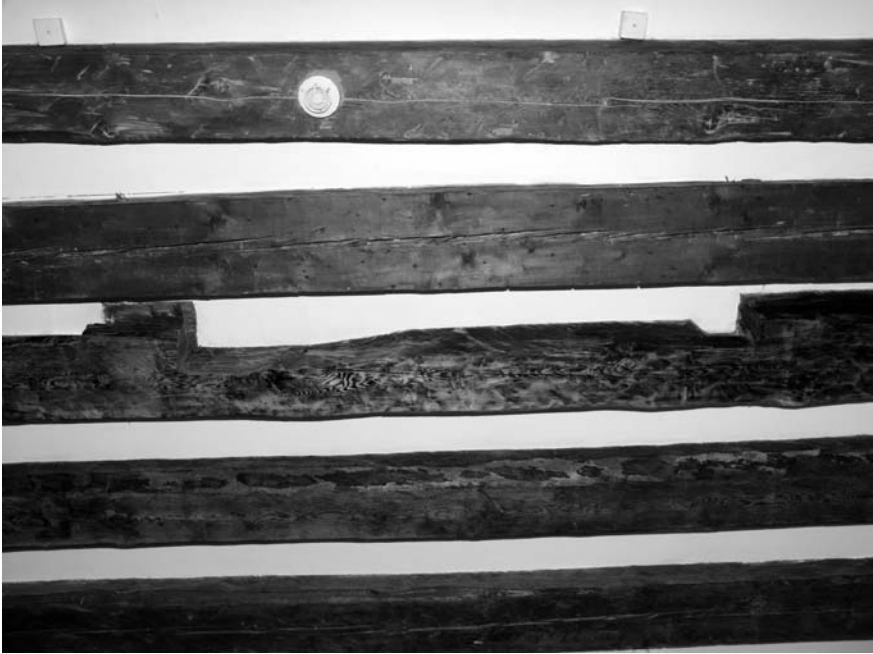
Fig. 17. Reused beams on the first storey. Photo by Heidi Tooming.

The northern room of the first floor, or the entresol, in the abbess's residence is covered with a beam ceiling but, unlike the basement and the ground floor, the beams here are placed on a north-south axis (Fig. 16); they were also never painted afterwards. Some of the timber in the ceiling had earlier been used in other constructions (Fig. 17). The entrance of the wall staircase leading to the lower storey is located in the northern wall of the room. Next to the entrance is a deep, 150-cm-wide niche, going through almost the entire wall thickness, which was later turned into a window (Fig. 18). Research has not established the function of the first floor rooms in the abbess's residence. No traces of any heating system have been found either (there might have been stoves), so the rooms could have been used temporarily and seasonally for work.

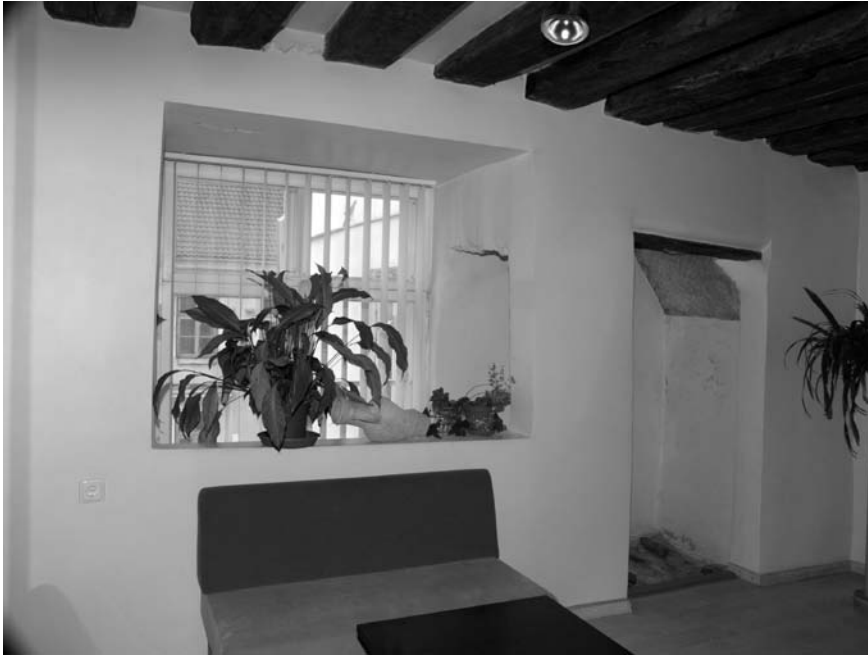
Fig. 18. Niche in the northern wall, later turned into a window. Photo by Heidi Tooming.

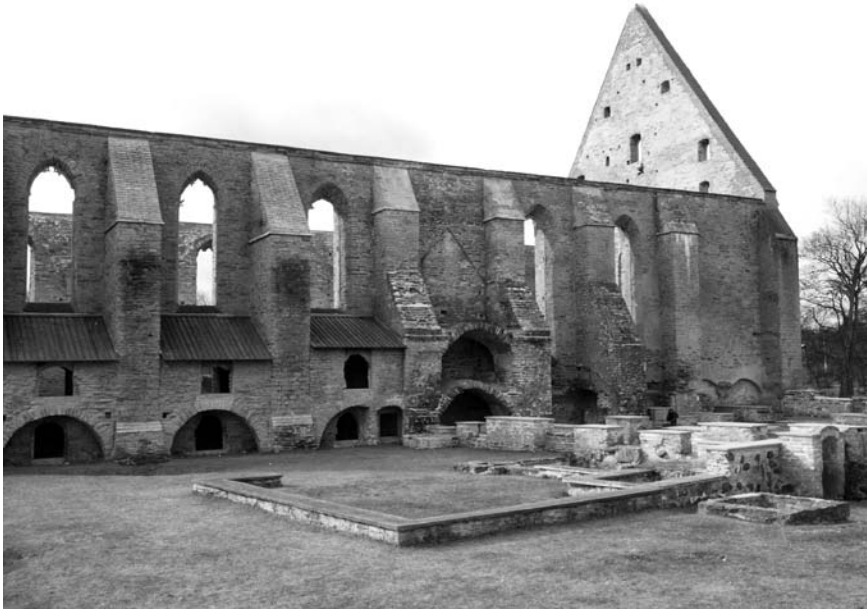
Fig. 20. Excavated and conserved foundations of the abbess's residence.
Photo by Heidi Tooming.

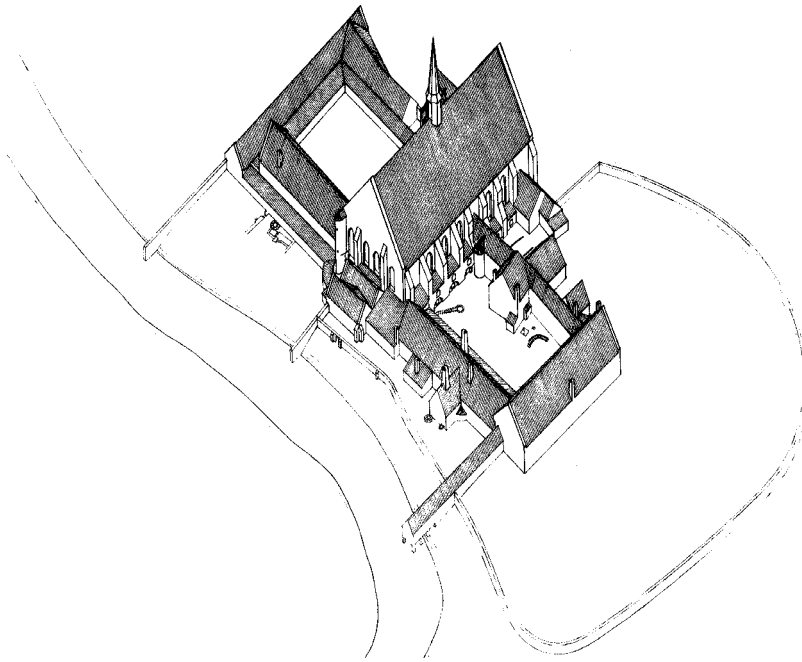
Fig. 21. Reconstruction of the first abbess's residence at Pirita. North-eastern view. Reconstruction by Villem Raam and Kalle Põllu.

As was already mentioned, the main floor of the abbess's house was wooden, and thus there is no data about its original external shape. The first reconstruction often presented in various publications³⁸ is no more than an architectural drawing as conjectured by the researchers of the convent (Fig. 21). After all, the building meant for the abbess and provided with a live-in basement was originally supposed to be only a temporary residence. According to the general plan, the first house had to be demolished after the abbess's quarters were established in the western wing of the nuns' closure. The reason

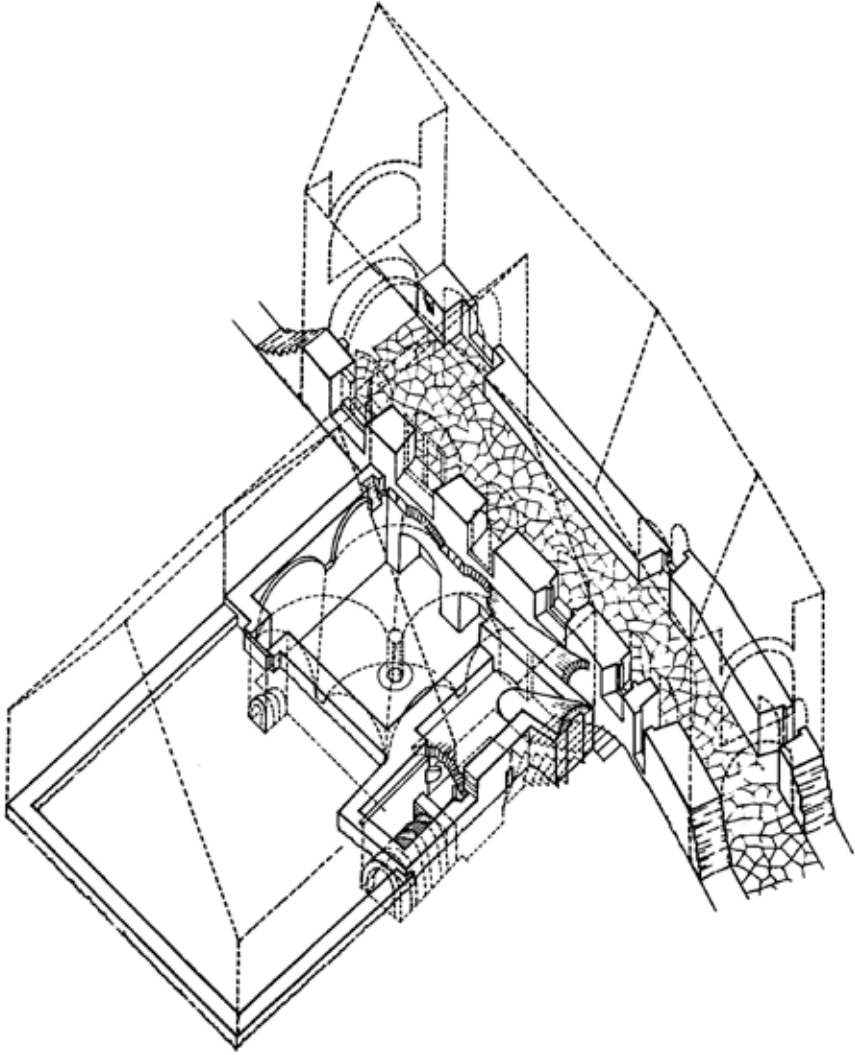
Fig. 22. Reconstruction of the second abbess's residence at Pirita. North-eastern view. Reconstruction by Villem Raam, Jaan Tamm and Kalle Põllu.
