THE SECOND RESTORATION OF THE WESTERN GATEWAY OF THE VARBOLA HILLFORT

Ülle TAMLA

RESTORATION OF THE DILAPIDATED GATEWAY IN 2006

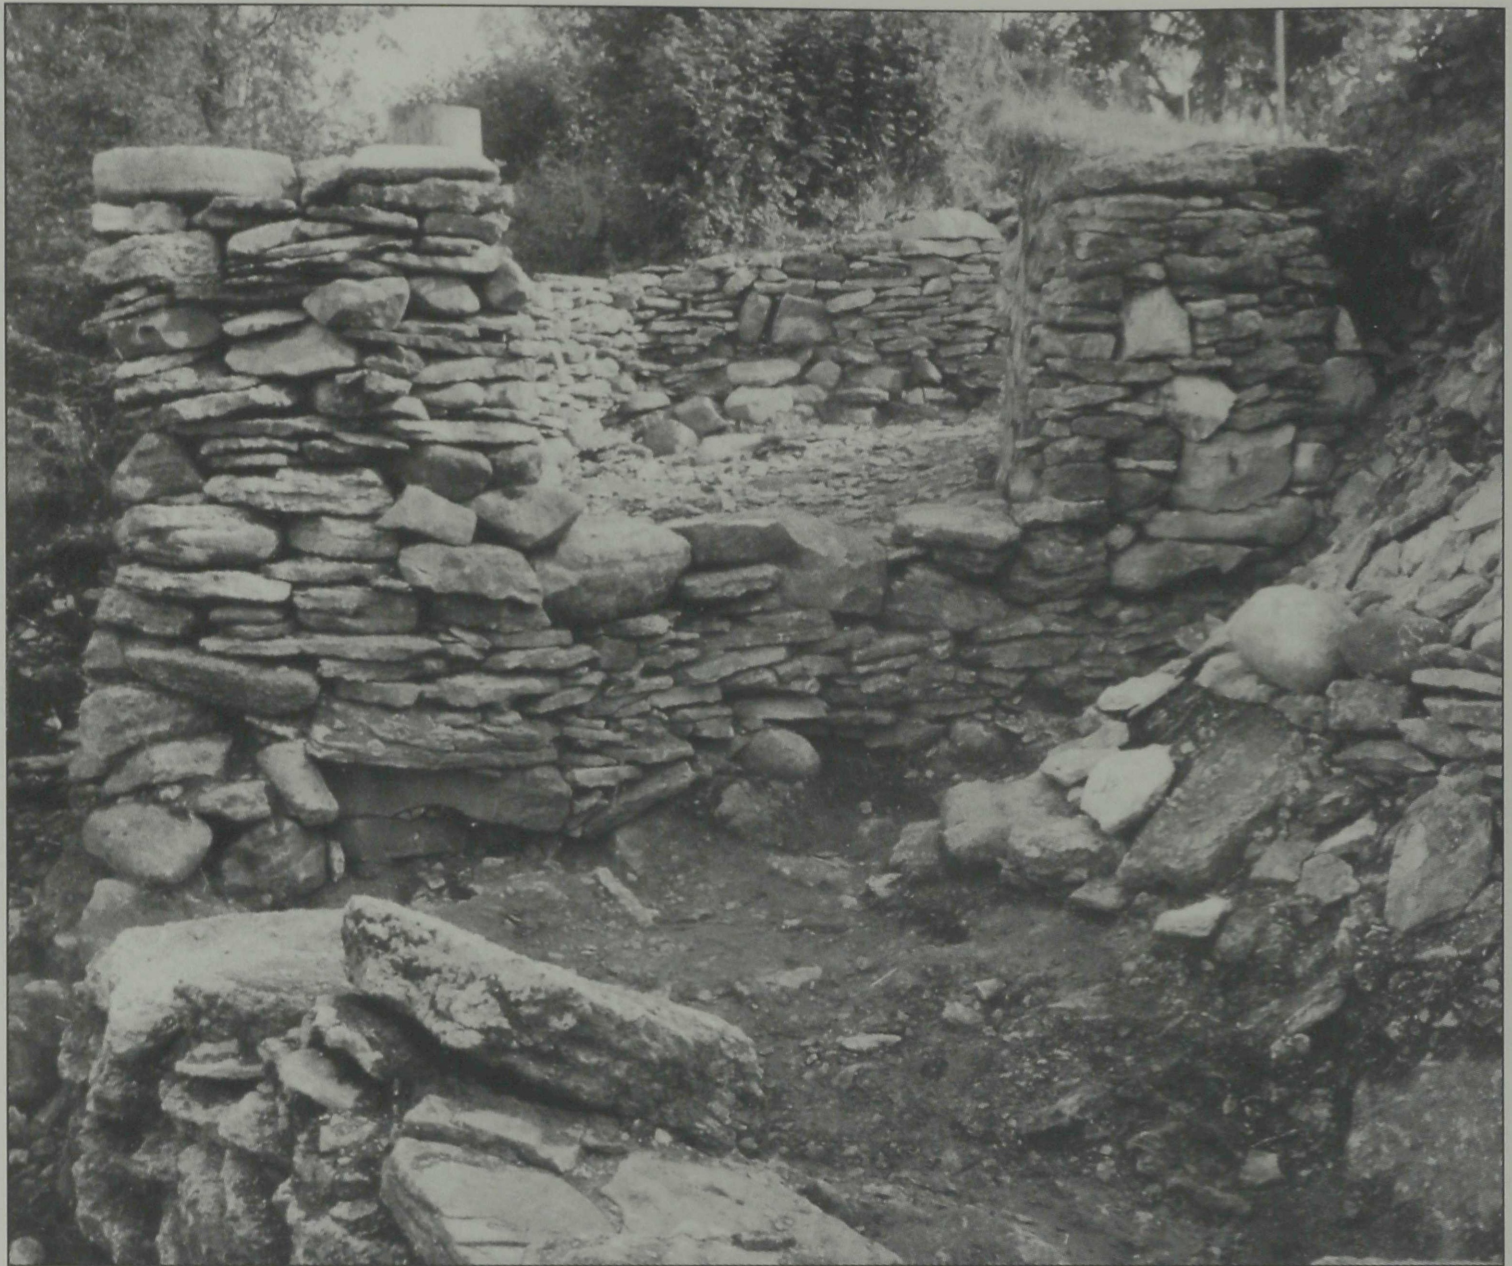
A surprising and exceptional discovery, at least in the context of Estonian prehistoric construction archaeology, was the 0.7–0.8 m high step of limestone slabs in front of the outer end of the gateway (Fig. 3). Since deep postholes were also discovered at each end of the step, it can be assumed that it supported a bridge-like construction, maybe even a drawbridge or a platform to prevent the enemy's intrusion into the fortress (Тамла & ТЫНИССОН 1988, 351, Fig. 1). It remained unclear where exactly the gate was located in the gateway, and whether there was one or several gates. The most probable location of the gate was the place where two mighty beams were placed close to each other in each wall of the gateway. Also more charcoal was preserved here than in other places, and their ¹⁴C-analyses gave the result 845±35 BP. With dendrochronological adjustment the

Fig. 3. Step of limestone slabs in front of the outer end of the gateway.

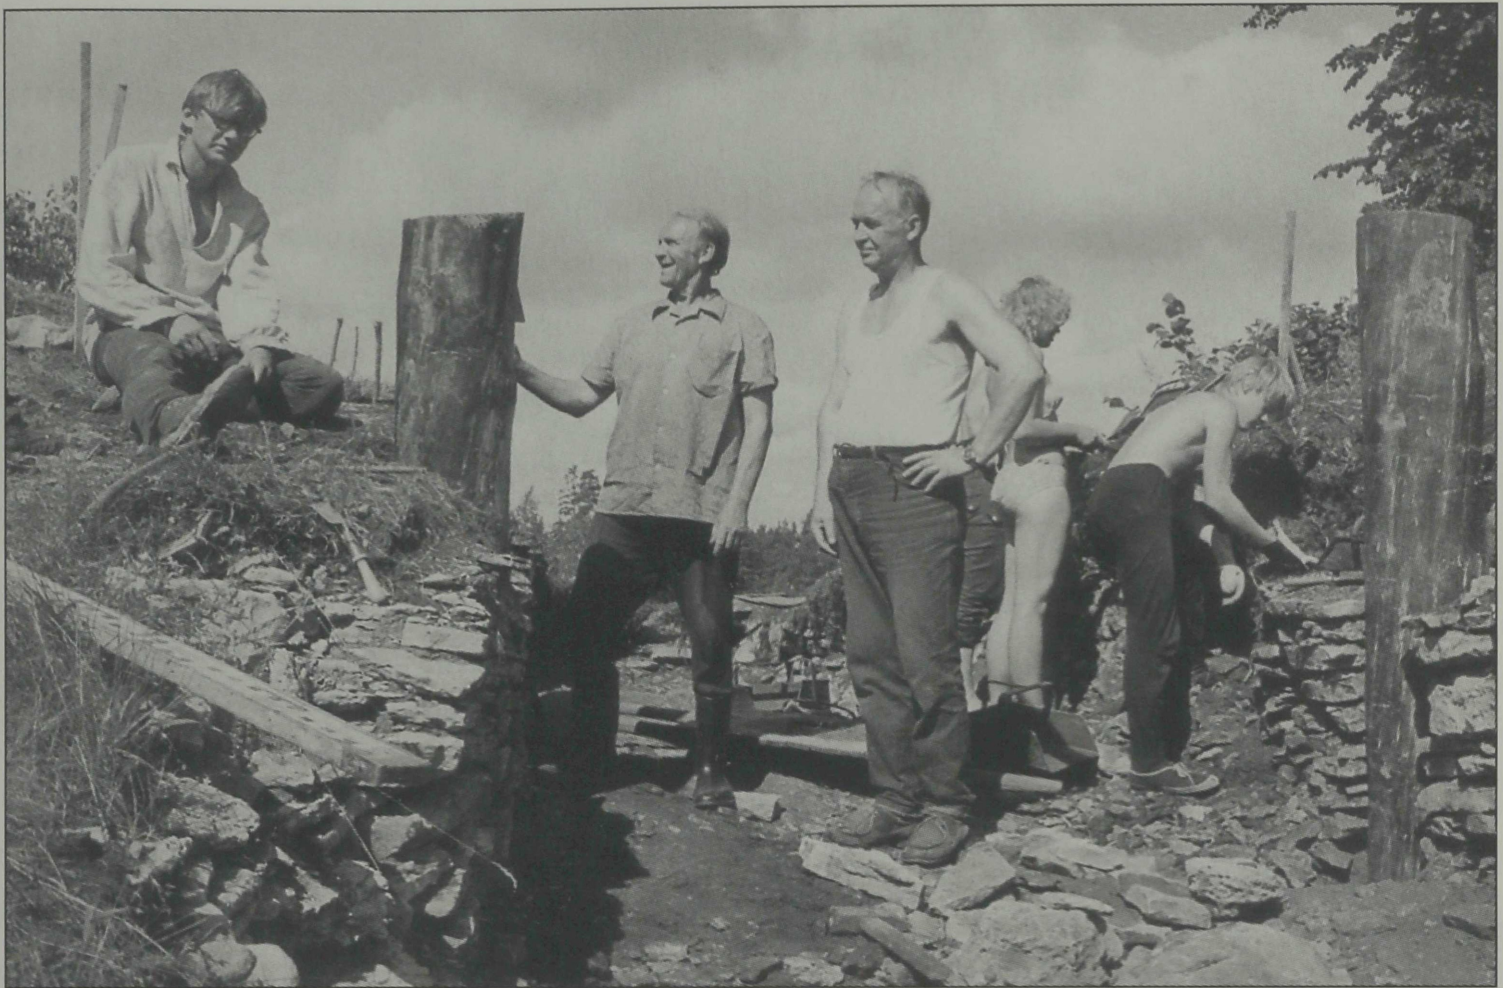
Simultaneously with archaeological excavations the restoration of the western gateway started in 1985. The two basic principles of the work (which was completed in autumn 1989) were that as much as possible must be preserved of the original wall construction of the gateway, and the dilapidated or completely

Fig. 4. The first restoration of the western gateway in 1985.

destroyed parts must be restored so that the general appearance of the gateway would be historically correct. Therefore the rear wall of the southern side was preserved as it had come to light in the course of the excavations. Of the front wall the 1.0–1.3 m high sections between the posts were preserved (Fig. 2). Since the limestone slabs of the front wall were heavily damaged by fire, new stones were laid upon the original construction to stop the dilapidation. The new posts placed in the existing gaps also helped to preserve the front wall (Fig. 4). Suitable beams for the posts were cut in the nearby forest, where six dead pines with a diameter of 40–45 cm were chosen for that purpose.
