Villu Kadakas

## NEW DATA ON THE FIRST STONE CHURCH OF JÕELÄHTME

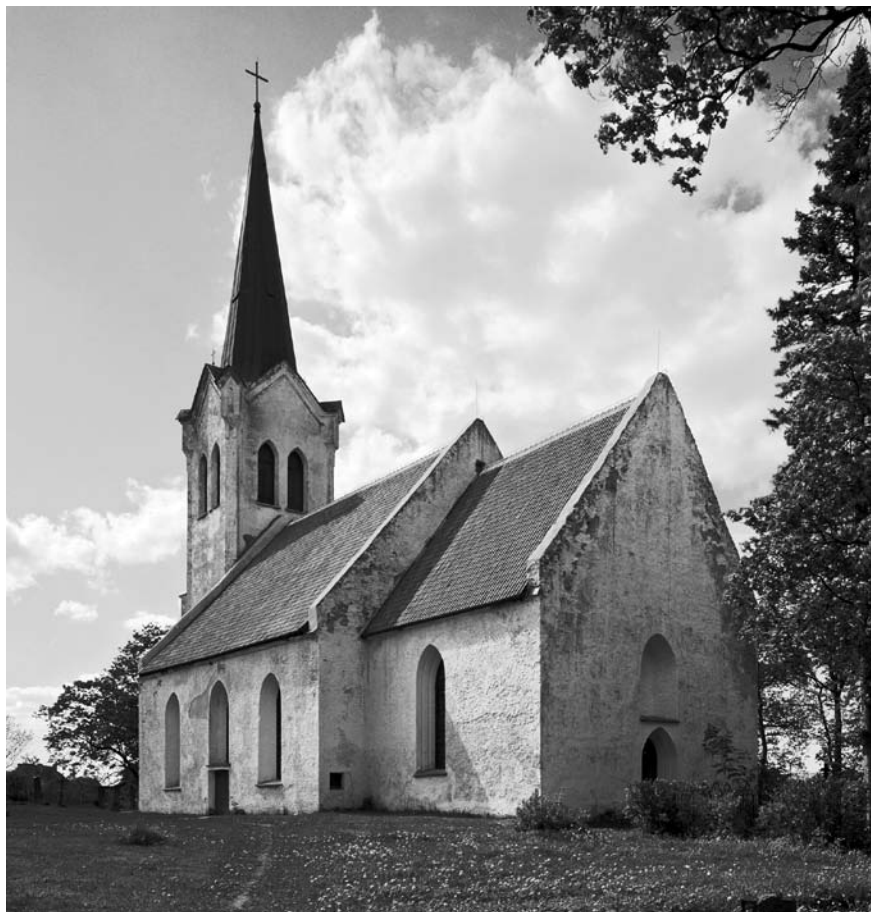
Fig. 2. Jõelähtme church from the south-east. Photo by Peeter Säre.

The present limestone church building consists of a square three-aisled nave, a rectangular vaulted chancel and a western tower (Fig. 2). Raam identified the present nave as the oldest part of the building, erected by about 1330, at the latest. The nave is approximately in the shape of a square, which is quite exceptional among the medieval churches in Estonia. For some reason, the eastern wall of the nave is significantly shorter (about 65 cm; the full length is about 13.1 m inside) than the rest of the walls (about 13.8 m inside). The first nave had no separate chancel. According to Raam's interpretation, the first stone nave, built in the period of Danish rule, originally had an exceptional

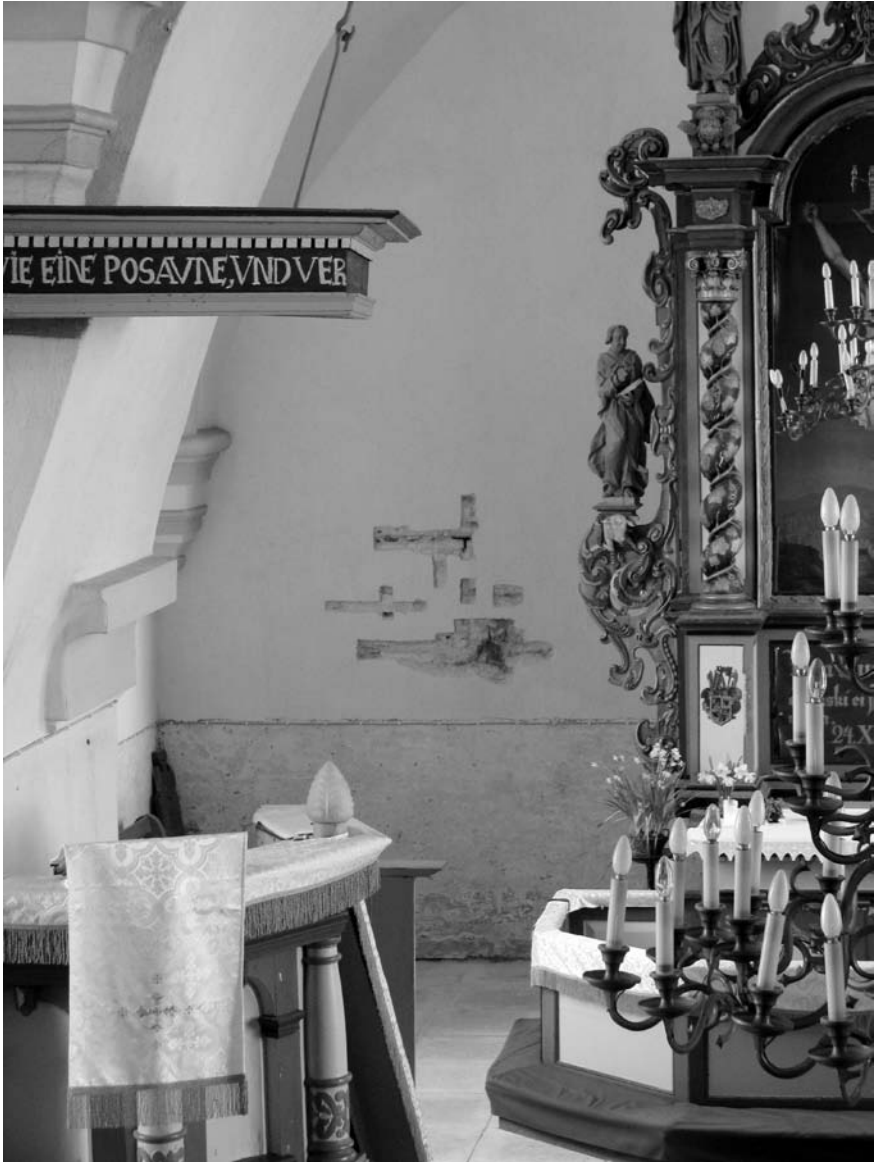
Fig. 4. Discovering the aumbry niche in the eastern wall of the chancel - plaster partly removed from the masonry (in the middle of the photo). Photo by Villu Kadakas.

The fieldwork started in the chancel and both expected liturgical niches were easily found. In the eastern part of the southern wall, a simple niche with a pointed arch was discovered. The filling masonry has not been removed yet, but probably the niche was a simple piscina (Fig. 3). The other niche was discovered in the northern part of the eastern wall. It was a simple rectangular cabinet with limestone jambs, roughly hewn and quite typical of the work of the masons of Tallinn in the late medieval period (Fig. 4). Grooves for a door and remains of iron hinges in the southern jamb indicate that it once was a closed cabinet – an aumbry would be expected in such a place. The niches do not contradict the dating by V. Raam of the chancel to the first half of the 15th century, although some irregularities in the aumbry masonry may indicate that it was added or rebuilt later. Comparing the mortar used in filling the masonry, the piscina was filled only during the 1878 interior remodeling, but the aumbry had been filled before that time, probably during the 17th or 18th century.

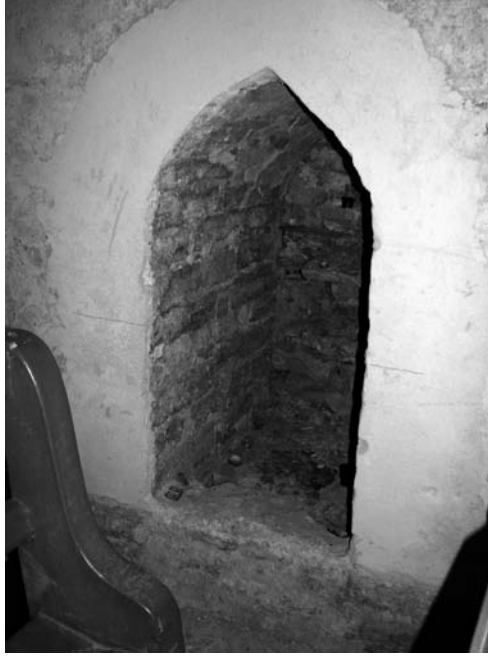
Fig. 6. Partly opened sacristy doorway.  
Photo by Villu Kadakas.

of a stone church next to an earlier wooden church was common on the Finnish mainland<sup>22</sup>, the Turku Cathedral probably being one of the best known examples<sup>23</sup>. A small part of the plaster was removed from the wall about 416 cm west of the other break as well, but no clear vertical joint was found. It is possible that the older sacristy wall was incorporated by partly demolishing the sacristy's masonry to join the two walls better, which would have left no clear vertical joint. There is another indication supporting the hypothesis. The northern wall of the nave is about 175 cm thick, but the sacristy's doorway is only about 120 cm deep. At that distance from the inner surface of the wall, the doorway ends and is blocked by later filling masonry, inserted during the 1878 work (Fig. 6). It seems that the wall of the sacristy was only 120 cm thick, i.e. part of the sacristy interior was

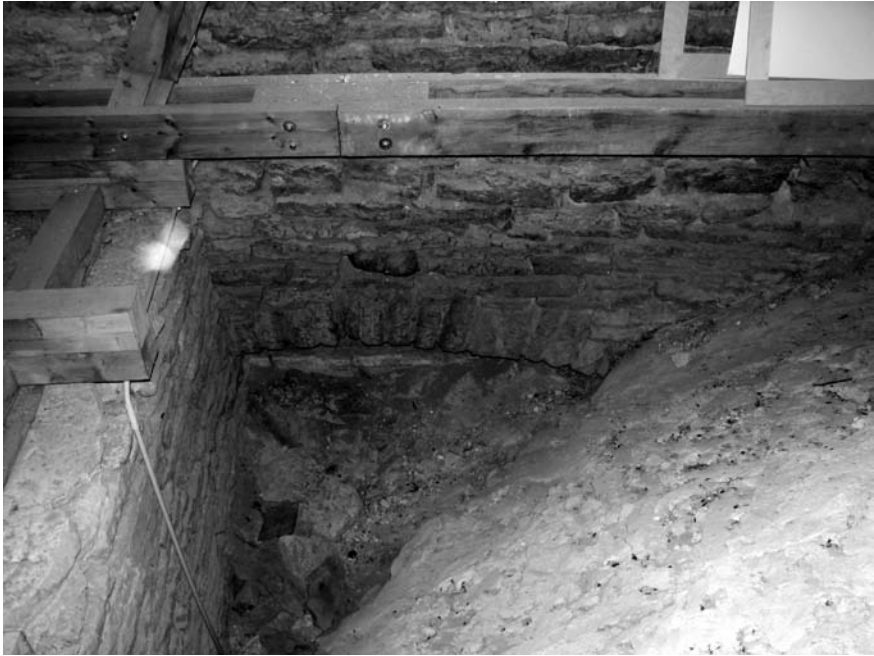
Fig. 7. Segment arch of the southern niche in the eastern wall of the nave seen above the chancel vault. Photo by Villu Kadakas.

Fortunately, the highest points of the segment arches have been preserved and are visible (Fig. 7, 8). Therefore, it is possible to measure the central axes of the niches. The extent of the niches towards the center of the façade makes it possible to calculate their minimum width (about 290 cm) and maximum width (about 470 cm). In an unpublished report, Raam used the bigger number to describe the niches<sup>26</sup>, but has not repeated this in publications, probably doubting the measurements himself. Comparing the measurements indicated that the central axes of the niches have been set on the unpublished drawings and the single published plan misleadingly incorrect<sup>27</sup>. The
