Villu Kadakas

NEW DATA ON THE FIRST STONE CHURCH OF JÕELÄHTME

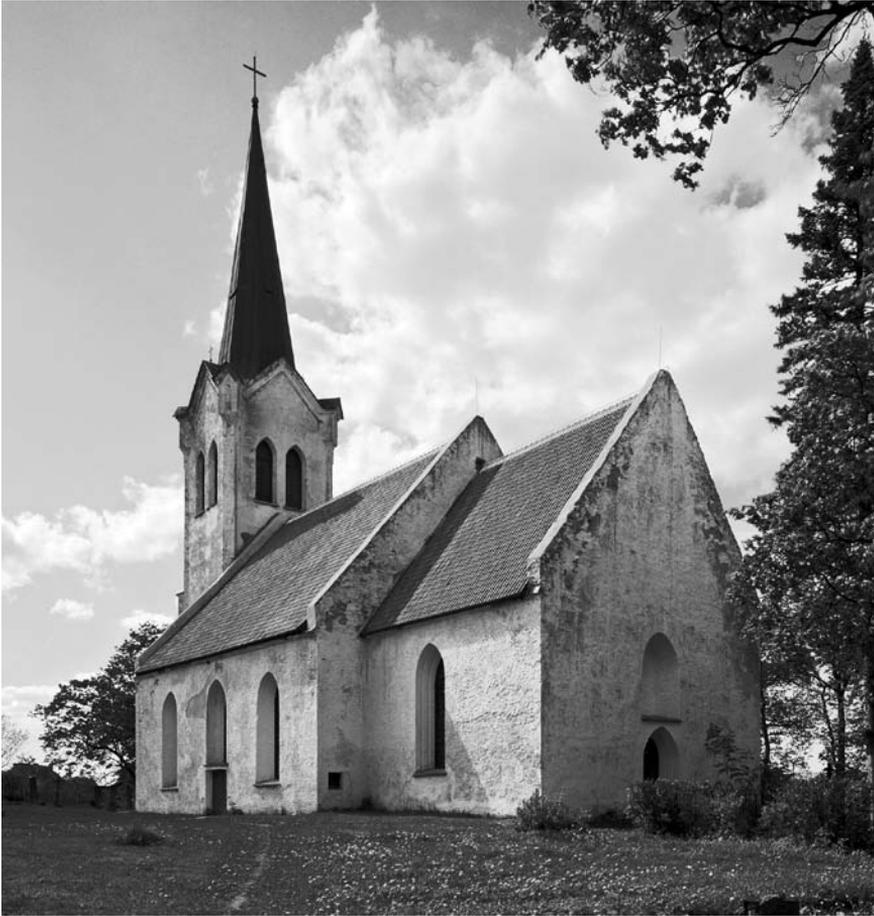
Fig. 2. Jõelähtme church from the south-east. Photo by Peeter Säre.

The present limestone church building consists of a square three-aisled nave, a rectangular vaulted chancel and a western tower (Fig. 2). Raam identified the present nave as the oldest part of the building, erected by about 1330, at the latest. The nave is approximately in the shape of a square, which is quite exceptional among the medieval churches in Estonia. For some reason, the eastern wall of the nave is significantly shorter (about 65 cm; the full length is about 13.1 m inside) than the rest of the walls (about 13.8 m inside). The first nave had no separate chancel. According to Raam's interpretation, the first stone nave, built in the period of Danish rule, originally had an exceptional

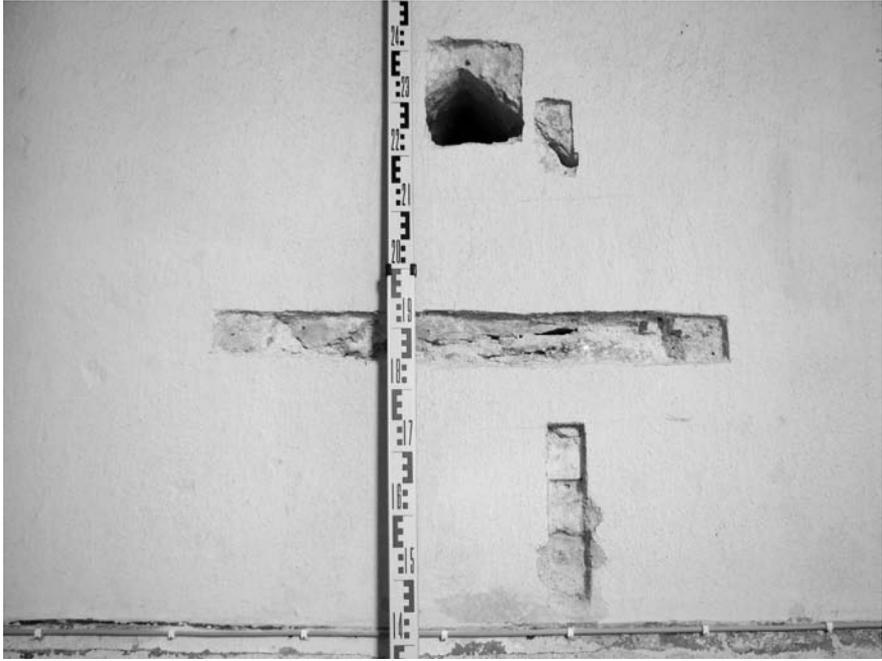
Fig. 3. Outlines of the piscina niche with a pointed arch in the southern wall of the chancel. Photo by Villu Kadakas.

The fieldwork started in the chancel and both expected liturgical niches were easily found. In the eastern part of the southern wall, a simple niche with a pointed arch was discovered. The filling masonry has not been removed yet, but probably the niche was a simple piscina (Fig. 3). The other niche was discovered in the northern part of the eastern wall. It was a simple rectangular cabinet with limestone jambs, roughly hewn and quite typical of the work of the masons of Tallinn in the late medieval period (Fig. 4). Grooves for a door and remains of iron hinges in the southern jamb indicate that it once was a closed cabinet – an aumbry would be expected in such a place. The niches do not contradict the dating by V. Raam of the chancel to the first half of the 15th century, although some irregularities in the aumbry masonry may indicate that it was added or rebuilt later. Comparing the mortar used in filling the masonry, the piscina was filled only during the 1878 interior remodeling, but the aumbry had been filled before that time, probably during the 17th or 18th century.

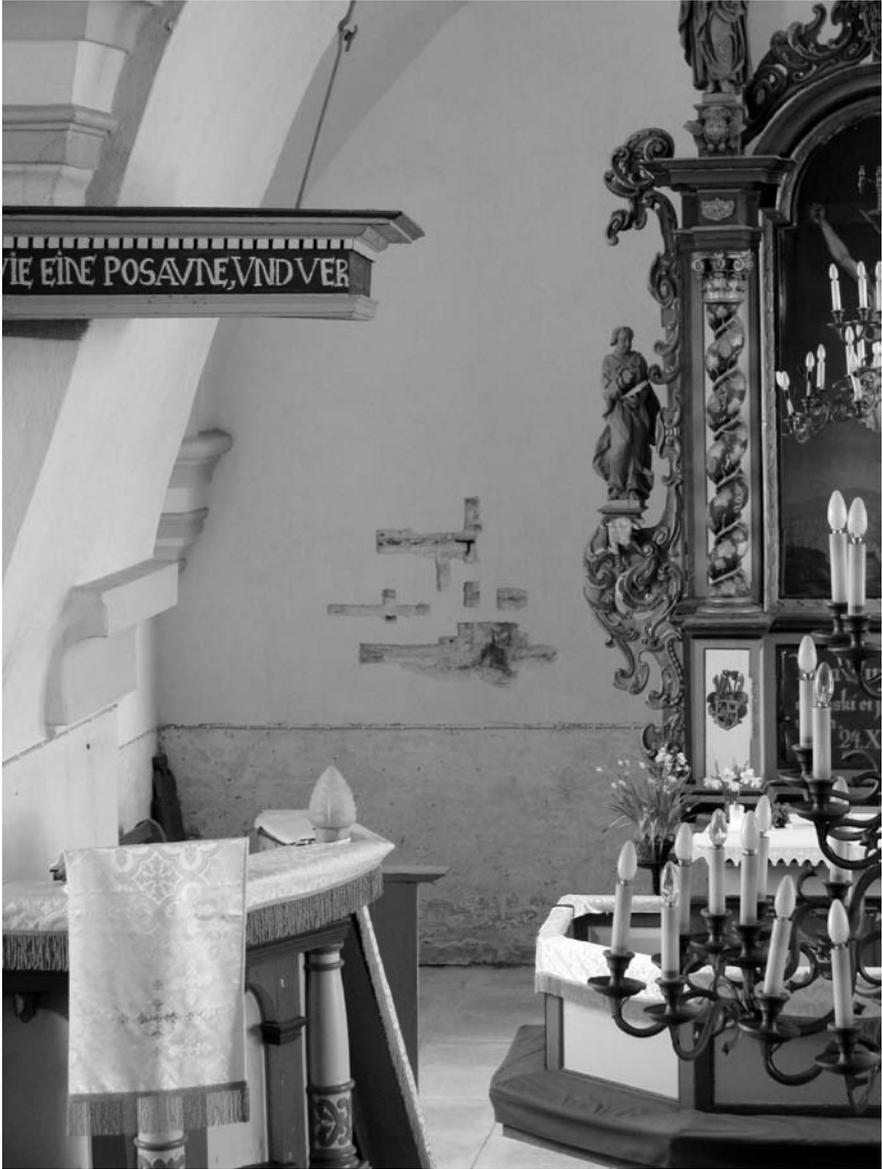
Fig. 4. Discovering the aumbry niche in the eastern wall of the chancel - plaster partly removed from the masonry (in the middle of the photo). Photo by Villu Kadakas.

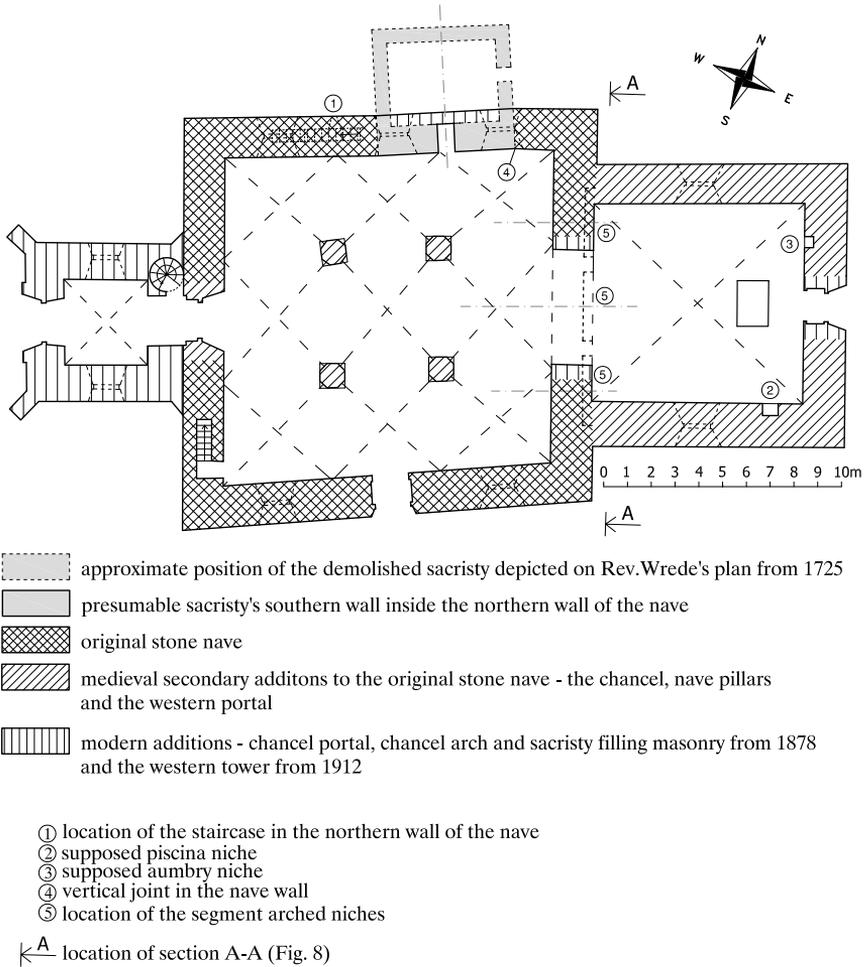
Fig. 5. Ground plan of Jõelähtme church below window level. Plan by Villu Kadakas (based on the plan by R. Jaaksoo).

²¹ The plan is based on the measured plan by R. Jaaksoo. See R. Jaaksoo, *Jõelähtme vald. Jõelähtme kirik. Ülesmõõtmisjoonised* (Tallinn, 1951, Manuscript in MKA, Ü-152).

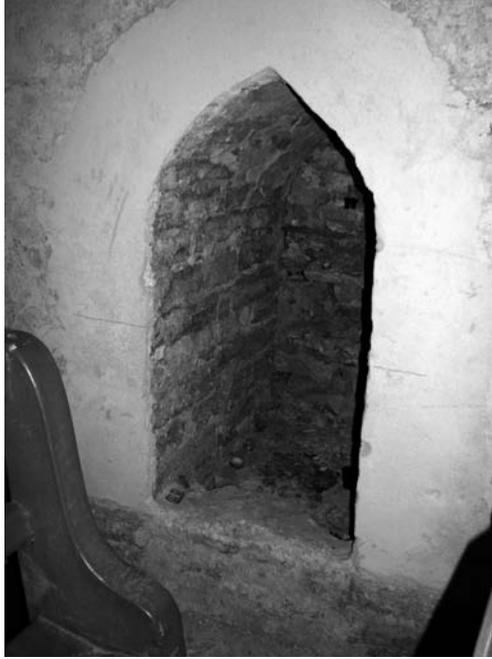
Fig. 6. Partly opened sacristy doorway.
Photo by Villu Kadakas.

of a stone church next to an earlier wooden church was common on the Finnish mainland²², the Turku Cathedral probably being one of the best known examples²³. A small part of the plaster was removed from the wall about 416 cm west of the other break as well, but no clear vertical joint was found. It is possible that the older sacristy wall was incorporated by partly demolishing the sacristy's masonry to join the two walls better, which would have left no clear vertical joint. There is another indication supporting the hypothesis. The northern wall of the nave is about 175 cm thick, but the sacristy's doorway is only about 120 cm deep. At that distance from the inner surface of the wall, the doorway ends and is blocked by later filling masonry, inserted during the 1878 work (Fig. 6). It seems that the wall of the sacristy was only 120 cm thick, i.e. part of the sacristy interior was

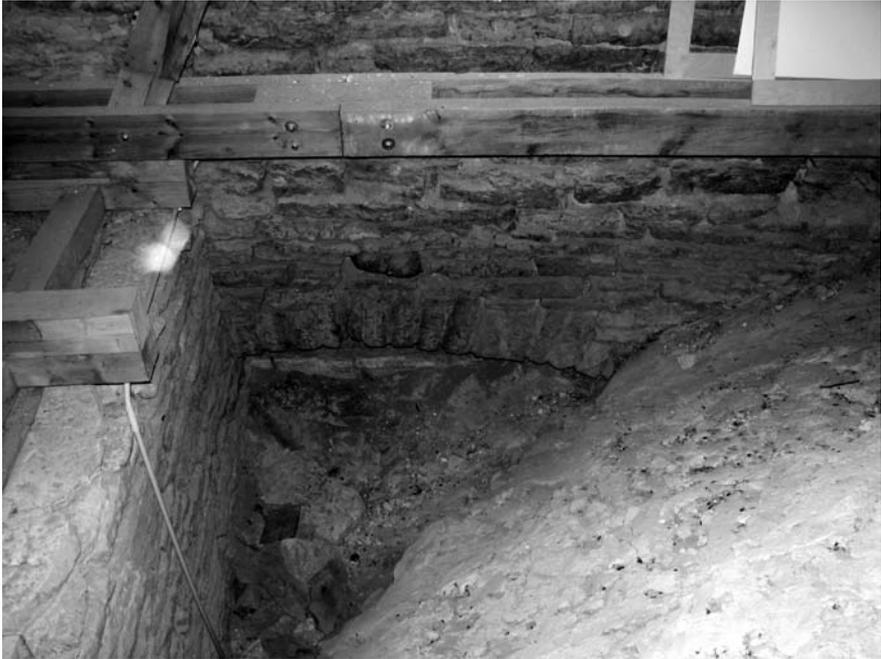
Fig. 7. Segment arch of the southern niche in the eastern wall of the nave seen above the chancel vault. Photo by Villu Kadakas.

Fortunately, the highest points of the segment arches have been preserved and are visible (Fig. 7, 8). Therefore, it is possible to measure the central axes of the niches. The extent of the niches towards the center of the façade makes it possible to calculate their minimum width (about 290 cm) and maximum width (about 470 cm). In an unpublished report, Raam used the bigger number to describe the niches²⁶, but has not repeated this in publications, probably doubting the measurements himself. Comparing the measurements indicated that the central axes of the niches have been set on the unpublished drawings and the single published plan misleadingly incorrect²⁷. The

It appeared that the closer ends of the arches have been fully demolished, but the vertical back walls of the niches continue further towards the middle axis of the church. It seems that these continuations of the back walls of the niches do have a demolished surface, indicating that the jambs of the niches have been demolished in exactly these places. As very little of this demolished back wall masonry is visible for study, this conclusion is not clear and it cannot be excluded that the niches extended further towards the central axis of the church, although it seems improbable.

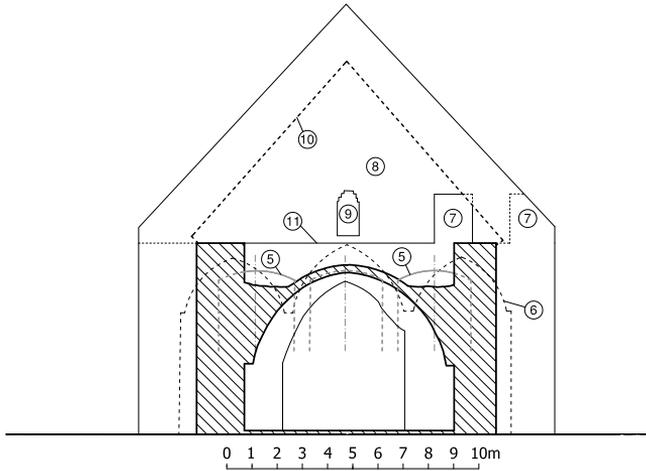
- ⑤ contours of the segment arched niches
- ⑥ contours of the nave interior
- ⑦ earlier masonry on the north-eastern corner of the nave - supposedly remains of a quadrangular turret
- ⑧ nave's eastern gable masonry
- ⑨ doorway in the nave's eastern gable
- ⑩ outline of the chancel's roof
- ⑪ horizontal joint between the eastern wall of the nave and the gable

Fig. 8. Cross-section A-A of the chancel. Segment arched niches in the eastern façade of the nave. Drawn by Villu Kadakas.
