Archaeological studies in the church of Juuru

Villu Kadakas

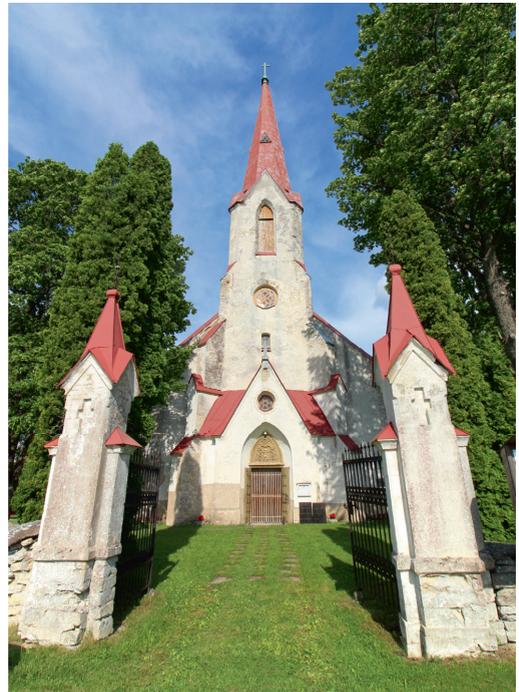
Fig. 1. *Juuru church from the west.*

The rural parish church of St Michael¹ in Juuru (Germ. *Joerden*) that today belongs to the local Lutheran congregation, is situated in the southern part of the historic province Harjumaa, ca. 45 km south from Tallinn. The church (Fig. 1) has been standing on the crossing of local roads, far from strategic roads and administrative centres. The archaeological research in the church (for a short summary in Estonian, see Kadakas 2017b) was undertaken because of the replacement of the rotten timber floor with a new one in the south-western corner of the nave and the western part of the southern range (Fig. 2). A ca. 15–20 cm thick layer of upper soil, consisting of various demolition and construction debris was removed. It was decided to peel off the upper soil, which had been contaminated by fungus, to keep the pollution from spreading and to provide a solid base for the new floor.

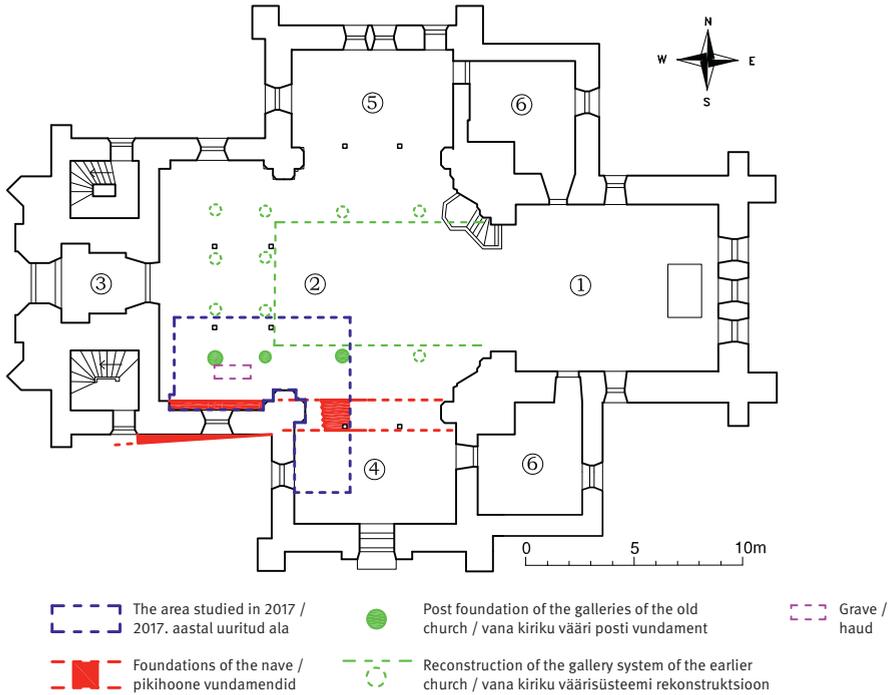
Fig. 2. Plan of Juuru church. 1 – chancel, 2 – nave, 3 – western tower, 4 – southern range, 5 – northern range, 6 – sacristy.
Jn 2. Juuru kiriku plaan. 1 – kooriruum, 2 – pikihoone, 3 – läänetorn, 4 – lõunatiib, 5 – põhjatiib, 6 – käärkamber.
 Drawing / Joonis: Villu Kadakas

As expected, the inner edge of this foundation came to light during the floor replacement of 2017 (Figs 2, 4). This inner edge of the foundation is in correspondence with the medieval side wall of the nave, depicted on the plan by Bernhard: the medieval wall has been wider inside than the present one, running also between the wall buttresses. As a surprise, the inner edge, in contrary to the outer one, runs parallel to the wall. Because of limited possibilities to study the foundations, it remained unclear, if this foundation comes from the medieval period or has been built in 1893–1895 together with the new wall.

Another section of foundation of the southern wall of the nave came to light under the arch between the nave and the southern range (Figs 2, 5). This 1.4 m thick section must come from the medieval church without doubt, because it has no function after the reconstruction of 1893–1895. Distinctively, it has been cut close to the wall pillar, which gives credit to the theory that new foundations were built for the new walls. This foundation came to light in a very limited extent, which does not enable to correctly assess its alignment regarding the new church walls. However, no misalignment could be detected.

It is common in the rural parish churches of Estonia, especially in the smaller ones, that a large part of the medieval floor has been disturbed while digging graves during the Early Modern period. As a surprise, in the studied area of the nave of Juuru church, place of only one grave was detected (Figs 2, 4). A rectangular area of loose soil within the hardened soil of the Late Medieval floor was very distinctive. Consequently, the south-western part of the nave of Juuru church has not been a popular burial ground.

Three more or less round foundations with a diameter of 45–60 cm were discovered, aligned in east-west direction (Figs 2, 4). These have been cut into the hardened soil of the Late Medieval floor. Based on their location and context, it can be assumed that these once carried the posts or columns of an Early Modern gallery system. Although only three foundations were discovered, the shape of the room, principles of symmetry and geometry enable to reconstruct the number and location of all posts and the overall extent of the galleries. Distinctively the easternmost post has been positioned at a longer distance than the two others from each other. It is likely that the two westernmost posts supported the organ gallery. It probably filled the whole western part of the nave to the same extent as the existing one, but was supported by eight posts, aligned in two rows (Figs 2, 3). The third discovered post foundation probably supported a southern gallery. The distance of the foundation from the western gallery and its location suggest that with the help of only one more post the southern gallery could have

Looking at this reconstruction attempt of the gallery system (Figs 2, 3), it is obvious that there was really a serious lack of space in the old nave by the end of the 19th century. This can be explained by a rather small area of the old nave (*ca.* 160 m²). The upper space was probably filled with galleries in the highest possible extent: the area without galleries was only roughly as wide as the chancel arch and made up only about 1/3 of the total area of the nave.

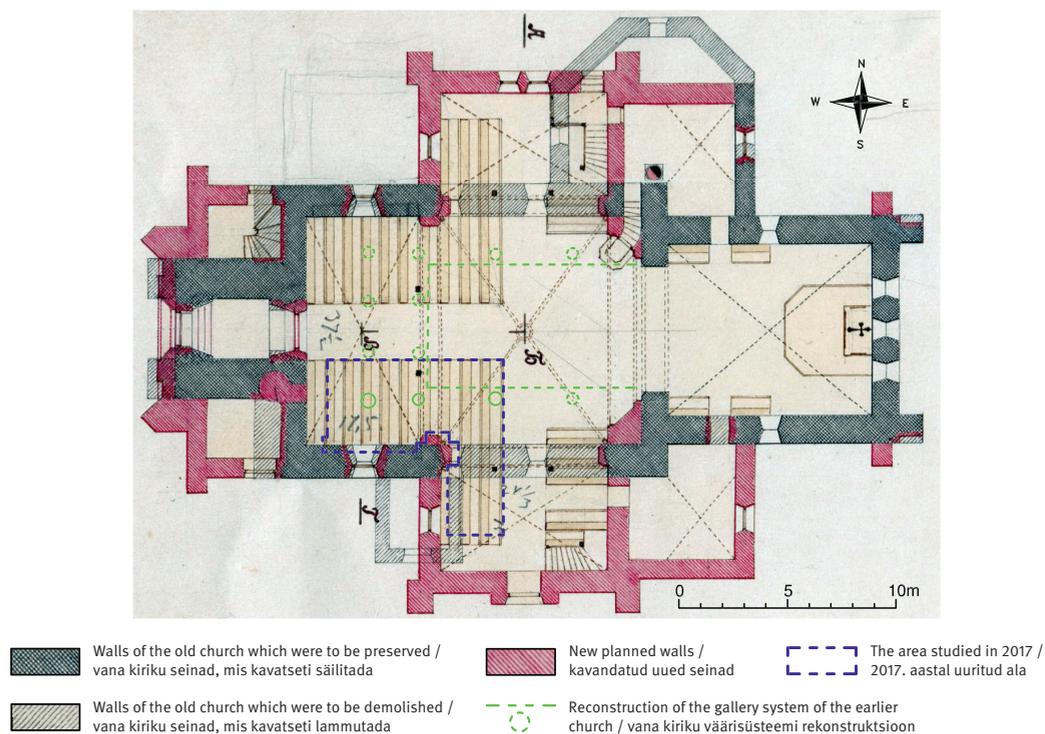
Fig. 3. Plan of Juuru church. Drawing from 1893. Rebuilding plans of the old church
Jn 3. Juuru kiriku plaan. Joonis 1893. aastast. Vana kiriku kavandatud ümberehitused.
 (RA EAA.33.3.2012)

Drawing / Joonis: Erwin Bernhard, additions / täiendused: Villu Kadakas

According to the ground plan of Bernhard the eastern wall of the southern porch should have come to light (Fig. 3). Unfortunately, only mixed soil with demolition debris was detected in the upper layers in this area,

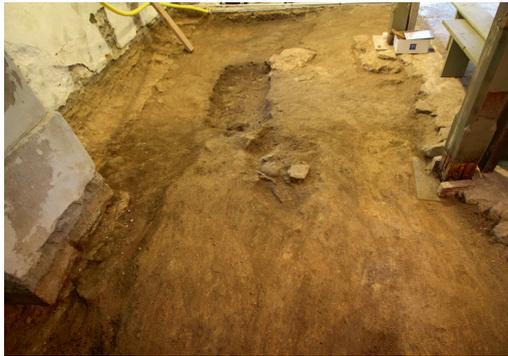
Fig. 4. Hardened soil of the late medieval floor in the south-western part of the nave. Foundation of the southern wall of the nave (left above), single grave, foundations of a previous gallery posts (middle), existing gallery posts with a square floor slab for foundation (right).

The uppermost layer consisted of loose soil mixed with demolition debris, where some copper coins from the late 17th until the 19th centuries could be collected. Based on analogies (Risti church: Kadakas *et al.* 2012, 179; Haljala church: Kadakas 2017a, 115), it can be supposed that this area was covered with timber pews on top of a timber floor during the 17th–19th centuries, and that the coins have probably got under the floor through the gaps between the floorboards. It can also be supposed that during the same period the central walkway was covered with regular square limestone slabs (52 cm = *ca.* 1 ell of Tallinn). Today the walkways are covered with larger slabs, but some slabs of the old standard were discovered. These have been reused in 1893–1895 for the foundations of the posts of the new organ gallery (Fig. 4).

Under this loose Early Modern layer, a hardened soil layer with a lot of organic material was discovered all over the studied area of the nave (Fig. 4). In spite of the construction plan, which prescribed to remove the soil even deeper, this hardened layer was preserved, as proposed by the archaeologist, because no contamination of it with fungus was likely. In order to get basic information about the function and age of this layer, some coins were detected with a metal detector and gathered. All these appeared to be coins from the 15th and 16th centuries, until the rule of the Swedish king Johan III. Therefore, this hardened layer can be interpreted as a floor of the corresponding period. No information was obtained whether this hard soil functioned as the floor surface itself or if it was covered with additional material, e.g. limestone slabs.

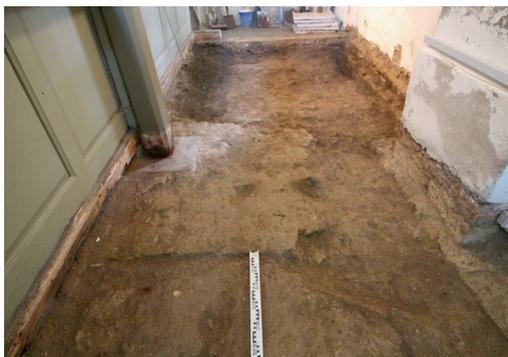
Fig. 5. The foundation of the southern wall of the old nave between the nave and the southern range.

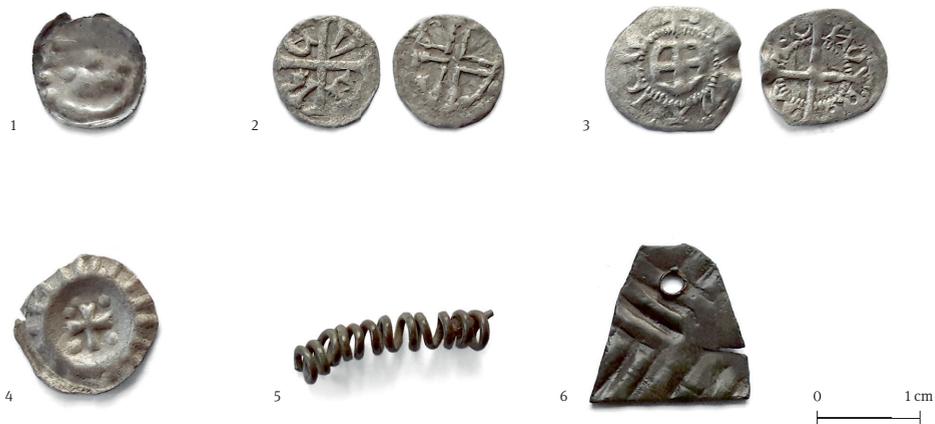
Fig. 6. Artefacts. 1 – Bracteate (1265–1332), 2 – seestling (1395–1398), 3 – penny (1422–1555), 4 – scherf (1426–1480), 5 – spiral tube decoration, 6 – trapezoid pendant.

The fieldwork of 2017 brought to light *ca.* 40 artefacts, including 26 single coins. Some finds – a fragment of a copper alloy spiral tube decoration (Fig. 6: 5) and a piece of wheel-thrown local pottery – may have little to do with the church, but might originate from an Iron Age burial site (see above). A decorated trapezoid copper alloy pendant (Fig. 6: 6) belongs to a type, which has been found from Lügänuuse church (Kadakas & Jonuks 2014, 144).

The early church period is represented by a single coin – a Danish bracteate with an image of a crown (1265–1332; Fig. 6: 1). Such so-called crown bracteates have not been found from the context of churches in Estonia. The coins minted slightly before the monetary reform of Old Livonia (1422/1426) are represented only by a single *seestling* of the Teutonic Order, minted in Tallinn (1395–1398; Fig. 6: 2). The period between the monetary reform and the start of the Livonian War (1558) is represented by 8 local coins, mostly of the Teutonic Order. This collection includes 4 *scherfs* (*ca.* 1426–1480; Fig. 6: 4), an anonymous penny minted in Tallinn (*ca.* 1422–1555; Fig. 6: 3) and a schilling of master Johann Freitag vom Loringhofe (1483–1494), minted in Cēsis. The bishopric of Tartu is represented by a *scherf* of Dietrich IV
