Buildings archaeological surveys at Maasi Castle on North-East Saaremaa

Garel Püüa

INTRODUCTION

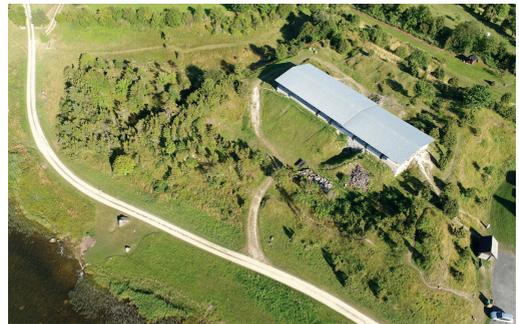
Fig. 1. The ruins and moat of The Castle of Livonian Order in Maasi. The castle's central residence was conserved and covered with a roof in 2001–2004. View towards south-east.

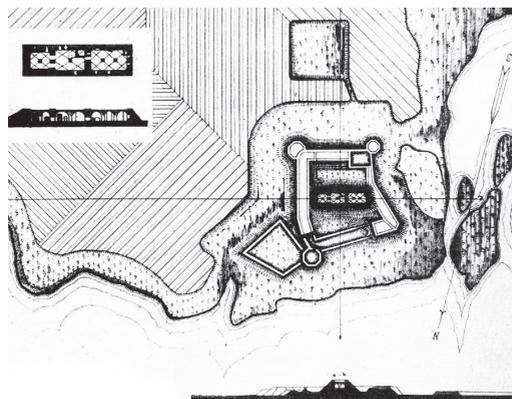
Fig. 3. Reinhold Guleke's reorganisation project of Maasi Castle, probably originating from the 1880s.

Kalvi Aluve used both plans (Figs 3–4) in his book, focusing on a more exact description of the castle's central dwelling. He viewed it as an extended 'dwelling tower-type' building (Germ. *Kemenate*) (46.9 × 12.2 m), not as a reduced single wing of a 'Konventhaus' (Aluve 1993, 28). According to him, the 'dwelling tower-type' main building was erected in two stages. The west room, 20.8 m long and 12.2 m wide with two pillars (and with a wall thickness of 2.1–2.3 m) is the older part of the building (Fig. 5, on the left). This was later supplemented by a 26.1 metres long, uniform width extension (with a wall thickness of 2.7–3.0 m; Fig. 5, on the right). The older part may have been built by Burchard von Dreileben and extended by Goswin von Herike (Aluve 1993, 29).

The south tower of the large curtain wall was built against the second corner of the presumed building, again separated from the wall by a vertical joint. A similar tower or building is included in Reinhold Guleke's project to tidy up Maasi Castle (Fig. 3), but the drawing does not correspond to the data collected at fieldwork. Light-coloured stucco patches were preserved at the junction between the tower and the curtain wall and it is possible that, similar to Kuressaare Castle, the curtain wall of Maasi Castle was also plastered smooth on the outside, using lime grout. After documenting, it was decided not to cover the curtain wall with soil. As it did not need immediate conservation, it is well observable and provides added value to the castle as a tourist attraction.

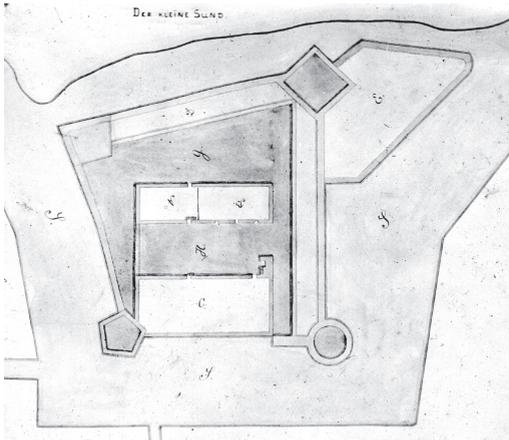
Fig. 4. Maasi Castle's main floor, as seen on the photo display of the 1904 excavations.

Oesels) arranged excavations around the Castle, which was the only major fieldwork known in the area in the 20th century. All the survey materials were eventually lost, except one general drawing and a few photos (Fig. 4).¹

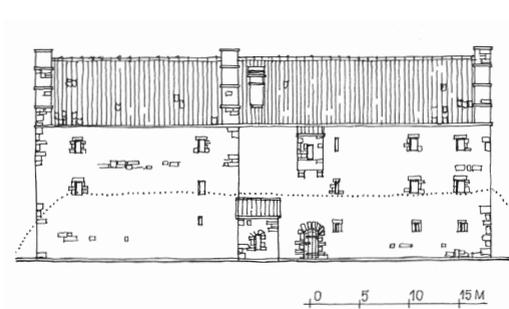
Fig. 5. A drawing of the view of the Maasi extended-dwelling-tower-type building by Kalvi Aluve (1993, fig. 96). The building's older part is on the left and the later extension is on the right. View from the south.

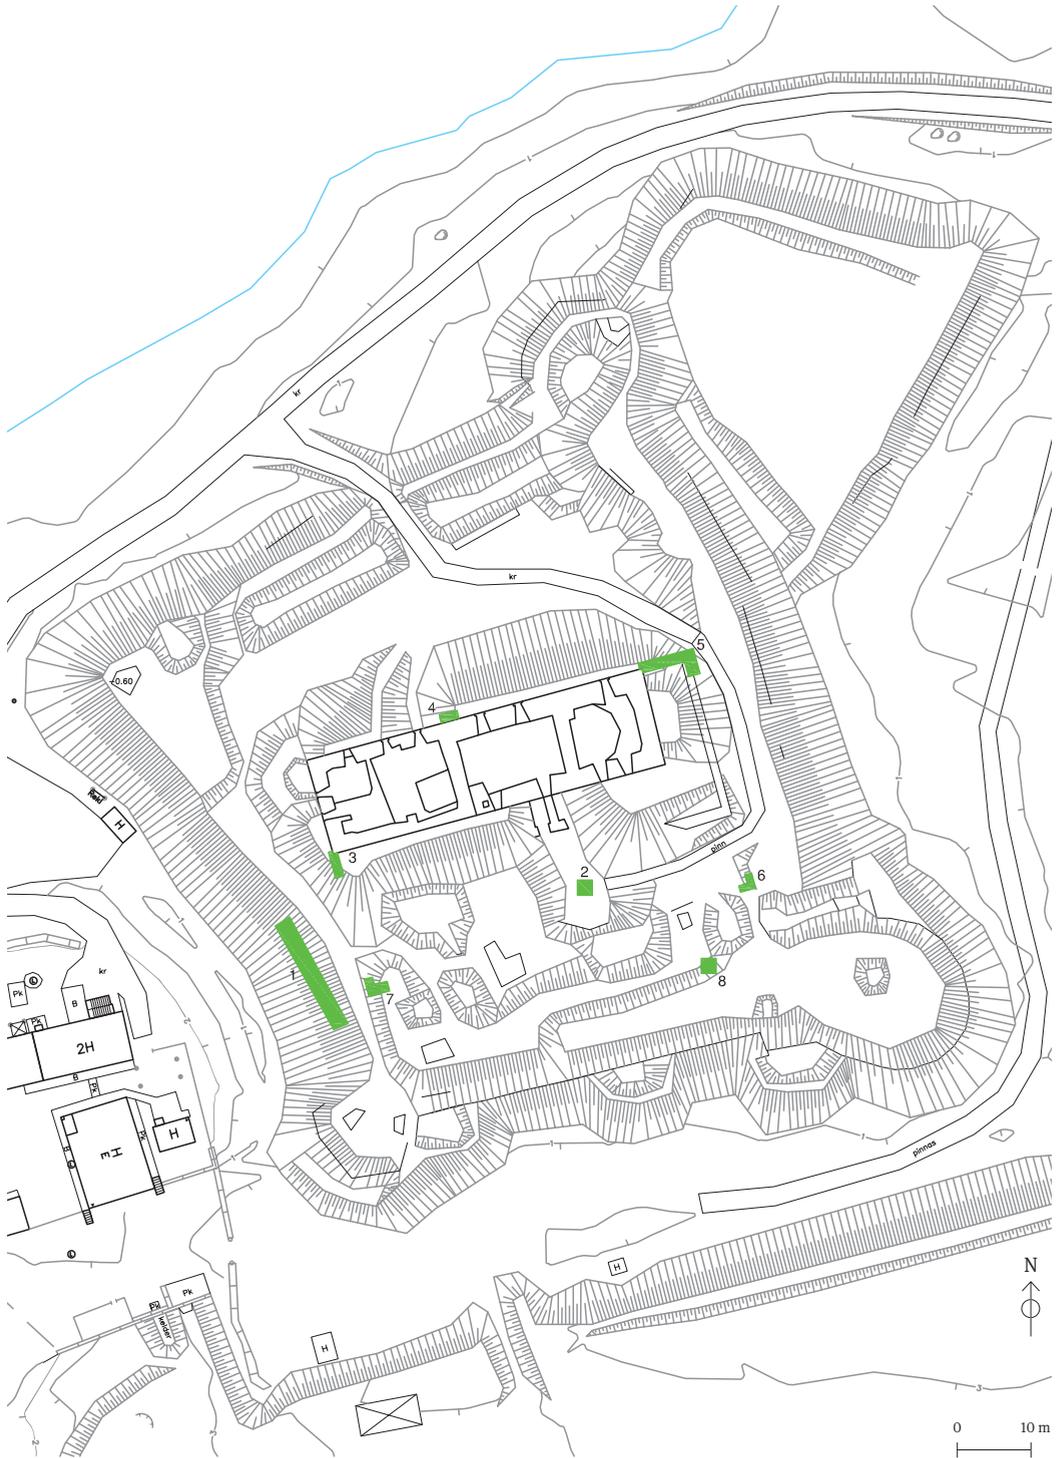
Fig. 6. Research at Maasi Castle in 2019. The schematic for pits 1–8.

The largest of the opened areas, trench no 1, covering around 125 m², was located on the western side of the castle's second curtain wall, i.e. the large wall with corner towers (Fig. 6: 1). If a gateway had been found, then it would have been possible to lead tourists from the car park directly into the castle without damaging the walls. A section of the curtain wall, approximately thirty metres wide, was cleared of rubble to the height of around 1.5–2 m, but no gate leading to the main castle was found. The wall's top was left covered with soil and grass to protect it, so the thickness of the curtain wall could not be verified.

Trench no 2 was erected on the southern side of the dwelling house (Fig. 6: 2) and was intended to determine the initial height of the castle's courtyard. The location of the trench was chosen in an area that had been least disturbed by earlier excavations. Almost immediately the last courtyard pavement which had been laid of irregularly-shaped limestone slabs was uncovered close to the level of the topsoil (the largest slab measured 60 × 33 × 9 cm). In the excavation the pavement was located at the height of 4.63–4.77 m above sea level and had been laid on a lime mortar layer about 6–7 cm thick. About 30 cm deeper (at an absolute height of 4.35–4.48 m above sea level), another presumed courtyard pavement was found, made of cobblestones and limestone (Fig. 8). From between the pavement stones, a crossbow bolt with a tang was found, dating from the end of the 14th or start of the 15th century (SM 10860: 23). The pavement stones were laid directly on a soil mixture which contained clay and crushed stone with smaller animal bones and roof tile fragments as well. The final depth of the trench remained about one metre.

Trench no 3 was established at the south-western corner of the older part of the Maasi dwelling in order to verify the continuation of the initial (first) curtain wall from the building towards the south (Fig. 6: 3). It turned out that, while constructing the building's older part (the elongated dwelling tower), binding stones with regular intervals were set at the corner for the later continuation of the wall. The binding stones were jutting out of the wall by about 35 cm (Fig. 9). Also, remains of the curtain wall were uncovered when clearing the bottom of the excavation. This indicates that, when erecting the dwelling tower, there were already plans to establish a housekeeping yard that was protected by a wall and to join the curtain wall to the tower's south-western corner.

Trench no 4 was dug at the junction between the dwelling's older and newer sections, on the northern side of the main castle, to determine the architectural connection between the various stages of construction (Fig. 6: 4). The geo-basis indicates that the building's older

Trench no 6 was erected at the presumed junction between the curtain wall's east side and the main castle's south wing (Fig. 6: 6). There are several wall sections from the south buildings that are visible in the castle's courtyard, and the wall's line at the courtyard side is pretty easily visible. Upon opening up the presumed junction point, it turned out that the buildings do not reach the curtain wall. Similarly to the case with the dwelling house's newer section, there is a gap that is 7 m wide between the south wing's building and the curtain wall's east side (see Fig. 12: 5, 6, 8). The wall had been opened in two places on the curtain wall's east side (at a height of about 8–9 m above sea level), and its measured thickness was about 120 cm in any case (see Fig. 12: 6).

Trench no 7 was dug at the presumed junction between the curtain wall's west side and the main castle's south wing buildings (Fig. 6: 7). The trench unearthed the curtain wall's west side for a length of about 2.7 m, and the wall's thickness in the excavation was measured at 125–140 cm at a height of 7.5–8 m above sea level. This is a little more than in other excavations. In some places the wall's interior side was preserved to a height that was up to 50 cm higher than its outer side. A series of buildings or rather rooms that had been arranged in a line and which measured about 43 m in length had been built against the curtain wall's west side. As was discovered during the excavation, the buildings had been separated from the curtain wall by a vertical joint. Therefore it could be seen that the south wing's buildings were erected only after the curtain wall had been completed. The thickness of the courtyard-side wall of the building, which had been laid against the curtain wall's west side, was 110 cm, while the width of the rooms (the distance from the curtain wall's south side) was about 8.5 m (see Fig. 12: 7).

Trench no 8 unearthed the junction between the curtain wall's south side and the buildings of the main castle's south wing, and this trench became an addition to trench no 6 (Fig. 6: 8). The buildings of the main castle's south wing ended at approximately the same line with the northern wing (the dwelling house's newer section). About seven metres of empty land was left between the curtain wall's east side and the south wing's buildings (see Fig. 12). It turned out that the buildings had been built against the curtain wall and the walls had been separated by a vertical joint (Fig. 11). Both limestone walls had been severely damaged by fire. In addition to trench no 8, it was possible to inspect the path and the thickness of the curtain wall at several more sites on the castle's south side (see Fig. 12). The wall had been preserved under the topsoil at an average height of 8 m above sea level and its thickness was measured as being between 120–130 cm.

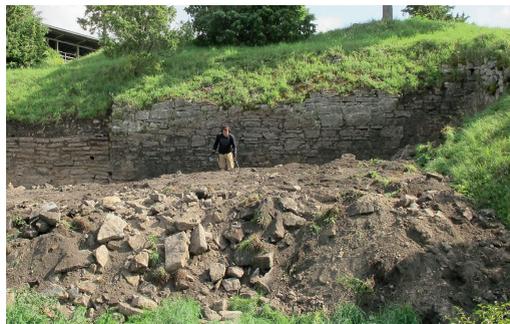
Fig. 7. A section of the big surrounding wall cleared on the castle's western side (pit 1), where no gates were found. The middle of the photo shows the higher wall of a probable earlier building, to which the later section of the surrounding wall (on the left) and a corner tower (on the right) were added. The background (on the left) displays the main Maasi Castle building. View from the south-west.

was separated from the curtain wall that had been laid against it by a vertical joint that could be tracked to the height of at least two metres (Fig. 7). Further away from the building, the curtain wall repeatedly changed its direction and was constructed not only of limestone, but also of suitable boulders (Fig. 7).

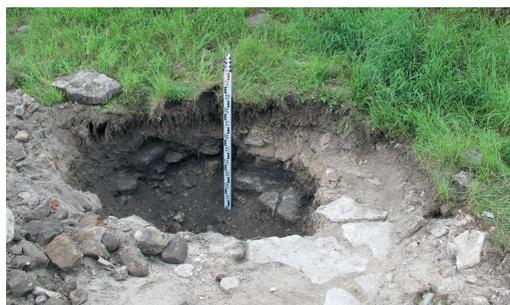
Fig. 8. Pavement laid with irregular limestone slabs and lime mortar, and an earlier pavement laid directly on soil, in the castle's courtyard (pit 2).

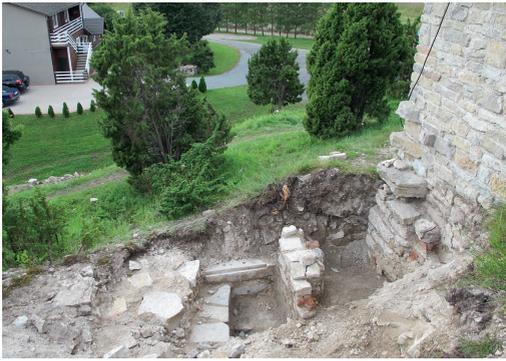
Fig. 9. Opening the surrounding wall at the dwelling tower's south-west corner (pit 3), where binding stones are seen jutting out of the wall. View of a probable embrasure (on the right) and remains of a window.

The wall's thickness at the height of the second floor (around 8.5–9 m above sea level) was at 120 cm and, while clearing it, a presumed broken embrasure and a window niche were found (Fig. 9). So there were at least two floors of a building on the dwelling tower's southern side, something that is also reminiscent of Kuressaare's early *castellum* with its corner tower (Püüa *et al.* 2016, 32–44 and fig. 19). The embrasure was located directly beside the dwelling tower (30–60 cm away) and its external end was broken. The embrasure's side which faced towards the tower was made up of jutting binding stones, with limestone and brick fragments packed tight between them. After that, the wall had been plastered smooth with lime grout. Right beside the embrasure (with a partition wall that was only about 30–60 cm thick) was a window niche about 95–120 cm wide. A presumed sitting bench about 30–45 cm wide, which had been laid with limestone was on its southern side. The room's wall towards the dwelling tower and probably the entire interior of the room were plastered with mortar.

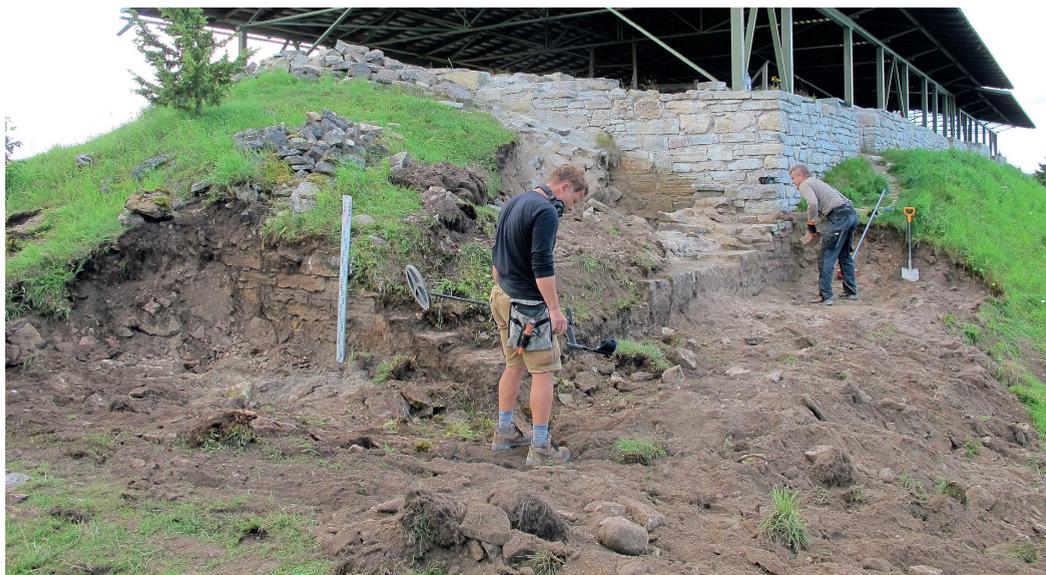
Fig. 10. Clearing the surrounding wall's north-east corner at the eastern side of the extended dwelling building (pit 5). The extension was laid directly against the surrounding wall's inner side.

According to Tõnu Sepp, who dealt with clearing, conserving, and reroofing the dwelling house's walls from 2001 to 2004, a clearly visible vertical joint was present in the north wall of the building's newer section, just as though the initial wall had afterwards been made thicker on the inside (see Fig. 12: 4). Unfortunately, photos of the joint that was found whilst clearing the wall have not been preserved. This is of significance for **trench no 5**, which was erected on the north-east side of the dwelling's newer section (Fig. 6: 5). Upon opening up the corner, it was discovered that the curtain wall continued from the dwelling house towards the east and was homogeneous with the laying of the building's wall, at least on the outside. No vertical joint or binding stones were visible, unlike in earlier excavations. On the one hand there was a vertical joint between the curtain wall's interior side and the dwelling house's newer section.³ It seems that the building's newer section was built against the existing curtain wall (width 120 cm) and the curtain wall was made thicker by more than a metre inside the dwelling in the course of its construction. The geo-basis indicates that the wall's total thickness is about 275–285 cm (see Fig. 12: 5). The curtain wall continued for about 6.5 m towards the east from the dwelling house's newer section and then turned towards the south at a right angle (Fig. 10). Trench no 5 provides evidence for an opinion that the tower's

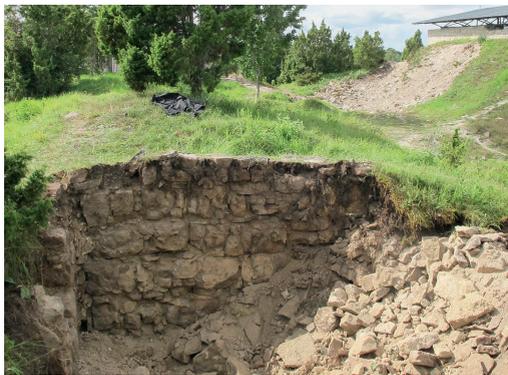
Fig. 11. View from the north-east onto the surrounding wall's southern side (on the left) and the building erected directly against it (trench no 8). A vertical joint is visible between the surrounding wall and the building. Both walls had been damaged by fire. On the right, Maasi Castle's main building.
